Manhole Inspection Report

Date:	11/01/2022	Weather:		Coding:	RZMACP
MH#:	M-809-051	Owner:	NA	Len. Surveyed:	6.1
P.O.#:		Surveyor:	Jen Costello	Rim to Invert:	7.2
Customer:		Cert. #:	U-907-5518	Wall Material:	Concrete (non-reinforced)

Street:	Bracken Parkway. 177' Southwest of	Project:	Missing GPS
City:	Hobart, IN	GPS Northing:	2278668.692
Location:		GPS Easting:	2908777.199
Drain Area:	Southwest	GPS Accuracy:	Sub-Meter
Cover Shape:	Circular	Evidence of Surcharge:	No
Cover Size:	24.0	Potential for Runoff:	None
Comments:

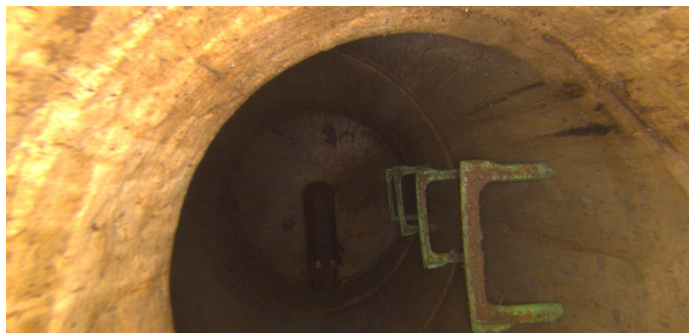
Code: **SRI**
Description: **Surface Roughness Increased**

Distance (ft): **.0**
Structural Grade: **1**
O&M Grade: **0**
Clock Start/From: **12**
Clock To: **12**
1st Value:
2nd Value:
Value Percent:
Step: **NO**
Remarks:

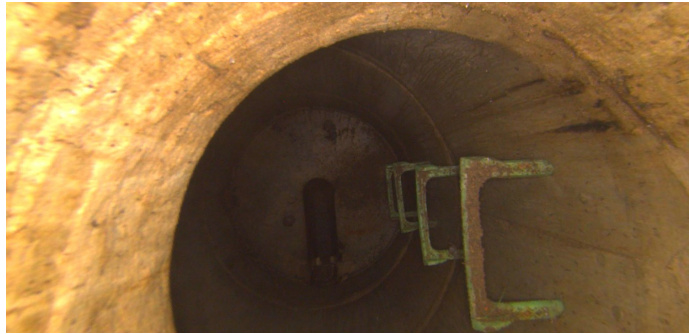
Code: **IW**
Description: **Infil Weeper**

Distance (ft): **.0**
Structural Grade: **0**
O&M Grade: **2**
Clock Start/From: **1**
Clock To: **2**
1st Value:
2nd Value:
Value Percent:
Step: **NO**
Remarks:

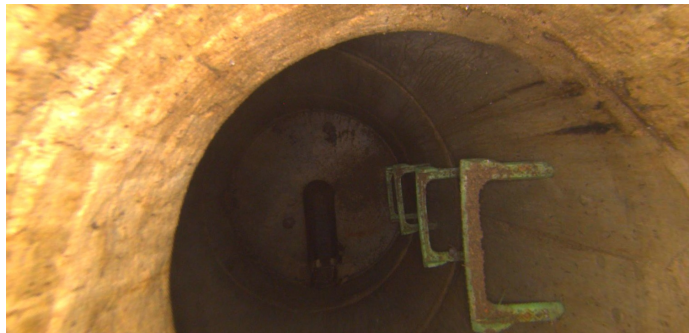
Code: **MGO**
Description: **General Observation**

Distance (ft): **.0**
Structural Grade: **0**
O&M Grade: **0**
Clock Start/From:
Clock To:
1st Value:
2nd Value:
Value Percent:
Step: **NO**
Remarks: **access mh**

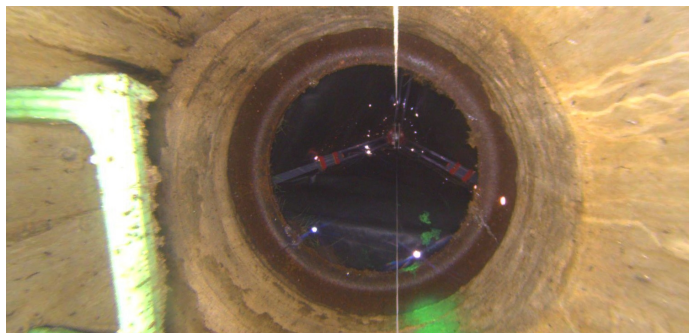
Code: **MGO**
Description: **General Observation**

Distance (ft): **2.3**
Structural Grade: **0**
O&M Grade: **0**
Clock Start/From:
Clock To:
1st Value:
2nd Value:
Value Percent:
Step: **NO**
Remarks: **underside of frame**

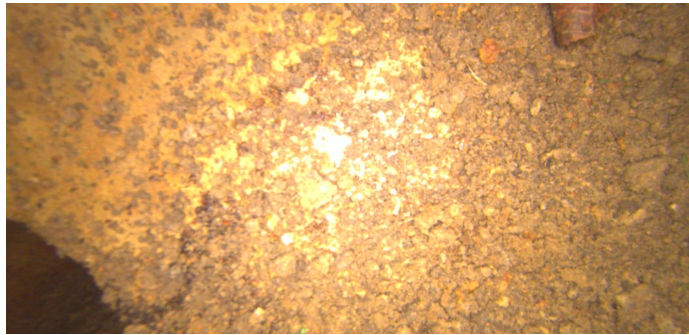
Code: **DSF**
Description: **Deposits Settled Fine**

Distance (ft): **6.1**
Structural Grade: **0**
O&M Grade: **2**
Clock Start/From: **12**
Clock To: **12**
1st Value:
2nd Value:
Value Percent: **5.000**
Step: **NO**
Remarks:

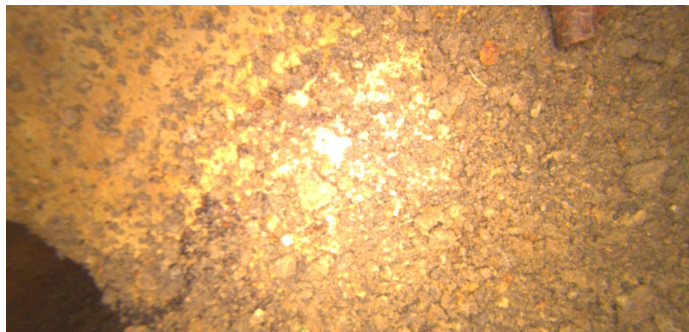
Code: **SRI**
Description: **Surface Roughness Increased**

Distance (ft): **6.1**
Structural Grade: **1**
O&M Grade: **0**
Clock Start/From: **12**
Clock To: **12**
1st Value:
2nd Value:
Value Percent:
Step: **NO**
Remarks:

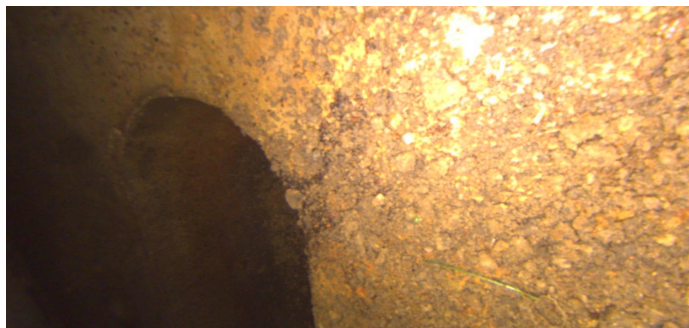
Code: **MGO**
Description: **General Observation**

Distance (ft): **6.1**
Structural Grade: **0**
O&M Grade: **0**
Clock Start/From:
Clock To:
1st Value:
2nd Value:
Value Percent:
Step: **NO**
Remarks: **end of survey**
