# Manhole Inspection Report

Date:	<b>11/01/2022</b>	Weather:		Coding:	<b>RZMACP</b>
MH#:	<b>M-809-054</b>	Owner:	<b>NA</b>	Len. Surveyed:	<b>8.5</b>
P.O.#:		Surveyor:	<b>Jen Costello</b>	Rim to Invert:	<b>9.4</b>
Customer:		Cert. #:	<b>U-907-5518</b>	Wall Material:	<b>Concrete (non-reinforced)</b>

Street:	<b>Bracken Parkway. 1023' Southwest</b>	Project:	<b>Missing GPS</b>
City:	<b>Hobart, IN</b>	GPS Northing:	<b>2278616.239</b>
Location:		GPS Easting:	<b>2907872.984</b>
Drain Area:	<b>Southwest</b>	GPS Accuracy:	<b>Sub-Meter</b>
Cover Shape:	<b>Circular</b>	Evidence of Surcharge:	<b>No</b>
Cover Size:	<b>24.0</b>	Potential for Runoff:	<b>None</b>
Comments:

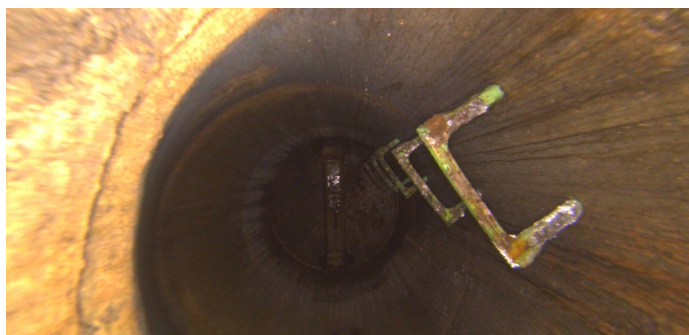
Code: **MGO**  
Description: **General Observation**

Distance (ft): **.0**  
Structural Grade: **0**  
O&M Grade: **0**  
Clock Start/From:  
Clock To:  
1st Value:  
2nd Value:  
Value Percent:  
Step: **NO**  
Remarks: **access mh**

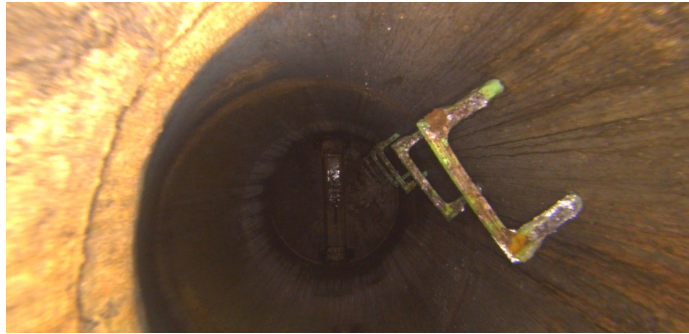
Code: **SRI**  
Description: **Surface Roughness Increased**

Distance (ft): **.0**  
Structural Grade: **1**  
O&M Grade: **0**  
Clock Start/From: **12**  
Clock To: **12**  
1st Value:  
2nd Value:  
Value Percent:  
Step: **NO**  
Remarks:

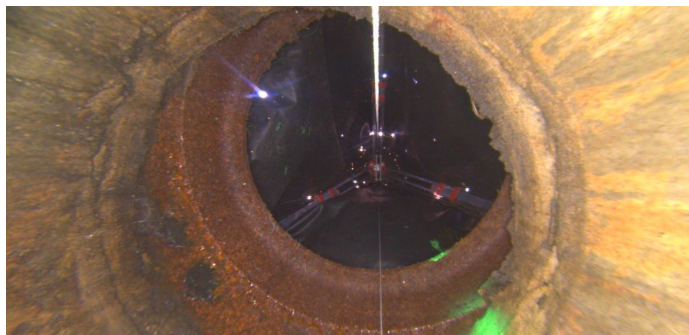
Code: **MGO**  
Description: **General Observation**

Distance (ft): **1.9**  
Structural Grade: **0**  
O&M Grade: **0**  
Clock Start/From:  
Clock To:  
1st Value:  
2nd Value:  
Value Percent:  
Step: **NO**  
Remarks: **underside of frame**

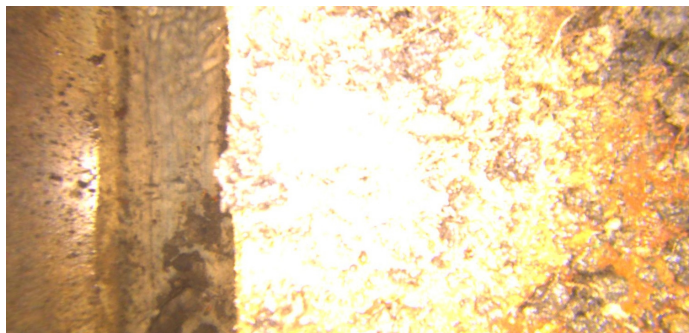
Code: **SRI**  
Description: **Surface Roughness Increased**

Distance (ft): **8.5**  
Structural Grade: **1**  
O&M Grade: **0**  
Clock Start/From: **12**  
Clock To: **12**  
1st Value:  
2nd Value:  
Value Percent:  
Step: **NO**  
Remarks:

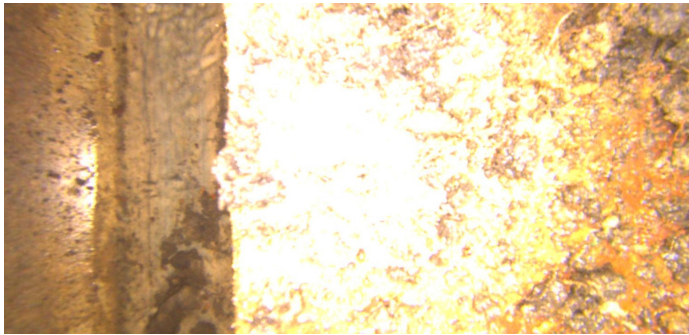
Code: **SRI**  
Description: **Surface Roughness Increased**

Distance (ft): **8.5**  
Structural Grade: **1**  
O&M Grade: **0**  
Clock Start/From: **3**  
Clock To: **9**  
1st Value:  
2nd Value:  
Value Percent:  
Step: **NO**  
Remarks:

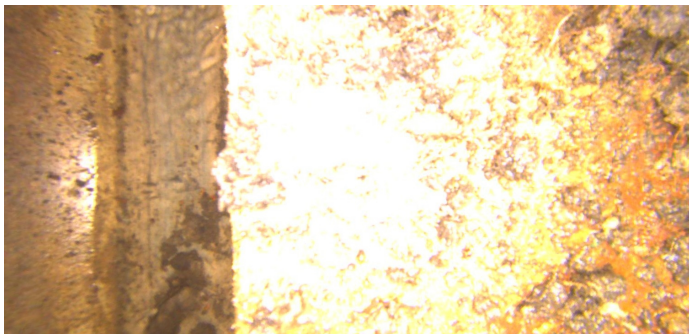
Code: **DSF**  
Description: **Deposits Settled Fine**

Distance (ft): **8.5**  
Structural Grade: **0**  
O&M Grade: **2**  
Clock Start/From: **12**  
Clock To: **12**  
1st Value:  
2nd Value:  
Value Percent: **5.000**  
Step: **NO**  
Remarks:
