Manhole Inspection Report

Date:	09/19/2022	Weather:		Coding:	RZMACP
MH#:	M-902-003	Owner:	NA	Len. Surveyed:	5.9
P.O.#:		Surveyor:	Jen Costello	Rim to Invert:	6.8
Customer:		Cert. #:	U-907-5518	Wall Material:	Concrete (cast in place)

Street:	North of Hwy 6. 358' East of St Josep	Project:	Hobart, IN
City:	Hobart, IN	GPS Northing:	2296090.538
Location:	Yard	GPS Easting:	2910952.002
Drain Area:	Northeast	GPS Accuracy:	Sub-Meter
Cover Shape:	Circular	Evidence of Surcharge:	No
Cover Size:	24.0	Potential for Runoff:	None
Comments:

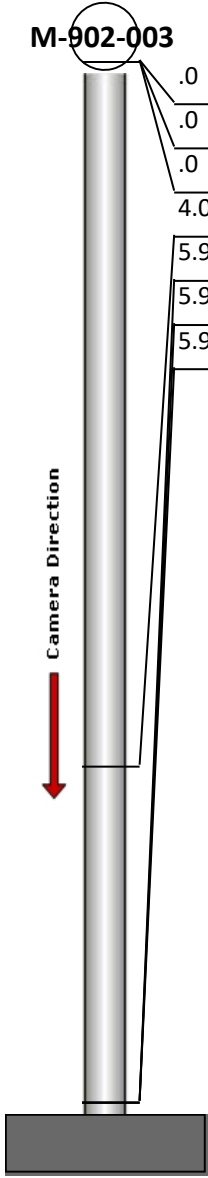
.0	MGO	General Observation	10	NA
	.0	B	Broken	21	S 5
	.0	SAV	Surface Aggregate Visible	32	S 3
	4.0	MGO	General Observation	54	NA
	5.9	DSF	Deposits Settled Fine	71	M 2
	5.9	SAV	Surface Aggregate Visible	82	S 3
	5.9	MGO	General Observation	93	NA

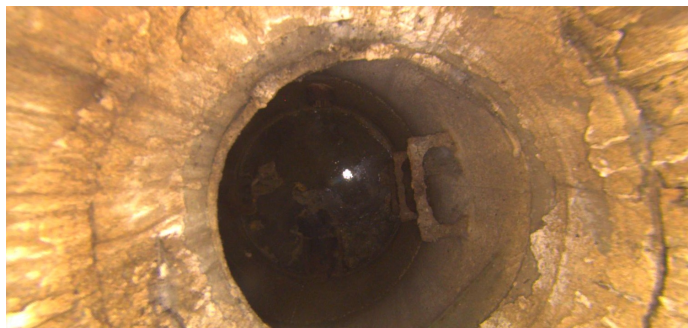
Code: **MGO**
Description: **General Observation**

Distance (ft): **.0**
Structural Grade: **0**
O&M Grade: **0**
Clock Start/From:
Clock To:
1st Value:
2nd Value:
Value Percent:
Step: **NO**
Remarks: **access mh**

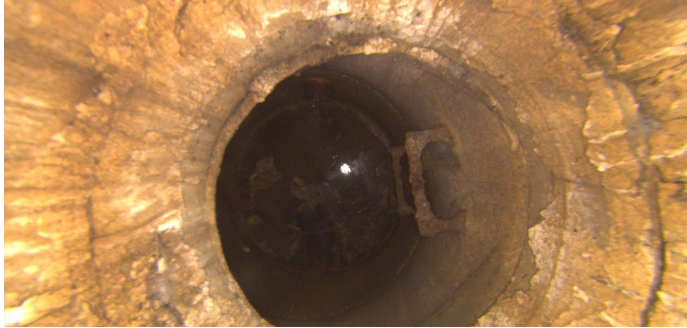
Code: **B**
Description: **Broken**

Distance (ft): **.0**
Structural Grade: **5**
O&M Grade: **0**
Clock Start/From: **12**
Clock To: **12**
1st Value:
2nd Value:
Value Percent:
Step: **NO**
Remarks:

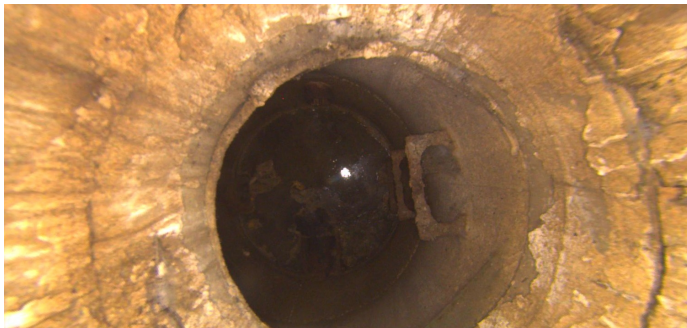
Code: **SAV**
Description: **Surface Aggregate Visible**

Distance (ft): **.0**
Structural Grade: **3**
O&M Grade: **0**
Clock Start/From: **12**
Clock To: **12**
1st Value:
2nd Value:
Value Percent:
Step: **NO**
Remarks:

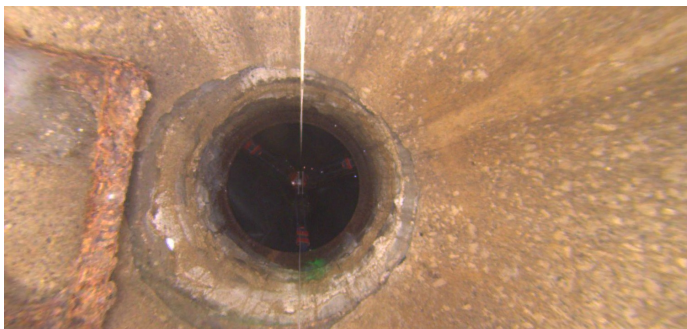
Code: **MGO**
Description: **General Observation**

Distance (ft): **4.0**
Structural Grade: **0**
O&M Grade: **0**
Clock Start/From:
Clock To:
1st Value:
2nd Value:
Value Percent:
Step: **NO**
Remarks: **underside of frame**

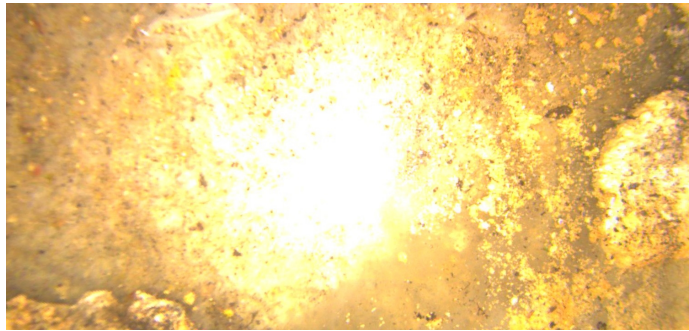
Code: **DSF**
Description: **Deposits Settled Fine**

Distance (ft): **5.9**
Structural Grade: **0**
O&M Grade: **2**
Clock Start/From: **12**
Clock To: **12**
1st Value:
2nd Value:
Value Percent: **5.000**
Step: **NO**
Remarks:

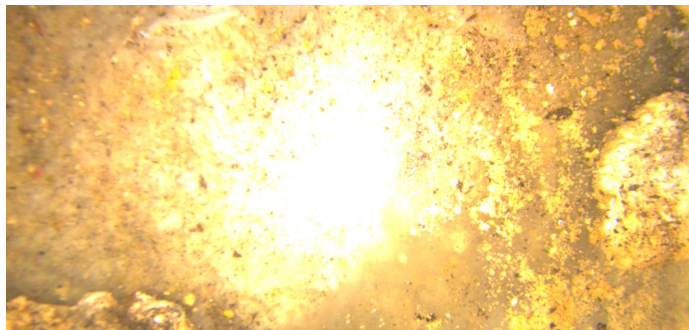
Code: **SAV**
Description: **Surface Aggregate Visible**

Distance (ft): **5.9**
Structural Grade: **3**
O&M Grade: **0**
Clock Start/From: **12**
Clock To: **12**
1st Value:
2nd Value:
Value Percent:
Step: **NO**
Remarks:

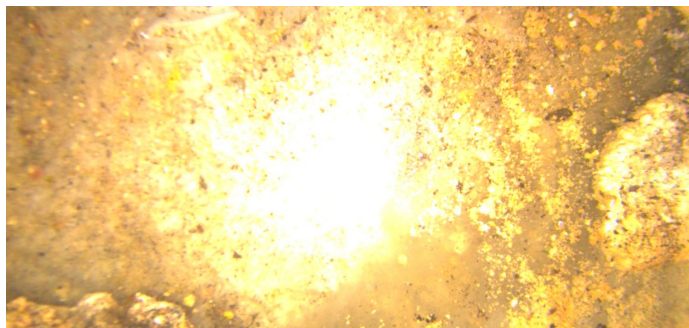
Code: **MGO**
Description: **General Observation**

Distance (ft): **5.9**
Structural Grade: **0**
O&M Grade: **0**
Clock Start/From:
Clock To:
1st Value:
2nd Value:
Value Percent:
Step: **NO**
Remarks: **end of survey**
