Manhole Inspection Report

Date:	03/24/2018	Weather:		Coding:	RZMACP
MH#:	M-902-008	Owner:	NA	Len. Surveyed:	6.8
P.O.#:		Surveyor:	John Kuglmaier	Rim to Invert:	8.0
Customer:		Cert. #:	U-1215-07002349	Wall Material:	Concrete (reinforced)

Street:	Spencer Pl. and 34th Ln. to the Sout	Project:	Hobart, IN
City:	Hobart, IN	GPS Northing:	0.0
Location:		GPS Easting:	0.0
Drain Area:	Northeast	GPS Accuracy:	Nearest Meter
Cover Shape:	Circular	Evidence of Surcharge:	No
Cover Size:	23.0	Potential for Runoff:	None
Comments:

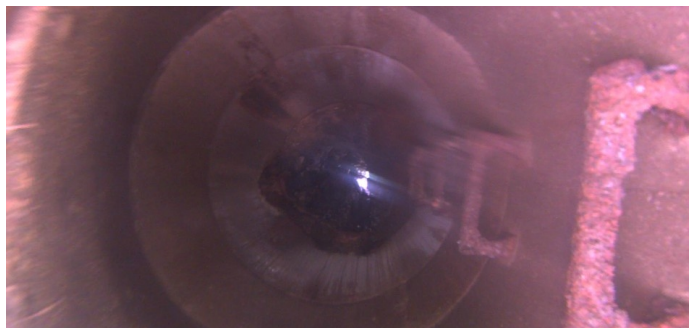
Code: **MGP**
Description: **General Photo**

Distance (ft): **.0**
Structural Grade: **0**
O&M Grade: **0**
Clock Start/From:
Clock To:
1st Value:
2nd Value:
Value Percent:
Step: **NO**
Remarks:

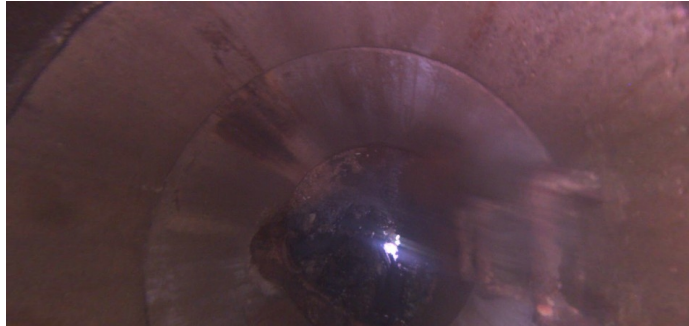
Code: **IS**
Description: **Infil Stain**

Distance (ft): **1.6**
Structural Grade: **0**
O&M Grade: **0**
Clock Start/From: **10**
Clock To:
1st Value:
2nd Value:
Value Percent:
Step: **NO**
Remarks:

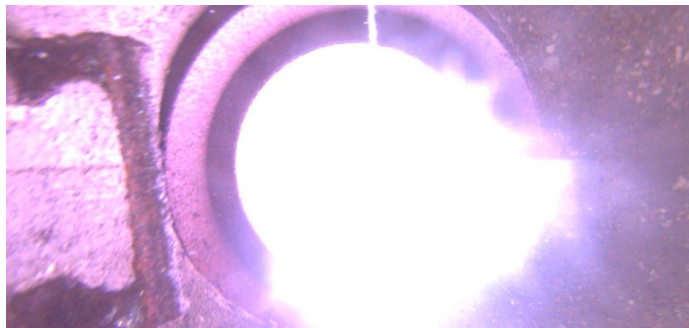
Code: **MGP**
Description: **General Photo**

Distance (ft): **1.8**
Structural Grade: **0**
O&M Grade: **0**
Clock Start/From:
Clock To:
1st Value:
2nd Value:
Value Percent:
Step: **NO**
Remarks:

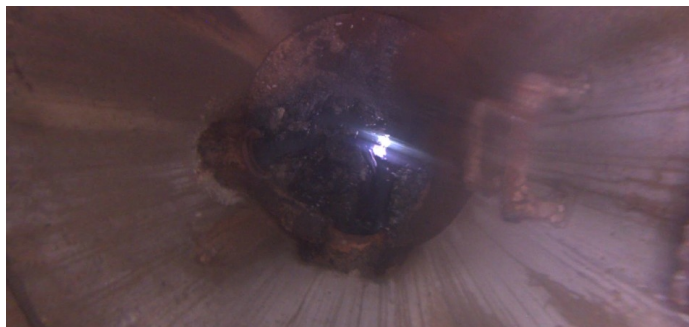
Code: **IS**
Description: **Infil Stain**

Distance (ft): **2.9**
Structural Grade: **0**
O&M Grade: **0**
Clock Start/From: **8**
Clock To:
1st Value:
2nd Value:
Value Percent:
Step: **NO**
Remarks:

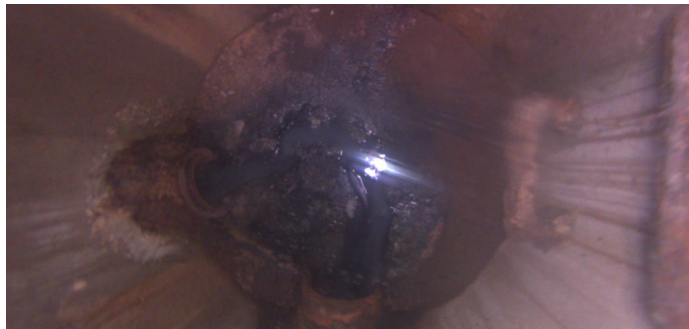
Code:	DAZ
Description:	Deposits Attached Other
Distance (ft):	4.1
Structural Grade:	0
O&M Grade:	2
Clock Start/From:	12
Clock To:	12
1st Value:	
2nd Value:	
Value Percent:	10.000
Step:	NO
Remarks:	Mixed materials

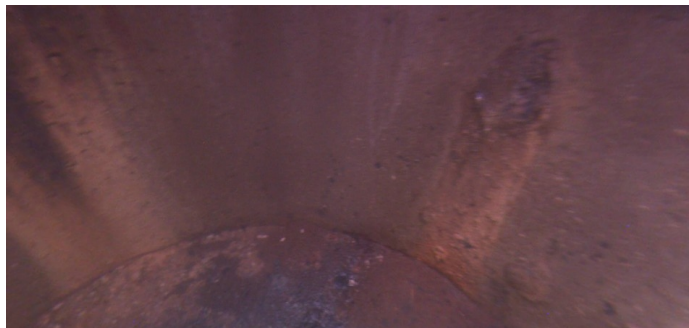
Code:	IS
Description:	Infil Stain
Distance (ft):	5.1
Structural Grade:	0
O&M Grade:	0
Clock Start/From:	2
Clock To:	
1st Value:	
2nd Value:	
Value Percent:	
Step:	NO
Remarks:

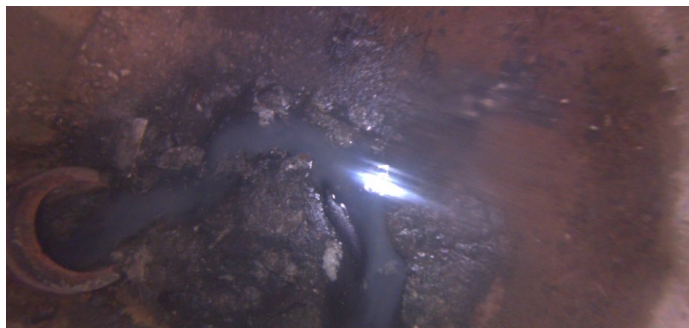
Code:	MGO
Description:	General Observation
Distance (ft):	5.6
Structural Grade:	0
O&M Grade:	0
Clock Start/From:	
Clock To:	
1st Value:	
2nd Value:	
Value Percent:	
Step:	NO
Remarks:	Ins. Comp.
