Manhole Inspection Report

Date:	03/25/2018	Weather:		Coding:	RZMACP
MH#:	M-902-017	Owner:	NA	Len. Surveyed:	7.7
P.O.#:		Surveyor:	John Kuglmaier	Rim to Invert:	8.6
Customer:		Cert. #:	U-1215-07002349	Wall Material:	Concrete (reinforced)

Street:	179' East of Shelby St. and 34th Ct.	Project:	Hobart, IN
City:	Hobart, IN	GPS Northing:	0.0
Location:		GPS Easting:	0.0
Drain Area:	Northeast	GPS Accuracy:	Nearest Meter
Cover Shape:	Circular	Evidence of Surcharge:	No
Cover Size:	23.0	Potential for Runoff:	None
Comments:

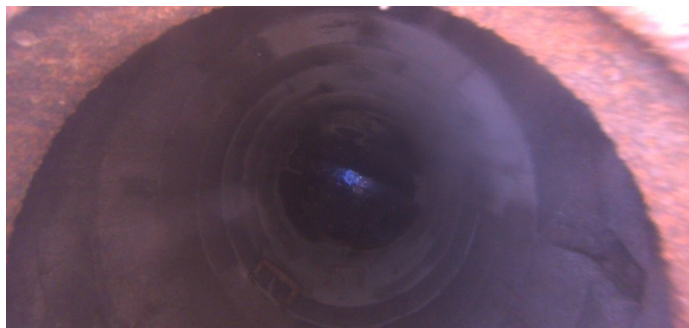
Code: **MGP**
Description: **General Photo**

Distance (ft): **.0**
Structural Grade: **0**
O&M Grade: **0**
Clock Start/From:
Clock To:
1st Value:
2nd Value:
Value Percent:
Step: **NO**
Remarks:

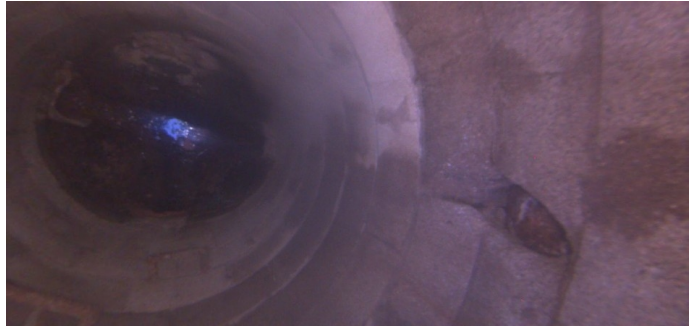
Code: **HSV**
Description: **Hole Soil Visible**

Distance (ft): **1.1**
Structural Grade: **5**
O&M Grade: **0**
Clock Start/From: **4**
Clock To:
1st Value:
2nd Value:
Value Percent:
Step: **NO**
Remarks:

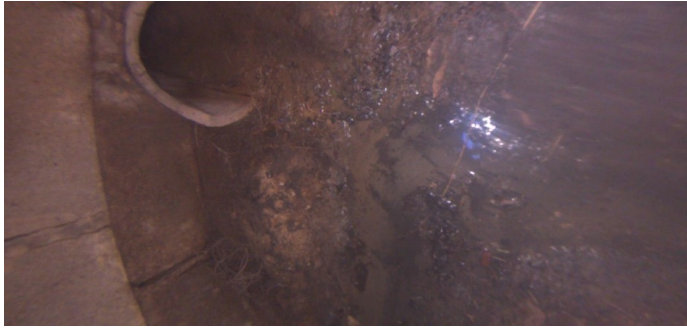
Code: **RFJ**
Description: **Roots Fine Joint**

Distance (ft): **6.8**
Structural Grade: **0**
O&M Grade: **1**
Clock Start/From: **8**
Clock To:
1st Value:
2nd Value:
Value Percent:
Step: **NO**
Remarks:

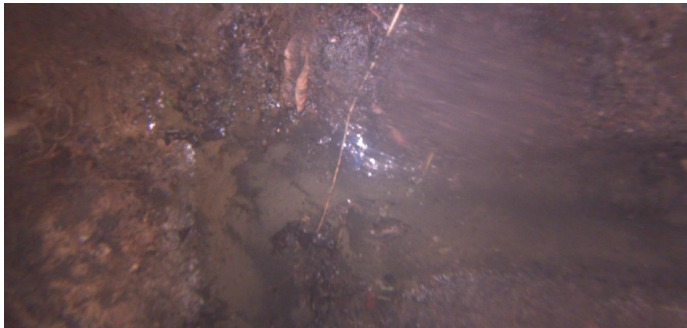
Code: **MGO**
Description: **General Observation**

Distance (ft): **7.1**
Structural Grade: **0**
O&M Grade: **0**
Clock Start/From:
Clock To:
1st Value:
2nd Value:
Value Percent:
Step: **NO**
Remarks: **Ins. Comp.**
