# Manhole Inspection Report

Date:	<b>03/24/2018</b>	Weather:		Coding:	<b>RZMACP</b>
MH#:	<b>M-902-018</b>	Owner:	<b>NA</b>	Len. Surveyed:	<b>9.3</b>
P.O.#:		Surveyor:	<b>John Kuglmaier</b>	Rim to Invert:	<b>10.0</b>
Customer:		Cert. #:	<b>U-1215-07002349</b>	Wall Material:	<b>Concrete (reinforced)</b>

Street:	<b>Spencer Pl. and 34th Ln.</b>	Project:	<b>Hobart, IN</b>
City:	<b>Hobart, IN</b>	GPS Northing:	<b>0.0</b>
Location:		GPS Easting:	<b>0.0</b>
Drain Area:	<b>Northeast</b>	GPS Accuracy:	<b>Nearest Meter</b>
Cover Shape:	<b>Circular</b>	Evidence of Surcharge:	<b>No</b>
Cover Size:	<b>23.0</b>	Potential for Runoff:	<b>None</b>
Comments:

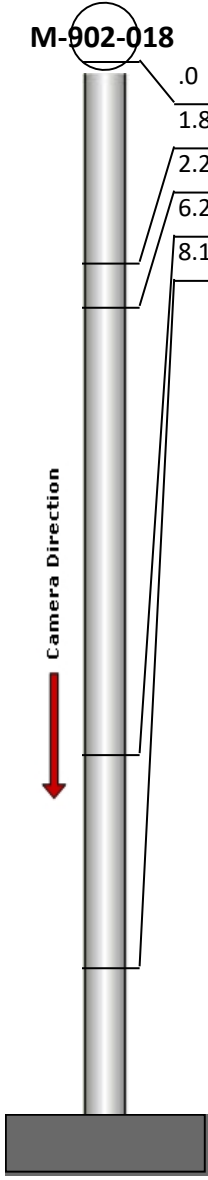
.0	MGP	General Photo	10	NA
	1.8	OBI	Obstacle Intruding Thru Wall	25	M 2
	2.2	MGP	General Photo	40	NA
	6.2	DSF	Deposits Settled Fine	61	M 2
	8.1	MGO	General Observation	77	NA

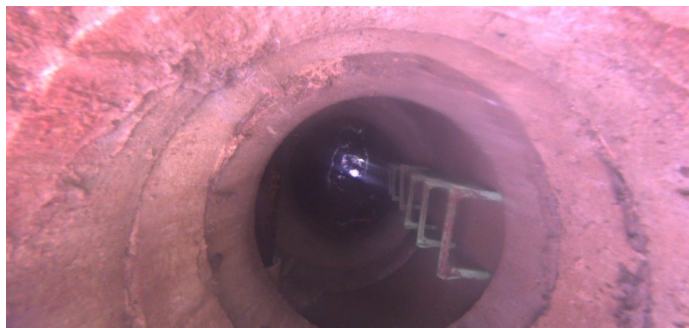
Code: **MGP**  
Description: **General Photo**

Distance (ft): **.0**  
Structural Grade: **0**  
O&M Grade: **0**  
Clock Start/From:  
Clock To:  
1st Value:  
2nd Value:  
Value Percent:  
Step: **NO**  
Remarks:

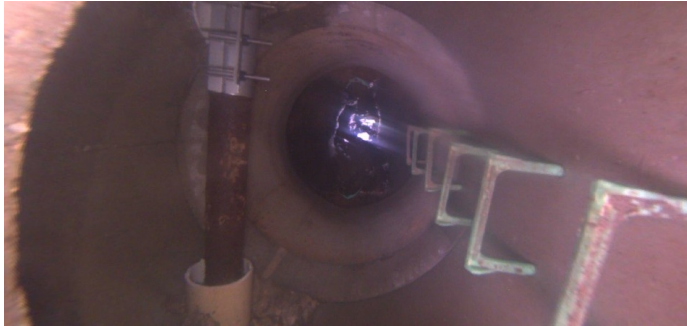
Code: **OBI**  
Description: **Obstacle Intruding Thru Wall**

Distance (ft): **1.8**  
Structural Grade: **0**  
O&M Grade: **2**  
Clock Start/From: **7**  
Clock To: **11**  
1st Value:  
2nd Value:  
Value Percent: **10.000**  
Step: **NO**  
Remarks:

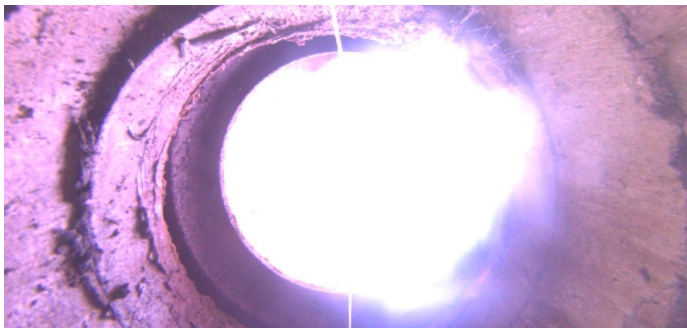
Code: **MGP**  
Description: **General Photo**

Distance (ft): **2.2**  
Structural Grade: **0**  
O&M Grade: **0**  
Clock Start/From:  
Clock To:  
1st Value:  
2nd Value:  
Value Percent:  
Step: **NO**  
Remarks:

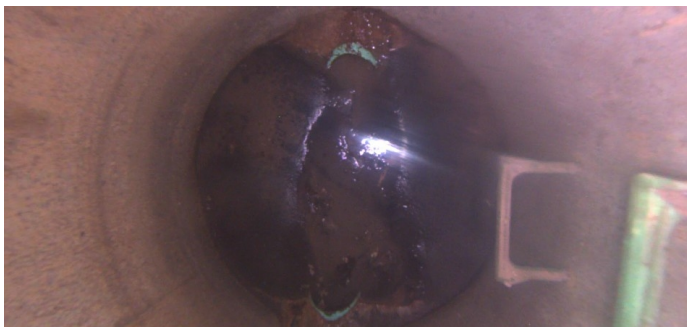
Code: **DSF**  
Description: **Deposits Settled Fine**

Distance (ft): **6.2**  
Structural Grade: **0**  
O&M Grade: **2**  
Clock Start/From: **12**  
Clock To: **12**  
1st Value:  
2nd Value:  
Value Percent: **10.000**  
Step: **NO**  
Remarks:

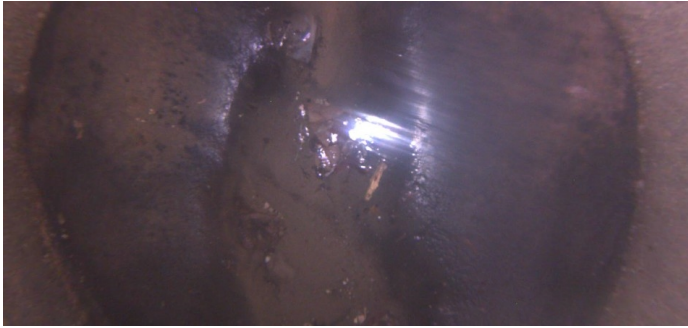
Code:	<b>MGO</b>
Description:	<b>General Observation</b>
Distance (ft):	<b>8.1</b>
Structural Grade:	<b>0</b>
O&M Grade:	<b>0</b>
Clock Start/From:	
Clock To:	
1st Value:	
2nd Value:	
Value Percent:	
Step:	<b>NO</b>
Remarks:	<b>Ins. Comp.</b>
