# Manhole Inspection Report

Date:	05/16/2018	Weather:		Coding:	RZMACP
MH#:	M-902-039	Owner:	NA	Len. Surveyed:	12.9
P.O.#:		Surveyor:	Jen Costello	Rim to Invert:	13.2
Customer:		Cert. #:	U-907-5518	Wall Material:	Brick

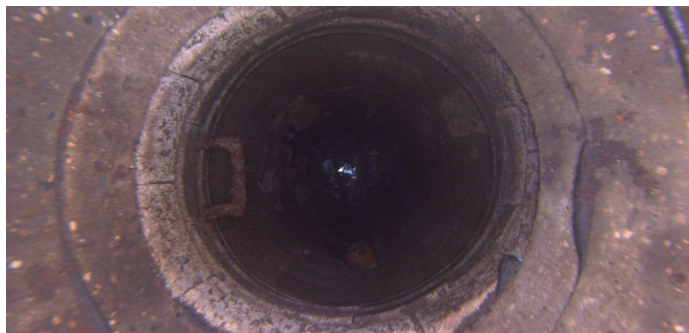
Code: **MGO**  
Description: **General Observation**

Distance (ft): **.0**  
Structural Grade: **0**  
O&M Grade: **0**  
Clock Start/From:  
Clock To:  
1st Value:  
2nd Value:  
Value Percent:  
Step: **NO**  
Remarks: **access mh**

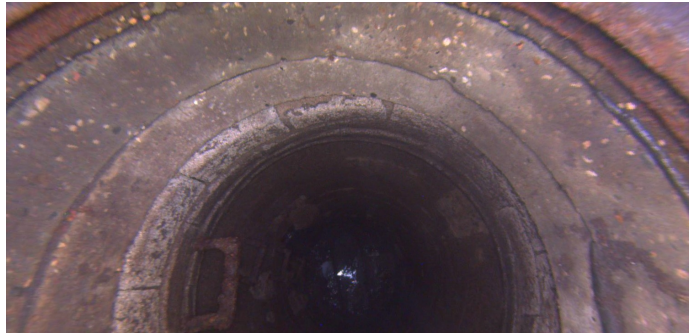
Code:	<b>SAV</b>
Description:	<b>Surface Aggregate Visible</b>
Distance (ft):	<b>.0</b>
Structural Grade:	<b>3</b>
O&M Grade:	<b>0</b>
Clock Start/From:	<b>12</b>
Clock To:	<b>12</b>
1st Value:	
2nd Value:	
Value Percent:	
Step:	<b>NO</b>
Remarks:

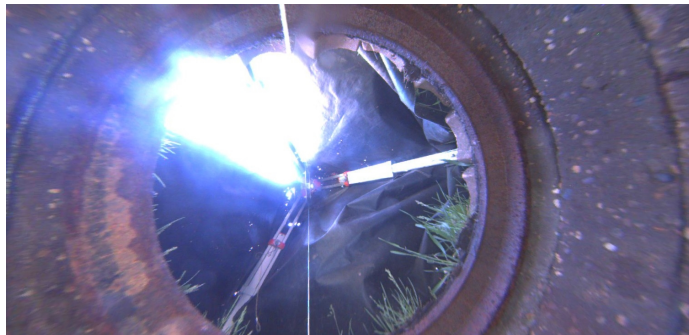
Code:	<b>MGO</b>
Description:	<b>General Observation</b>
Distance (ft):	<b>1.6</b>
Structural Grade:	<b>0</b>
O&M Grade:	<b>0</b>
Clock Start/From:	
Clock To:	
1st Value:	
2nd Value:	
Value Percent:	
Step:	<b>NO</b>
Remarks:	<b>underside of frame</b>

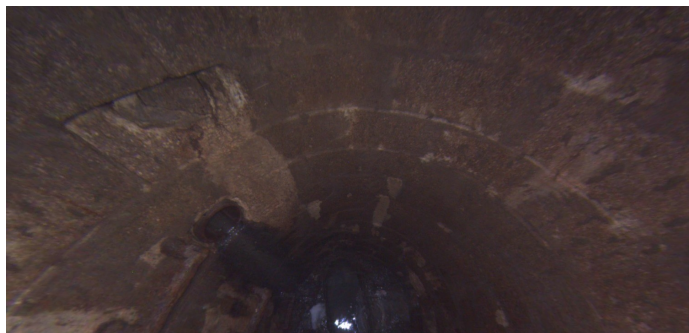
Code:	<b>B</b>
Description:	<b>Broken</b>
Distance (ft):	<b>5.6</b>
Structural Grade:	<b>4</b>
O&M Grade:	<b>0</b>
Clock Start/From:	<b>10</b>
Clock To:	<b>11</b>
1st Value:	
2nd Value:	
Value Percent:	
Step:	<b>NO</b>
Remarks:

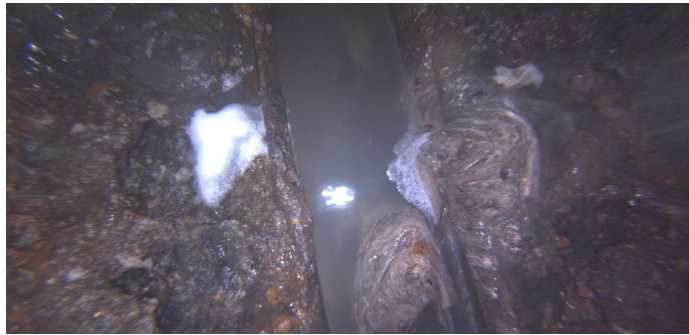
Code:	<b>DSF</b>
Description:	<b>Deposits Settled Fine</b>
Distance (ft):	<b>12.7</b>
Structural Grade:	<b>0</b>
O&M Grade:	<b>2</b>
Clock Start/From:	<b>12</b>
Clock To:	<b>12</b>
1st Value:	
2nd Value:	
Value Percent:	<b>10.000</b>
Step:	<b>NO</b>
Remarks:

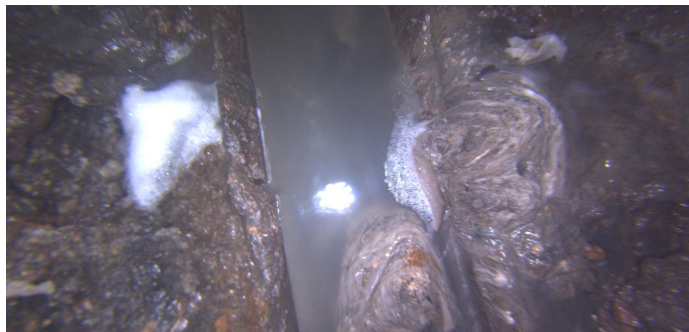
Code:	<b>MGO</b>
Description:	<b>General Observation</b>
Distance (ft):	<b>12.9</b>
Structural Grade:	<b>0</b>
O&M Grade:	<b>0</b>
Clock Start/From:	
Clock To:	
1st Value:	
2nd Value:	
Value Percent:	
Step:	<b>NO</b>
Remarks:	<b>end survey</b>
