# Manhole Inspection Report

Date:	<b>03/25/2018</b>	Weather:		Coding:	<b>RZMACP</b>
MH#:	<b>M-902-040</b>	Owner:	<b>NA</b>	Len. Surveyed:	<b>10.7</b>
P.O.#:		Surveyor:	<b>John Kuglmaier</b>	Rim to Invert:	<b>11.6</b>
Customer:		Cert. #:	<b>U-1215-07002349</b>	Wall Material:	<b>Concrete (reinforced)</b>

Street:	<b>South of 34th Ln. 374' East of St. Jos</b>	Project:	<b>Hobart, IN</b>
City:	<b>Hobart, IN</b>	GPS Northing:	<b>0.0</b>
Location:		GPS Easting:	<b>0.0</b>
Drain Area:	<b>Northeast</b>	GPS Accuracy:	<b>Nearest Meter</b>
Cover Shape:	<b>Circular</b>	Evidence of Surcharge:	<b>No</b>
Cover Size:	<b>23.0</b>	Potential for Runoff:	<b>None</b>
Comments:

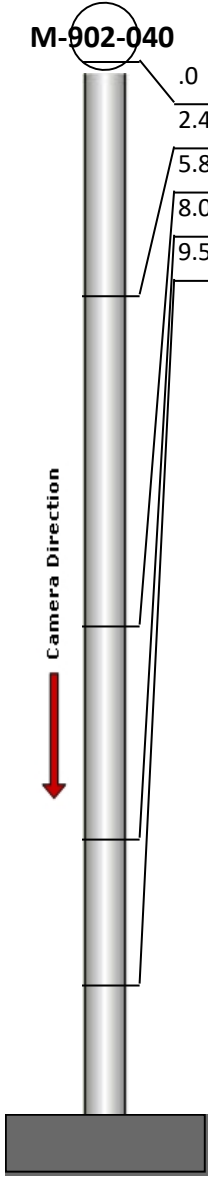
.0	MGP	General Photo	10	NA
	2.4	MGP	General Photo	29	NA
	5.8	IS	Infil Stain	49	NA
	8.0	DAZ	Deposits Attached Other	65	M 2
	9.5	MGO	General Observation	79	NA

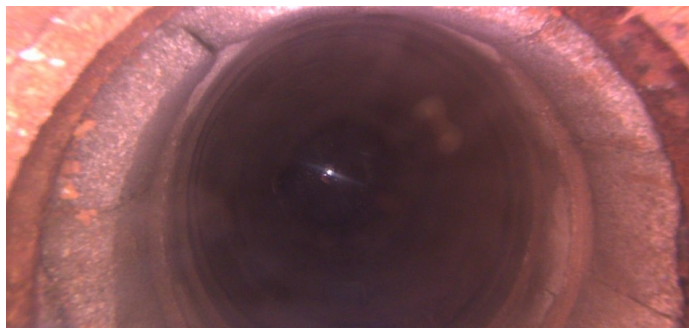
Code: **MGP**  
Description: **General Photo**

Distance (ft): **.0**  
Structural Grade: **0**  
O&M Grade: **0**  
Clock Start/From:  
Clock To:  
1st Value:  
2nd Value:  
Value Percent:  
Step: **NO**  
Remarks:

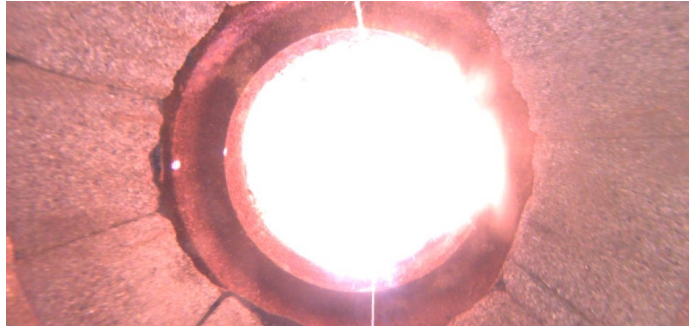
Code: **MGP**  
Description: **General Photo**

Distance (ft): **2.4**  
Structural Grade: **0**  
O&M Grade: **0**  
Clock Start/From:  
Clock To:  
1st Value:  
2nd Value:  
Value Percent:  
Step: **NO**  
Remarks:

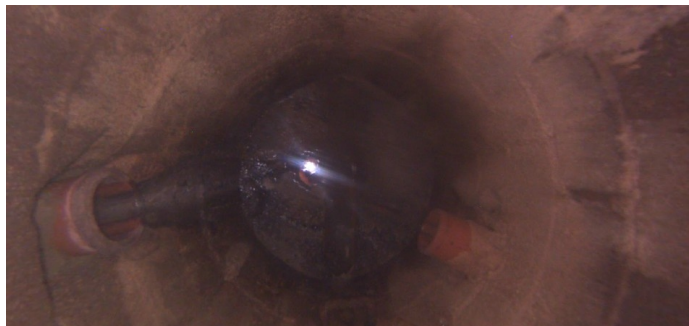
Code: **IS**  
Description: **Infil Stain**

Distance (ft): **5.8**  
Structural Grade: **0**  
O&M Grade: **0**  
Clock Start/From: **12**  
Clock To: **12**  
1st Value:  
2nd Value:  
Value Percent:  
Step: **NO**  
Remarks:

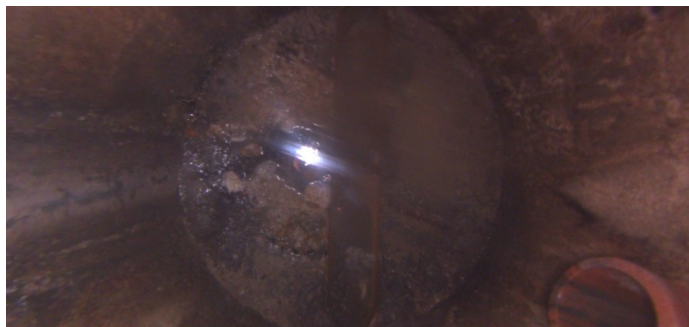
Code: **DAZ**  
Description: **Deposits Attached Other**

Distance (ft): **8.0**  
Structural Grade: **0**  
O&M Grade: **2**  
Clock Start/From: **12**  
Clock To: **12**  
1st Value:  
2nd Value:  
Value Percent: **10.000**  
Step: **NO**  
Remarks: **Mixed materials**

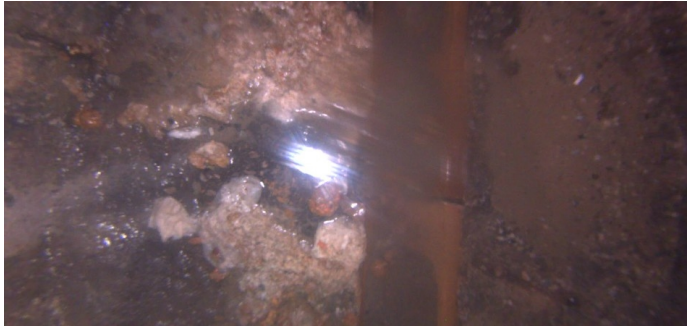
Code:	<b>MGO</b>
Description:	<b>General Observation</b>
Distance (ft):	<b>9.5</b>
Structural Grade:	<b>0</b>
O&M Grade:	<b>0</b>
Clock Start/From:	
Clock To:	
1st Value:	
2nd Value:	
Value Percent:	
Step:	<b>NO</b>
Remarks:	<b>Ins. Comp.</b>
