# Manhole Inspection Report

Position	Code	Observation	Video (sec)	Grade

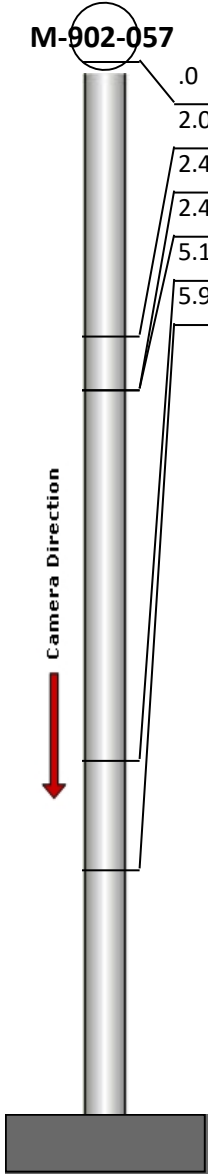
.0	MGP	General Photo	10	NA
	2.0	MGP	General Photo	28	NA
	2.4	IS	Infil Stain	42	NA
	2.4	IS	Infil Stain	54	NA
	5.1	DSF	Deposits Settled Fine	71	M 2
	5.9	MGO	General Observation	84	NA

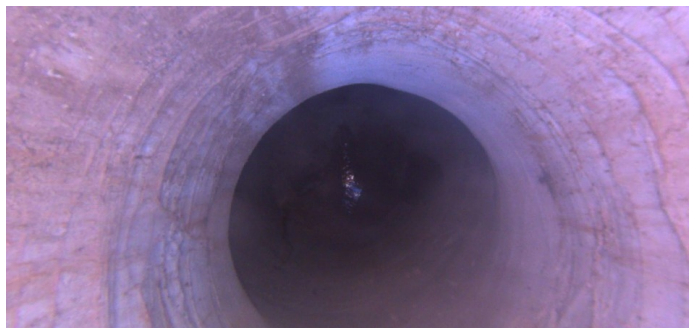
Code: **MGP**  
Description: **General Photo**

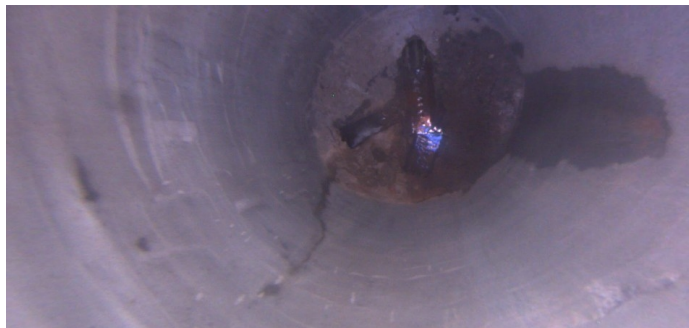
Code:	<b>IS</b>
Description:	<b>Infil Stain</b>
Distance (ft):	<b>2.4</b>
Structural Grade:	<b>0</b>
O&M Grade:	<b>0</b>
Clock Start/From:	<b>7</b>
Clock To:	
1st Value:	
2nd Value:	
Value Percent:	
Step:	<b>NO</b>
Remarks:

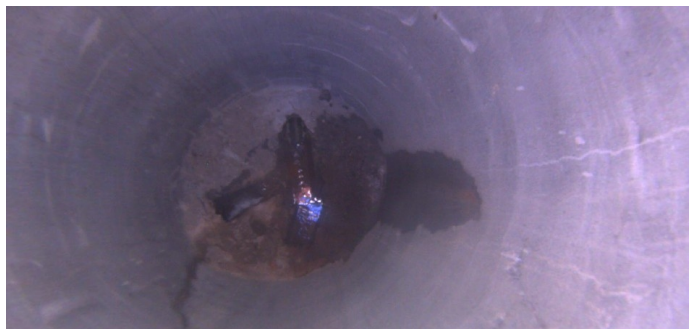
Code:	<b>IS</b>
Description:	<b>Infil Stain</b>
Distance (ft):	<b>2.4</b>
Structural Grade:	<b>0</b>
O&M Grade:	<b>0</b>
Clock Start/From:	<b>3</b>
Clock To:	
1st Value:	
2nd Value:	
Value Percent:	
Step:	<b>NO</b>
Remarks:

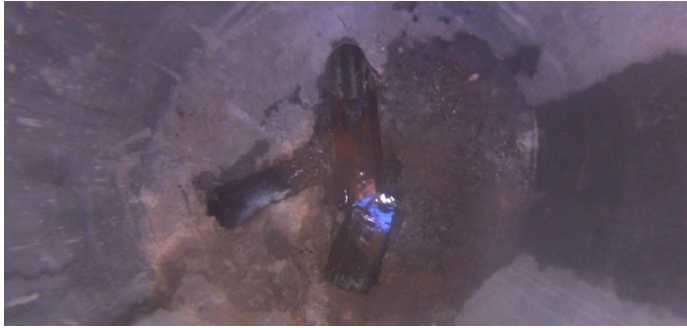
Code:	<b>DSF</b>
Description:	<b>Deposits Settled Fine</b>
Distance (ft):	<b>5.1</b>
Structural Grade:	<b>0</b>
O&M Grade:	<b>2</b>
Clock Start/From:	<b>12</b>
Clock To:	<b>12</b>
1st Value:	
2nd Value:	
Value Percent:	<b>5.000</b>
Step:	<b>NO</b>
Remarks:
