Manhole Inspection Report

Date:	03/23/2018	Weather:		Coding:	RZMACP
MH#:	M-902-058	Owner:	NA	Len. Surveyed:	6.8
P.O.#:		Surveyor:	John Kuglmaier	Rim to Invert:	7.9
Customer:		Cert. #:	U-1215-07002349	Wall Material:	Concrete (reinforced)

Street:	Rush Pl. 172' North of 36th Ave.	Project:	Hobart, IN
City:	Hobart, IN	GPS Northing:	0.0
Location:		GPS Easting:	0.0
Drain Area:	Northeast	GPS Accuracy:	Nearest Meter
Cover Shape:	Circular	Evidence of Surcharge:	No
Cover Size:	23.0	Potential for Runoff:	None
Comments:

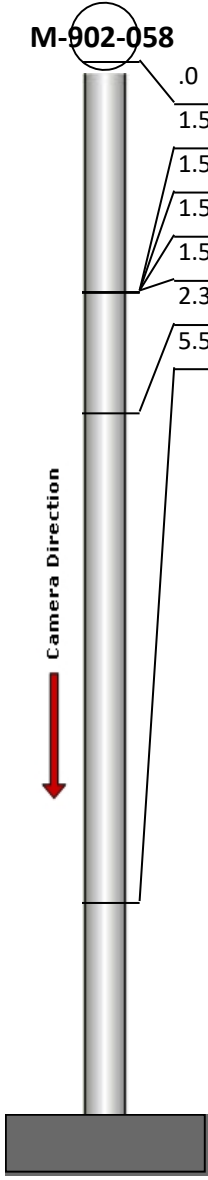
.0	MGP	General Photo	10	NA
	1.5	IS	Infil Stain	25	NA
	1.5	IS	Infil Stain	36	NA
	1.5	IS	Infil Stain	48	NA
	1.5	IS	Infil Stain	59	NA
	2.3	MGP	General Photo	75	NA
	5.5	MGO	General Observation	95	NA

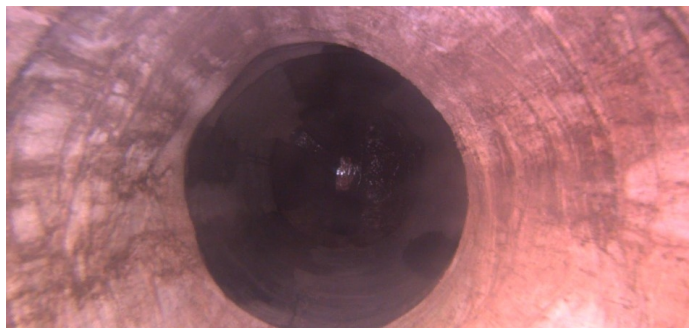
Code: **MGP**
Description: **General Photo**

Distance (ft): **.0**
Structural Grade: **0**
O&M Grade: **0**
Clock Start/From:
Clock To:
1st Value:
2nd Value:
Value Percent:
Step: **NO**
Remarks:

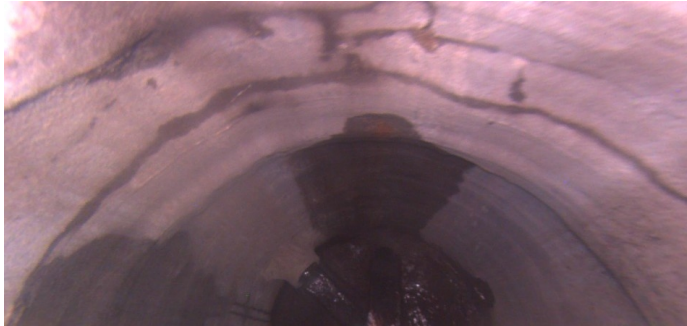
Code: **IS**
Description: **Infil Stain**

Distance (ft): **1.5**
Structural Grade: **0**
O&M Grade: **0**
Clock Start/From: **11**
Clock To: **1**
1st Value:
2nd Value:
Value Percent:
Step: **NO**
Remarks:

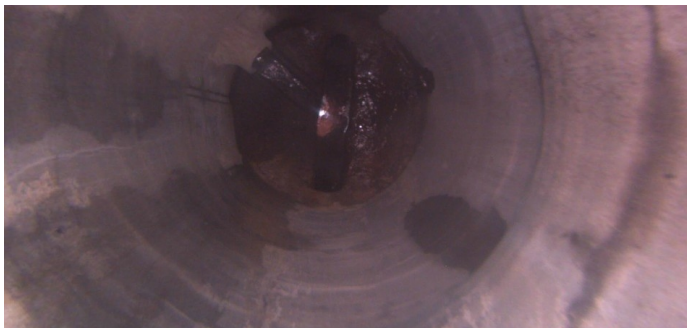
Code: **IS**
Description: **Infil Stain**

Distance (ft): **1.5**
Structural Grade: **0**
O&M Grade: **0**
Clock Start/From: **4**
Clock To:
1st Value:
2nd Value:
Value Percent:
Step: **NO**
Remarks:

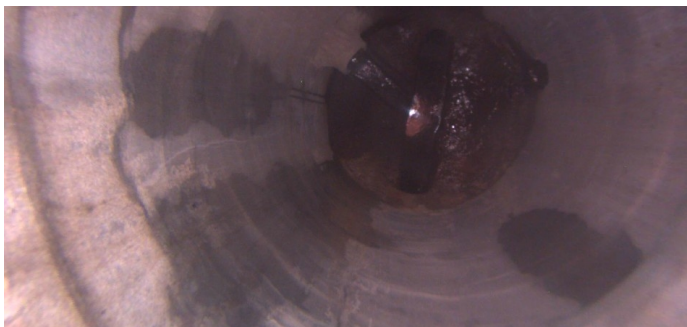
Code: **IS**
Description: **Infil Stain**

Distance (ft): **1.5**
Structural Grade: **0**
O&M Grade: **0**
Clock Start/From: **7**
Clock To: **8**
1st Value:
2nd Value:
Value Percent:
Step: **NO**
Remarks:

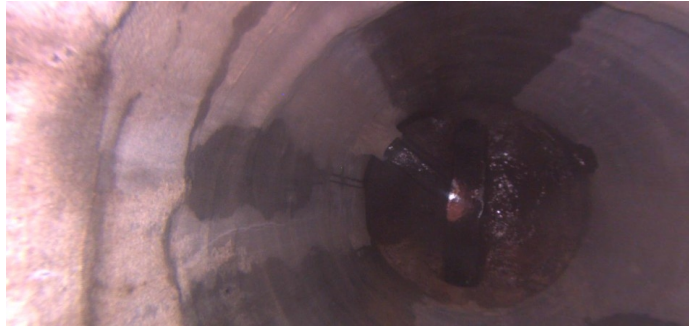
Code: **IS**
Description: **Infil Stain**

Distance (ft): **1.5**
Structural Grade: **0**
O&M Grade: **0**
Clock Start/From: **9**
Clock To:
1st Value:
2nd Value:
Value Percent:
Step: **NO**
Remarks:

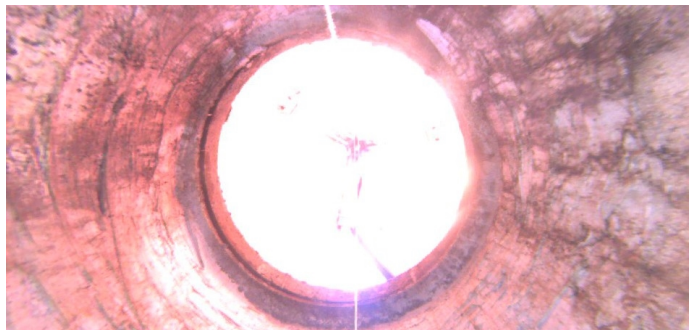
Code: **MGP**
Description: **General Photo**

Distance (ft): **2.3**
Structural Grade: **0**
O&M Grade: **0**
Clock Start/From:
Clock To:
1st Value:
2nd Value:
Value Percent:
Step: **NO**
Remarks:

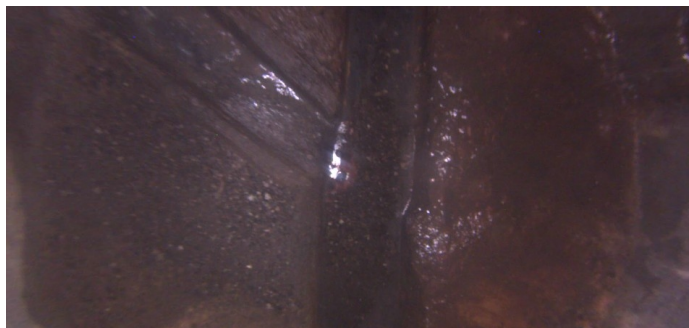
Code: **MGO**
Description: **General Observation**

Distance (ft): **5.5**
Structural Grade: **0**
O&M Grade: **0**
Clock Start/From:
Clock To:
1st Value:
2nd Value:
Value Percent:
Step: **NO**
Remarks: **Ins. Comp.**
