Manhole Inspection Report

Date:	03/23/2018	Weather:		Coding:	RZMACP
MH#:	M-902-066	Owner:	NA	Len. Surveyed:	6.6
P.O.#:		Surveyor:	John Kuglmaier	Rim to Invert:	7.3
Customer:		Cert. #:	U-1215-07002349	Wall Material:	Concrete (reinforced)

Street:	Rush Pl. 270' South of 36th Ave.	Project:	Hobart, IN
City:	Hobart, IN	GPS Northing:	0.0
Location:		GPS Easting:	0.0
Drain Area:	Northeast	GPS Accuracy:	Nearest Meter
Cover Shape:	Circular	Evidence of Surcharge:	No
Cover Size:	23.0	Potential for Runoff:	None
Comments:

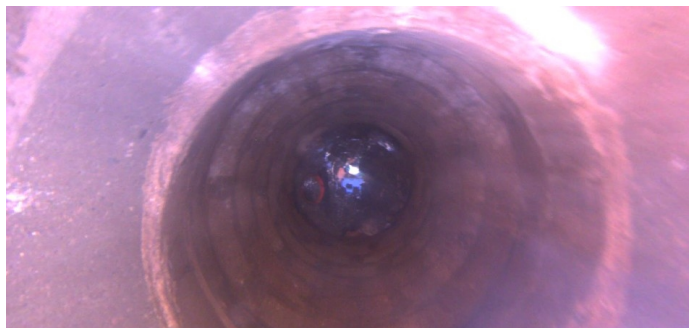
Code: **MGP**
Description: **General Photo**

Distance (ft): **.0**
Structural Grade: **0**
O&M Grade: **0**
Clock Start/From:
Clock To:
1st Value:
2nd Value:
Value Percent:
Step: **NO**
Remarks:

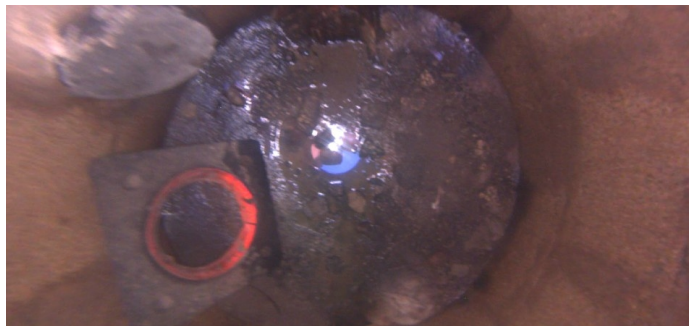
Code: **DAZ**
Description: **Deposits Attached Other**

Distance (ft): **4.8**
Structural Grade: **0**
O&M Grade: **2**
Clock Start/From: **12**
Clock To: **12**
1st Value:
2nd Value:
Value Percent: **10.000**
Step: **NO**
Remarks: **Mixed materials**

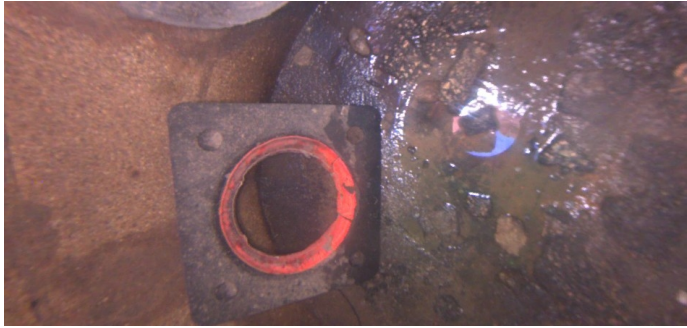
Code: **OBZ**
Description: **Obstacle Other**

Distance (ft): **5.6**
Structural Grade: **0**
O&M Grade: **2**
Clock Start/From: **8**
Clock To: **9**
1st Value:
2nd Value:
Value Percent: **10.000**
Step: **NO**
Remarks: **Construction cone**

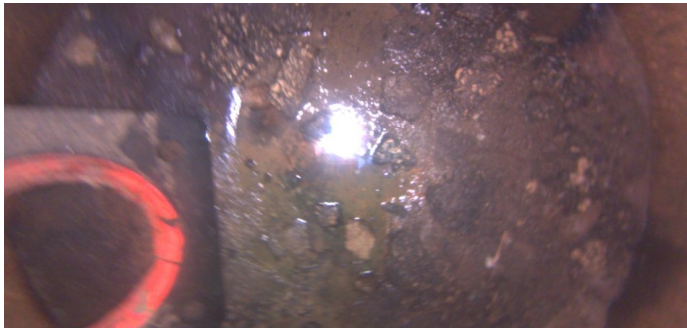
Code: **MGO**
Description: **General Observation**

Distance (ft): **5.9**
Structural Grade: **0**
O&M Grade: **0**
Clock Start/From:
Clock To:
1st Value:
2nd Value:
Value Percent:
Step: **NO**
Remarks: **Ins. Comp.**
