Manhole Inspection Report

Date:	09/19/2022	Weather:		Coding:	RZMACP
MH#:	M-902-072	Owner:	NA	Len. Surveyed:	7.7
P.O.#:		Surveyor:	Jen Costello	Rim to Invert:	8.4
Customer:		Cert. #:	U-907-5518	Wall Material:	Brick

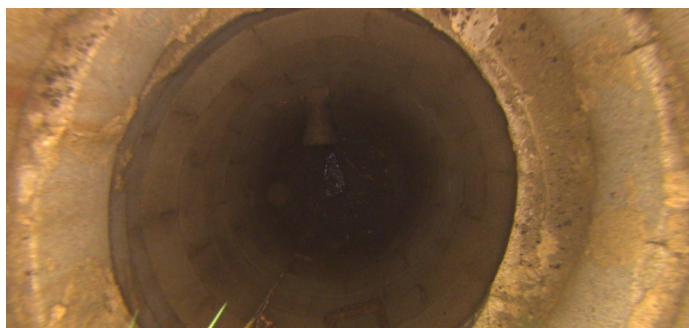
Code: **MGO**
Description: **General Observation**

Distance (ft): **.0**
Structural Grade: **0**
O&M Grade: **0**
Clock Start/From:
Clock To:
1st Value:
2nd Value:
Value Percent:
Step: **NO**
Remarks: **access mh**

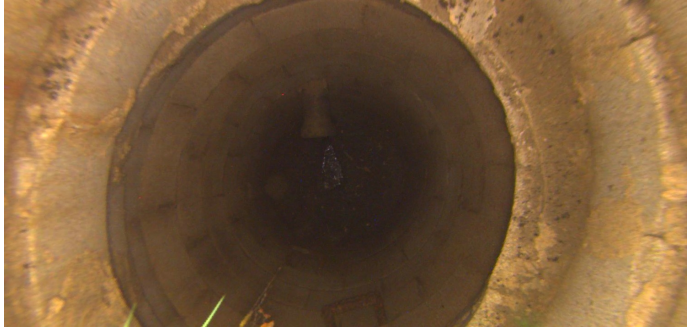
Code: **SRI**
Description: **Surface Roughness Increased**

Distance (ft): **.0**
Structural Grade: **1**
O&M Grade: **0**
Clock Start/From: **12**
Clock To: **12**
1st Value:
2nd Value:
Value Percent:
Step: **NO**
Remarks:

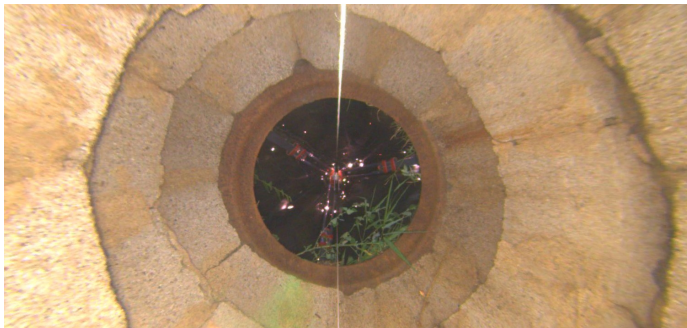
Code: **MGO**
Description: **General Observation**

Distance (ft): **3.1**
Structural Grade: **0**
O&M Grade: **0**
Clock Start/From:
Clock To:
1st Value:
2nd Value:
Value Percent:
Step: **NO**
Remarks: **underside of frame**

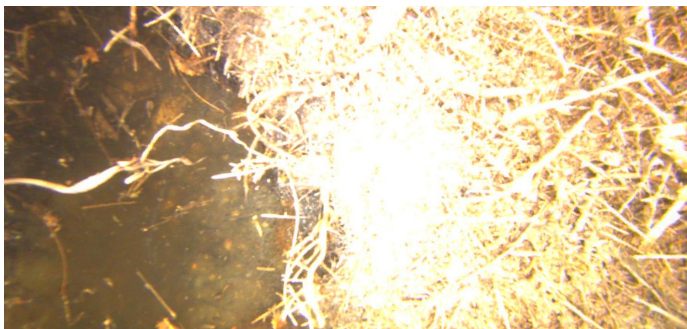
Code: **DSF**
Description: **Deposits Settled Fine**

Distance (ft): **7.7**
Structural Grade: **0**
O&M Grade: **2**
Clock Start/From: **12**
Clock To: **12**
1st Value:
2nd Value:
Value Percent: **5.000**
Step: **NO**
Remarks:

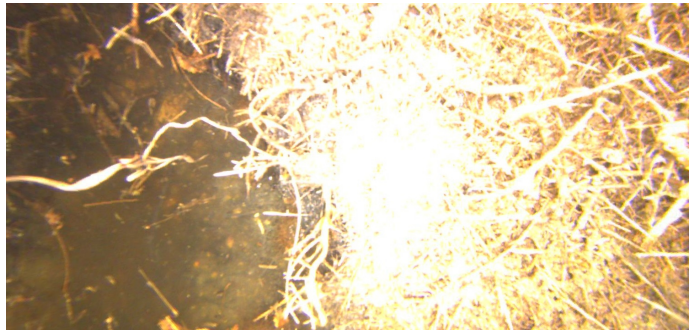
Code: **DSZ**
Description: **Deposits Settled Other**

Distance (ft): **7.7**
Structural Grade: **0**
O&M Grade: **2**
Clock Start/From: **12**
Clock To: **12**
1st Value:
2nd Value:
Value Percent: **10.000**
Step: **NO**
Remarks: **weeds**

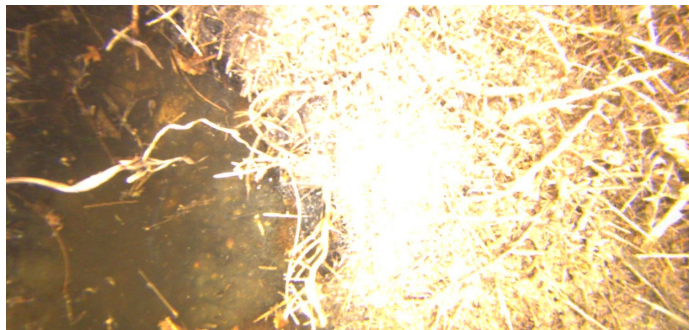
Code: **MGO**
Description: **General Observation**

Distance (ft): **7.7**
Structural Grade: **0**
O&M Grade: **0**
Clock Start/From:
Clock To:
1st Value:
2nd Value:
Value Percent:
Step: **NO**
Remarks: **end of survey**

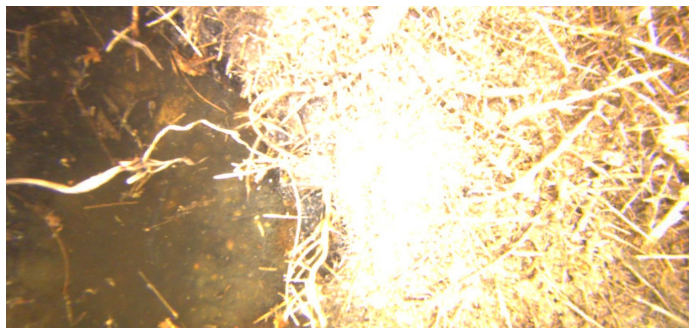
Code: **SRI**
Description: **Surface Roughness Increased**

Distance (ft): **7.7**
Structural Grade: **1**
O&M Grade: **0**
Clock Start/From: **12**
Clock To: **12**
1st Value:
2nd Value:
Value Percent:
Step: **NO**
Remarks:
