Manhole Inspection Report

Date:	09/19/2022	Weather:		Coding:	RZMACP
MH#:	M-902-082	Owner:	NA	Len. Surveyed:	6.0
P.O.#:		Surveyor:	Jen Costello	Rim to Invert:	8.1
Customer:		Cert. #:	U-907-5518	Wall Material:	Concrete (cast in place)

Street:	380' North of Hwy 6 and 320' West	Project:	Hobart, IN
City:	Hobart, IN	GPS Northing:	2296000.068
Location:	Yard	GPS Easting:	2910346.065
Drain Area:	Northeast	GPS Accuracy:	Sub-Meter
Cover Shape:	Circular	Evidence of Surcharge:	No
Cover Size:	24.0	Potential for Runoff:	None
Comments:

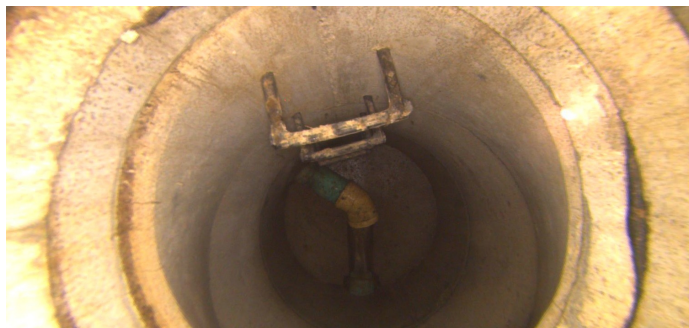
Code: **MGO**
Description: **General Observation**

Distance (ft): **.0**
Structural Grade: **0**
O&M Grade: **0**
Clock Start/From:
Clock To:
1st Value:
2nd Value:
Value Percent:
Step: **NO**
Remarks: **access mh**

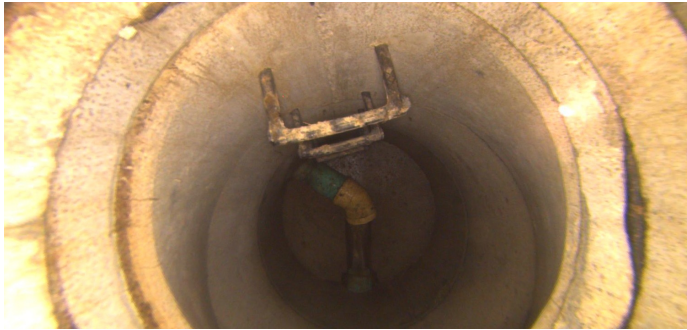
Code: **SRI**
Description: **Surface Roughness Increased**

Distance (ft): **.0**
Structural Grade: **1**
O&M Grade: **0**
Clock Start/From: **12**
Clock To: **12**
1st Value:
2nd Value:
Value Percent:
Step: **NO**
Remarks:

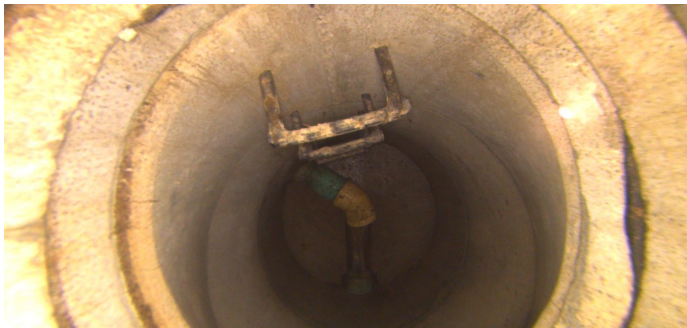
Code: **ISGT**
Description: **Intruding Sealing Grout**

Distance (ft): **.0**
Structural Grade: **0**
O&M Grade: **2**
Clock Start/From: **3**
Clock To: **4**
1st Value:
2nd Value:
Value Percent: **5.000**
Step: **NO**
Remarks:

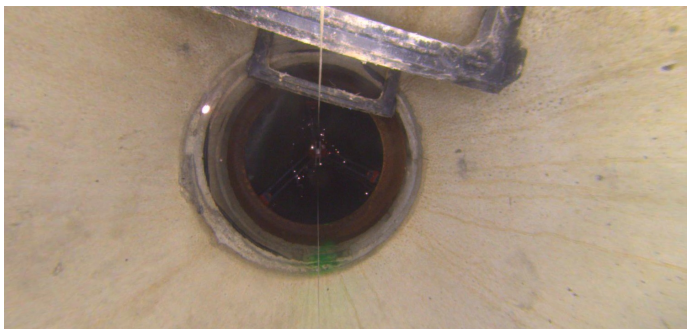
Code: **MGO**
Description: **General Observation**

Distance (ft): **3.9**
Structural Grade: **0**
O&M Grade: **0**
Clock Start/From:
Clock To:
1st Value:
2nd Value:
Value Percent:
Step: **NO**
Remarks: **underside of frame**

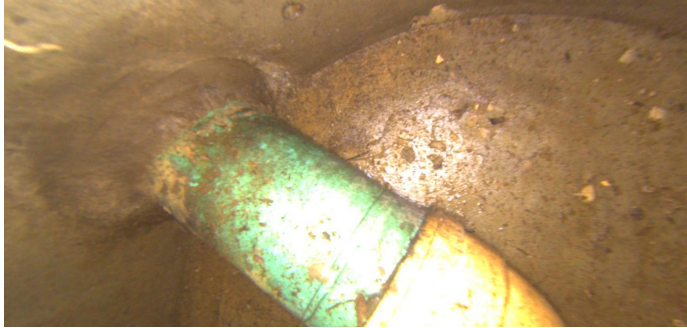
Code:	MGO
Description:	General Observation
Distance (ft):	5.8
Structural Grade:	0
O&M Grade:	0
Clock Start/From:	
Clock To:	
1st Value:	
2nd Value:	
Value Percent:	
Step:	NO
Remarks:	end of survey

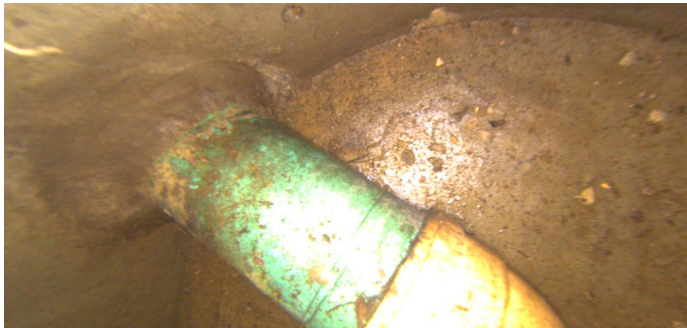
Code:	SRI
Description:	Surface Roughness Increased
Distance (ft):	5.8
Structural Grade:	1
O&M Grade:	0
Clock Start/From:	12
Clock To:	12
1st Value:	
2nd Value:	
Value Percent:	
Step:	NO
Remarks:
