Manhole Inspection Report

Date:	10/08/2022	Weather:		Coding:	RZMACP
MH#:	M-903-001	Owner:	NA	Len. Surveyed:	7.8
P.O.#:		Surveyor:	Jen Costello	Rim to Invert:	9.0
Customer:		Cert. #:	U-907-5518	Wall Material:	Concrete (cast in place)

Street:	Hwy 51. 89' South of North St.	Project:	Hobart, IN
City:	Hobart, IN	GPS Northing:	2293283.451
Location:	Other	GPS Easting:	2909719.924
Drain Area:	Northeast	GPS Accuracy:	Sub-Meter
Cover Shape:	Circular	Evidence of Surcharge:	No
Cover Size:	24.0	Potential for Runoff:	None
Comments:

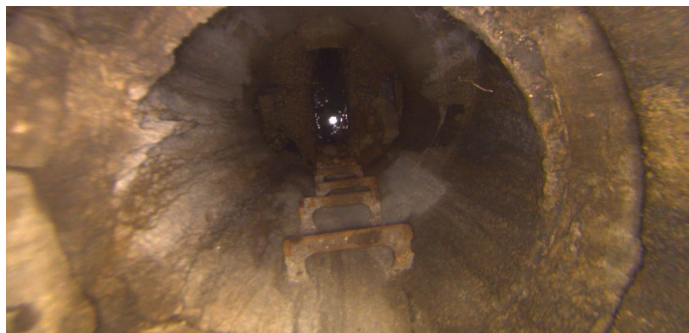
Code: **MGO**
Description: **General Observation**

Distance (ft): **.0**
Structural Grade: **0**
O&M Grade: **0**
Clock Start/From:
Clock To:
1st Value:
2nd Value:
Value Percent:
Step: **NO**
Remarks: **access mh**

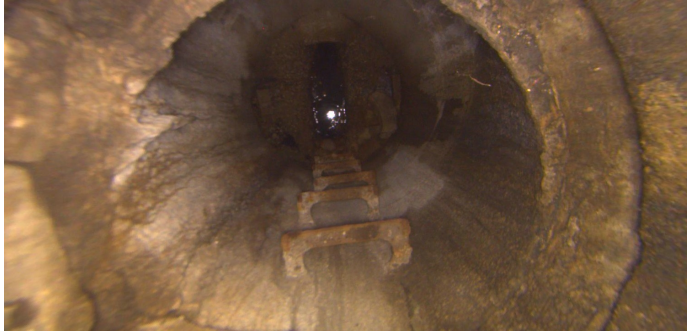
Code: **B**
Description: **Broken**

Distance (ft): **.0**
Structural Grade: **5**
O&M Grade: **0**
Clock Start/From: **6**
Clock To: **9**
1st Value:
2nd Value:
Value Percent:
Step: **NO**
Remarks:

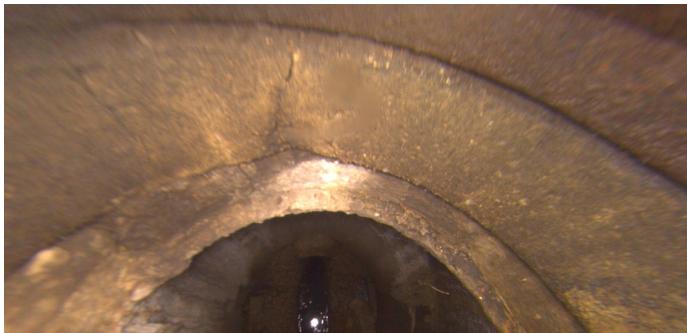
Code: **FL**
Description: **Fracture Longitudinal**

Distance (ft): **.0**
Structural Grade: **3**
O&M Grade: **0**
Clock Start/From: **12**
Clock To:
1st Value:
2nd Value:
Value Percent:
Step: **NO**
Remarks:

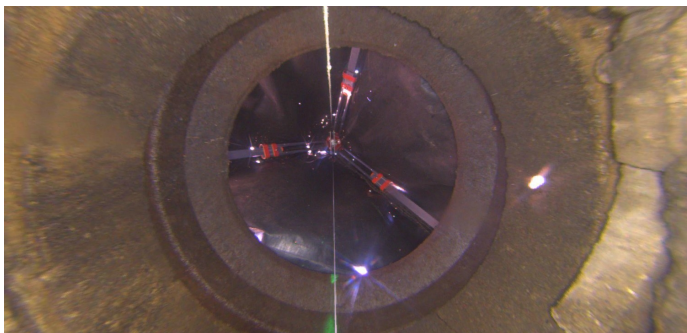
Code: **MGO**
Description: **General Observation**

Distance (ft): **1.5**
Structural Grade: **0**
O&M Grade: **0**
Clock Start/From:
Clock To:
1st Value:
2nd Value:
Value Percent:
Step: **NO**
Remarks: **underside of frame**

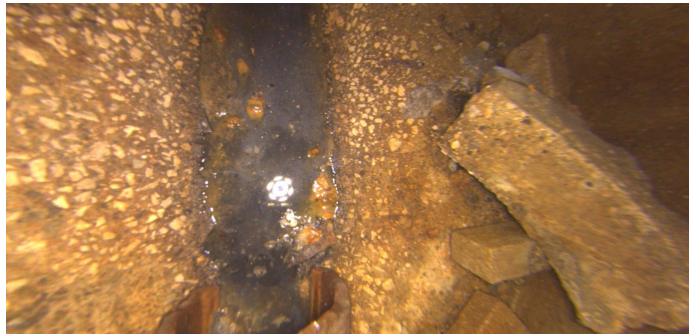
Code: **OBM**
Description: **Obstacle Pipe Material**

Distance (ft): **6.9**
Structural Grade: **0**
O&M Grade: **3**
Clock Start/From: **12**
Clock To: **12**
1st Value:
2nd Value:
Value Percent: **20.000**
Step: **NO**
Remarks:

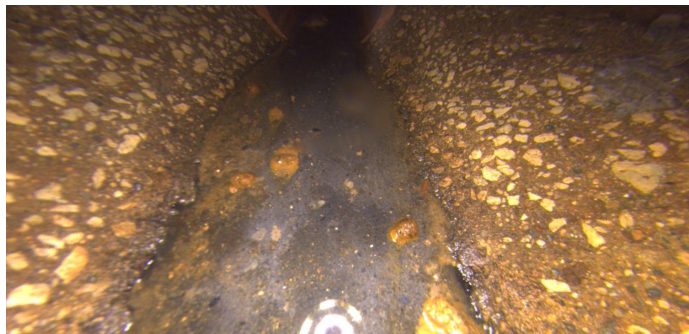
Code: **SAP**
Description: **Surface Aggregate Projecting**

Distance (ft): **7.7**
Structural Grade: **3**
O&M Grade: **0**
Clock Start/From: **12**
Clock To: **12**
1st Value:
2nd Value:
Value Percent:
Step: **NO**
Remarks:

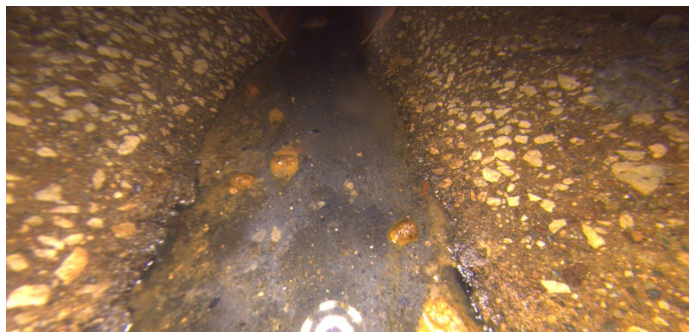
Code: **SAP**
Description: **Surface Aggregate Projecting**

Distance (ft): **7.7**
Structural Grade: **3**
O&M Grade: **0**
Clock Start/From: **3**
Clock To: **9**
1st Value:
2nd Value:
Value Percent:
Step: **NO**
Remarks:

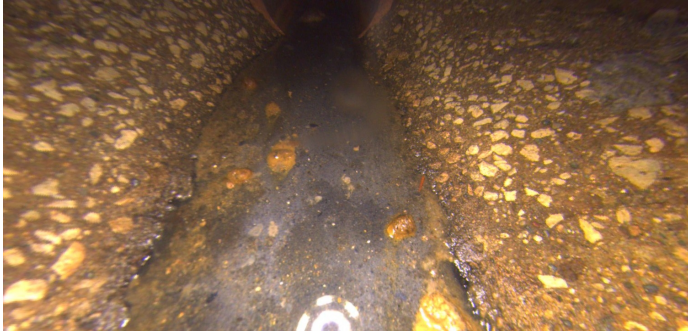
Code:	MGO
Description:	General Observation
Distance (ft):	7.7
Structural Grade:	0
O&M Grade:	0
Clock Start/From:	
Clock To:	
1st Value:	
2nd Value:	
Value Percent:	
Step:	NO
Remarks:	end of survey
