# Manhole Inspection Report

Date:	<b>03/20/2018</b>	Weather:		Coding:	<b>RZMACP</b>
MH#:	<b>M-903-013</b>	Owner:	<b>NA</b>	Len. Surveyed:	<b>5.1</b>
P.O.#:		Surveyor:	<b>John Kuglmaier</b>	Rim to Invert:	<b>6.4</b>
Customer:		Cert. #:	<b>U-1215-07002349</b>	Wall Material:	<b>Concrete (reinforced)</b>

Street:	<b>Shelby Pl. 39' South of 38th Pl.</b>	Project:	<b>Hobart, IN</b>
City:	<b>Hobart, IN</b>	GPS Northing:	<b>2911208.957</b>
Location:		GPS Easting:	<b>2911208.957</b>
Drain Area:	<b>Northeast</b>	GPS Accuracy:	<b>Sub-Meter</b>
Cover Shape:	<b>Circular</b>	Evidence of Surcharge:	<b>Yes</b>
Cover Size:	<b>23.0</b>	Potential for Runoff:	<b>None</b>
Comments:

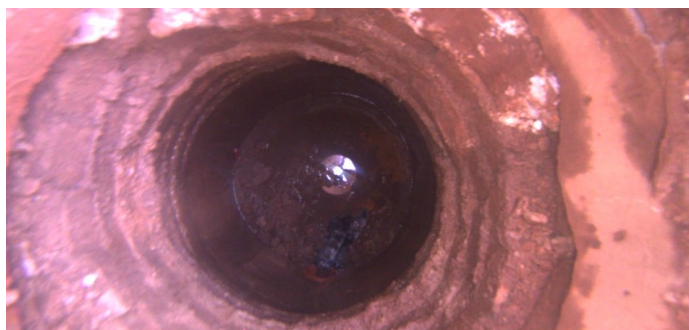
Code: **MGP**  
Description: **General Photo**

Distance (ft): **.0**  
Structural Grade: **0**  
O&M Grade: **0**  
Clock Start/From:  
Clock To:  
1st Value:  
2nd Value:  
Value Percent:  
Step: **NO**  
Remarks:

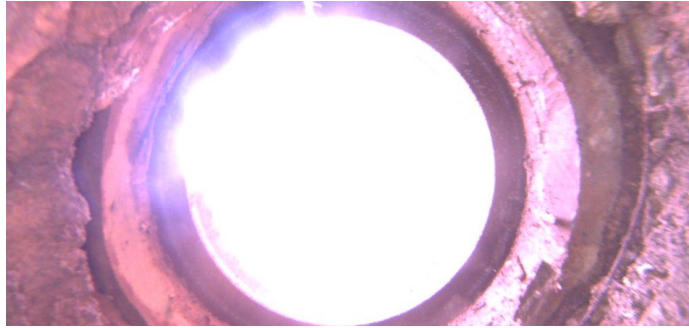
Code: **MGP**  
Description: **General Photo**

Distance (ft): **2.2**  
Structural Grade: **0**  
O&M Grade: **0**  
Clock Start/From:  
Clock To:  
1st Value:  
2nd Value:  
Value Percent:  
Step: **NO**  
Remarks:

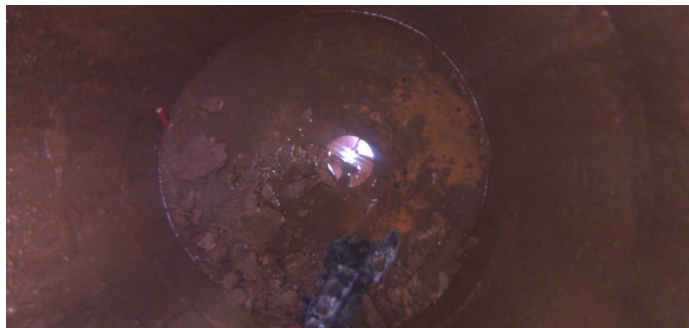
Code: **DAZ**  
Description: **Deposits Attached Other**

Distance (ft): **2.9**  
Structural Grade: **0**  
O&M Grade: **2**  
Clock Start/From: **12**  
Clock To: **12**  
1st Value:  
2nd Value:  
Value Percent: **10.000**  
Step: **NO**  
Remarks: **Mixed materials**

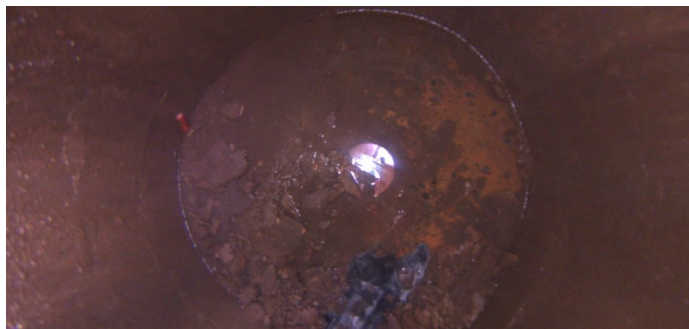
Code: **MGO**  
Description: **General Observation**

Distance (ft): **3.1**  
Structural Grade: **0**  
O&M Grade: **0**  
Clock Start/From:  
Clock To:  
1st Value:  
2nd Value:  
Value Percent:  
Step: **NO**  
Remarks: **Surcharge**

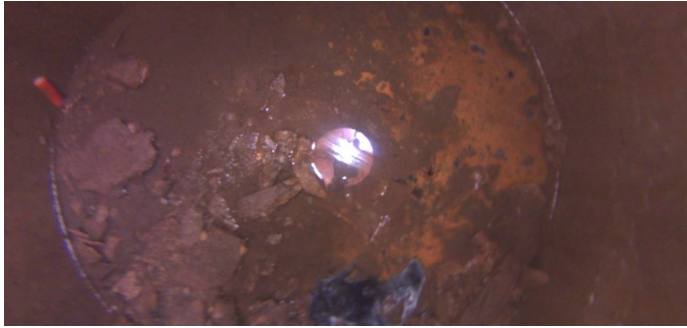
Code:	<b>MGO</b>
Description:	<b>General Observation</b>
Distance (ft):	<b>4.2</b>
Structural Grade:	<b>0</b>
O&M Grade:	<b>0</b>
Clock Start/From:	
Clock To:	
1st Value:	
2nd Value:	
Value Percent:	
Step:	<b>NO</b>
Remarks:	<b>Ins. Comp.</b>
