Manhole Inspection Report

Date:	03/28/2018	Weather:		Coding:	RZMACP
MH#:	M-903-015	Owner:	NA	Len. Surveyed:	4.4
P.O.#:		Surveyor:	John Kuglmaier	Rim to Invert:	5.7
Customer:		Cert. #:	U-1215-07002349	Wall Material:	Concrete (reinforced)

Street:	Intersection of Rand St. and Shelby	Project:	Hobart, IN
City:	Hobart, IN	GPS Northing:	0.0
Location:		GPS Easting:	0.0
Drain Area:	Northeast	GPS Accuracy:	Nearest Meter
Cover Shape:	Circular	Evidence of Surcharge:	Yes
Cover Size:	23.0	Potential for Runoff:	None
Comments:

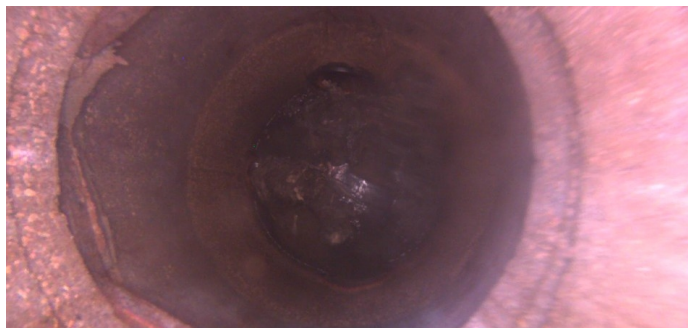
Code: **MGP**
Description: **General Photo**

Distance (ft): **.0**
Structural Grade: **0**
O&M Grade: **0**
Clock Start/From:
Clock To:
1st Value:
2nd Value:
Value Percent:
Step: **NO**
Remarks:

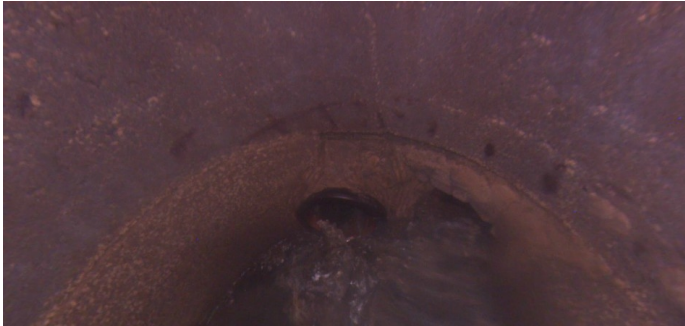
Code:	SRV
Description:	Surface Reinforcement Visible

Distance (ft):	1.6
Structural Grade:	5
O&M Grade:	0
Clock Start/From:	11
Clock To:	1
1st Value:	
2nd Value:	
Value Percent:	
Step:	NO
Remarks:

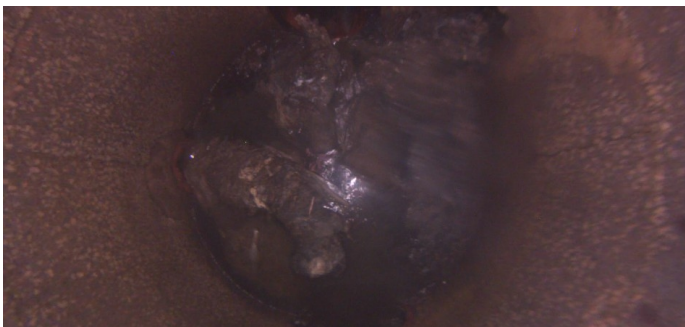
Code:	MGO
Description:	General Observation

Distance (ft):	2.1
Structural Grade:	0
O&M Grade:	0
Clock Start/From:	
Clock To:	
1st Value:	
2nd Value:	
Value Percent:	
Step:	NO
Remarks:	Surcharge

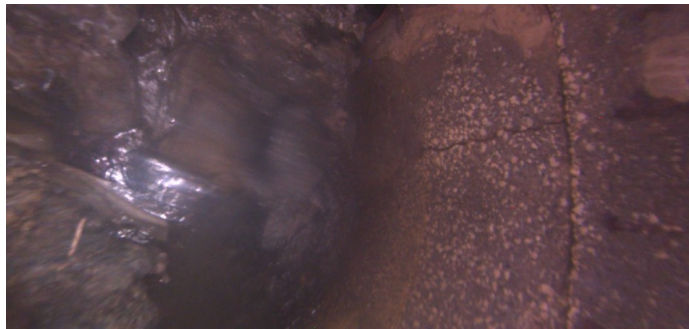
Code: **CL**
Description: **Crack Longitudinal**

Distance (ft): **3.2**
Structural Grade: **2**
O&M Grade: **0**
Clock Start/From: **3**
Clock To:
1st Value:
2nd Value:
Value Percent:
Step: **NO**
Remarks:

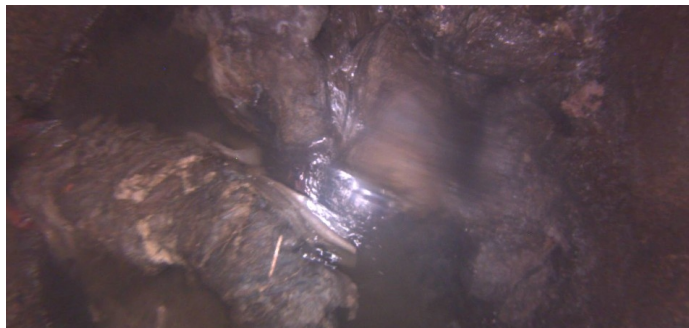
Code: **MGO**
Description: **General Observation**

Distance (ft): **3.8**
Structural Grade: **0**
O&M Grade: **0**
Clock Start/From:
Clock To:
1st Value:
2nd Value:
Value Percent:
Step: **NO**
Remarks: **Ins. Comp.**
