# Manhole Inspection Report

Date:	<b>03/28/2018</b>	Weather:		Coding:	<b>RZMACP</b>
MH#:	<b>M-903-022</b>	Owner:	<b>NA</b>	Len. Surveyed:	<b>7.4</b>
P.O.#:		Surveyor:	<b>John Kuglmaier</b>	Rim to Invert:	<b>9.0</b>
Customer:		Cert. #:	<b>U-1215-07002349</b>	Wall Material:	<b>Concrete (reinforced)</b>

Street:	<b>220' South of Rand St. 167' East of R</b>	Project:	<b>Hobart, IN</b>
City:	<b>Hobart, IN</b>	GPS Northing:	<b>0.0</b>
Location:		GPS Easting:	<b>0.0</b>
Drain Area:	<b>Northeast</b>	GPS Accuracy:	<b>Nearest Meter</b>
Cover Shape:	<b>Circular</b>	Evidence of Surcharge:	<b>No</b>
Cover Size:	<b>23.0</b>	Potential for Runoff:	<b>None</b>
Comments:

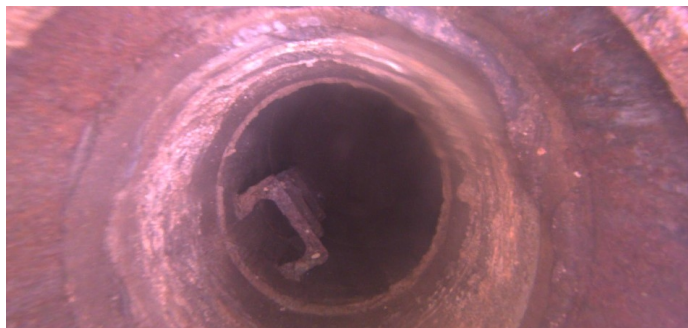
Code: **MGP**  
Description: **General Photo**

Distance (ft): **.0**  
Structural Grade: **0**  
O&M Grade: **0**  
Clock Start/From:  
Clock To:  
1st Value:  
2nd Value:  
Value Percent:  
Step: **NO**  
Remarks:

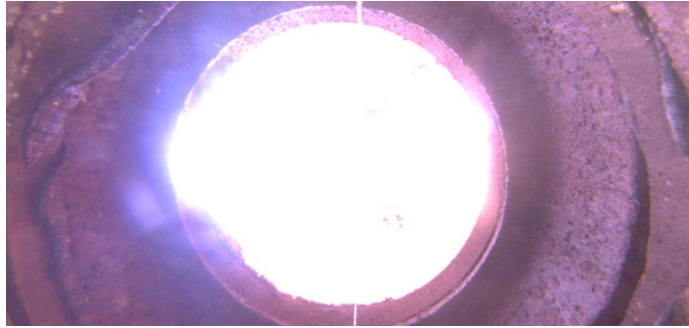
Code: **MGP**  
Description: **General Photo**

Distance (ft): **2.1**  
Structural Grade: **0**  
O&M Grade: **0**  
Clock Start/From:  
Clock To:  
1st Value:  
2nd Value:  
Value Percent:  
Step: **NO**  
Remarks:

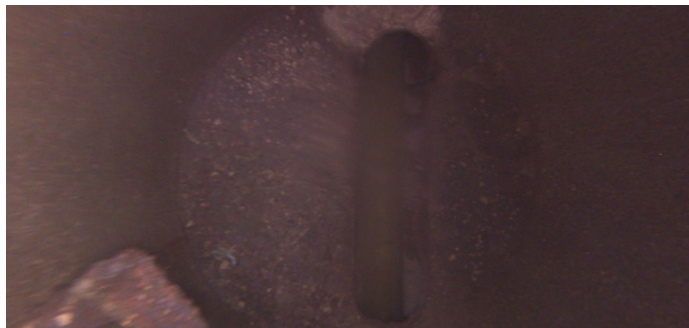
Code: **DAZ**  
Description: **Deposits Attached Other**

Distance (ft): **5.6**  
Structural Grade: **0**  
O&M Grade: **2**  
Clock Start/From: **12**  
Clock To: **12**  
1st Value:  
2nd Value:  
Value Percent: **10.000**  
Step: **NO**  
Remarks: **Mixed materials**

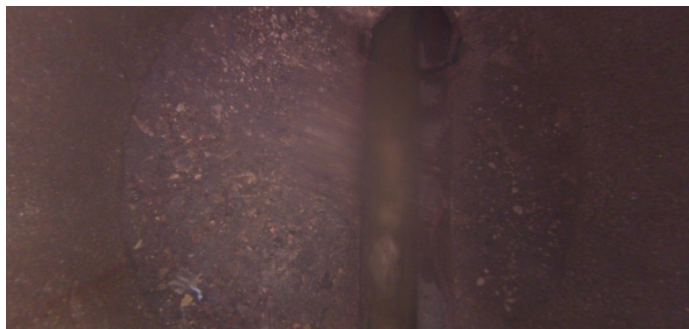
Code: **MGO**  
Description: **General Observation**

Distance (ft): **6.2**  
Structural Grade: **0**  
O&M Grade: **0**  
Clock Start/From:  
Clock To:  
1st Value:  
2nd Value:  
Value Percent:  
Step: **NO**  
Remarks: **Ins. Comp.**
