Manhole Inspection Report

Date:	03/28/2018	Weather:		Coding:	RZMACP
MH#:	M-903-023	Owner:	NA	Len. Surveyed:	6.7
P.O.#:		Surveyor:	John Kuglmaier	Rim to Invert:	7.5
Customer:		Cert. #:	U-1215-07002349	Wall Material:	Concrete (reinforced)

Street:	415' South of Rand St. 167' East of R	Project:	Hobart, IN
City:	Hobart, IN	GPS Northing:	0.0
Location:		GPS Easting:	0.0
Drain Area:	Northeast	GPS Accuracy:	Nearest Meter
Cover Shape:	Circular	Evidence of Surcharge:	No
Cover Size:	23.0	Potential for Runoff:	None
Comments:

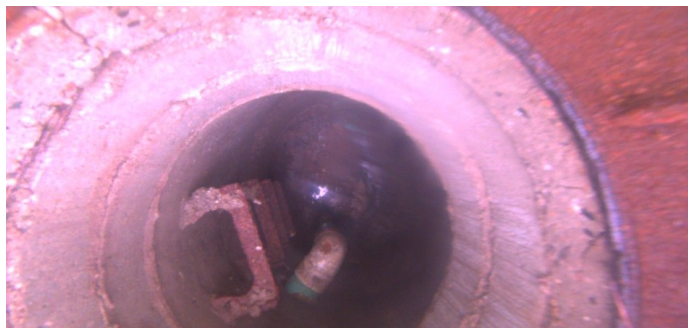
Code: **MGP**
Description: **General Photo**

Distance (ft): **.0**
Structural Grade: **0**
O&M Grade: **0**
Clock Start/From:
Clock To:
1st Value:
2nd Value:
Value Percent:
Step: **NO**
Remarks:

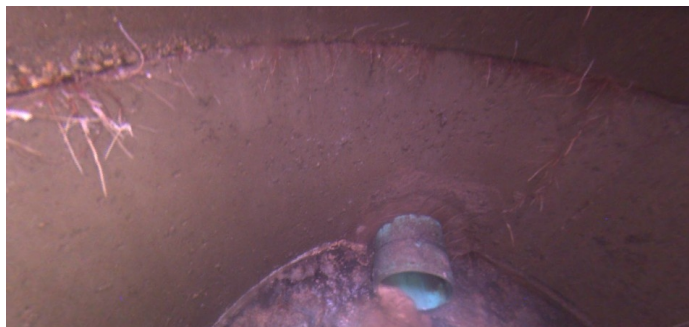
Code: **RFJ**
Description: **Roots Fine Joint**

Distance (ft): **4.6**
Structural Grade: **0**
O&M Grade: **1**
Clock Start/From: **9**
Clock To: **4**
1st Value:
2nd Value:
Value Percent:
Step: **NO**
Remarks:

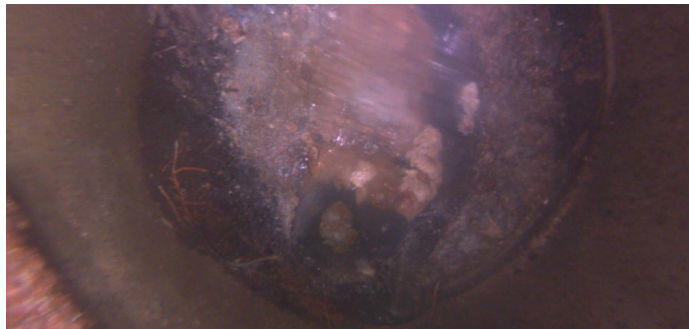
Code:	RFC
Description:	Roots Fine Connection
Distance (ft):	4.7
Structural Grade:	0
O&M Grade:	1
Clock Start/From:	6
Clock To:	
1st Value:	
2nd Value:	
Value Percent:	
Step:	NO
Remarks:

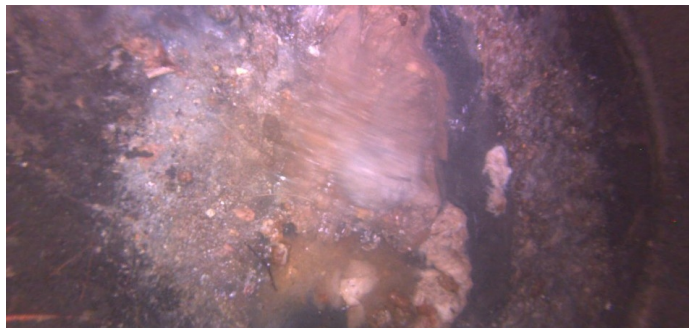
Code:	MGO
Description:	General Observation
Distance (ft):	5.7
Structural Grade:	0
O&M Grade:	0
Clock Start/From:	
Clock To:	
1st Value:	
2nd Value:	
Value Percent:	
Step:	NO
Remarks:	Ins. Comp.
