# Manhole Inspection Report

Date:	<b>03/28/2018</b>	Weather:		Coding:	<b>RZMACP</b>
MH#:	<b>M-903-025</b>	Owner:	<b>NA</b>	Len. Surveyed:	<b>9.0</b>
P.O.#:		Surveyor:	<b>John Kuglmaier</b>	Rim to Invert:	<b>10.9</b>
Customer:		Cert. #:	<b>U-1215-07002349</b>	Wall Material:	<b>Concrete (reinforced)</b>

Street:	<b>Rand St. 165' East of Pershing St.</b>	Project:	<b>Hobart, IN</b>
City:	<b>Hobart, IN</b>	GPS Northing:	<b>0.0</b>
Location:		GPS Easting:	<b>0.0</b>
Drain Area:	<b>Northeast</b>	GPS Accuracy:	<b>Nearest Meter</b>
Cover Shape:	<b>Circular</b>	Evidence of Surcharge:	<b>Yes</b>
Cover Size:	<b>23.0</b>	Potential for Runoff:	<b>None</b>
Comments:

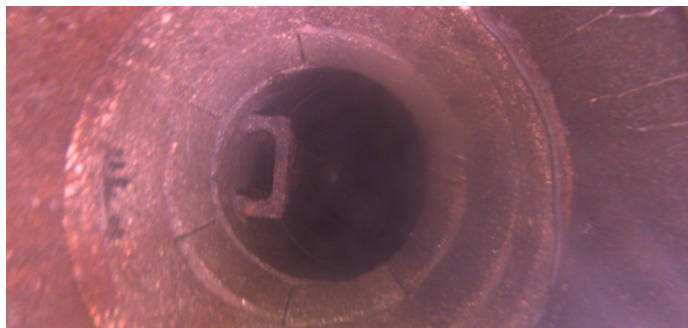
Code: **MGP**  
Description: **General Photo**

Distance (ft): **.0**  
Structural Grade: **0**  
O&M Grade: **0**  
Clock Start/From:  
Clock To:  
1st Value:  
2nd Value:  
Value Percent:  
Step: **NO**  
Remarks:

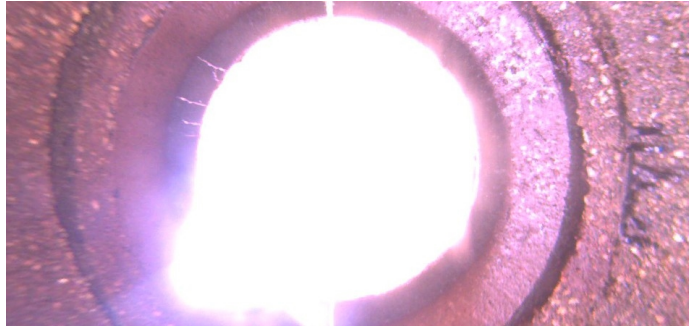
Code: **MGP**  
Description: **General Photo**

Distance (ft): **2.2**  
Structural Grade: **0**  
O&M Grade: **0**  
Clock Start/From:  
Clock To:  
1st Value:  
2nd Value:  
Value Percent:  
Step: **NO**  
Remarks:

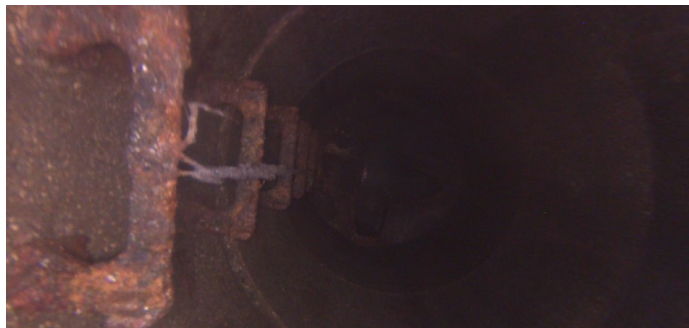
Code: **OBZ**  
Description: **Obstacle Other**

Distance (ft): **3.1**  
Structural Grade: **0**  
O&M Grade: **2**  
Clock Start/From: **9**  
Clock To:  
1st Value:  
2nd Value:  
Value Percent: **5.000**  
Step: **YES**  
Remarks: **Rope**

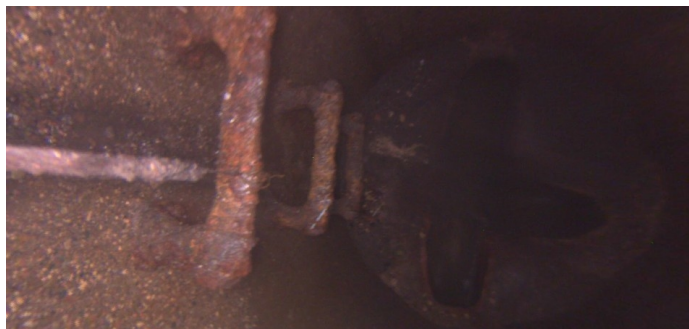
Code: **OBZ**  
Description: **Obstacle Other**

Distance (ft): **6.0**  
Structural Grade: **0**  
O&M Grade: **2**  
Clock Start/From: **9**  
Clock To:  
1st Value:  
2nd Value:  
Value Percent: **5.000**  
Step: **NO**  
Remarks: **Rope**

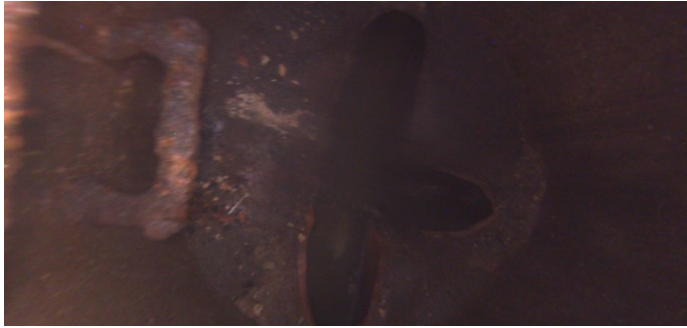
Code:	<b>DSF</b>
Description:	<b>Deposits Settled Fine</b>
Distance (ft):	<b>7.2</b>
Structural Grade:	<b>0</b>
O&M Grade:	<b>2</b>
Clock Start/From:	<b>12</b>
Clock To:	<b>12</b>
1st Value:	
2nd Value:	
Value Percent:	<b>10.000</b>
Step:	<b>NO</b>
Remarks:

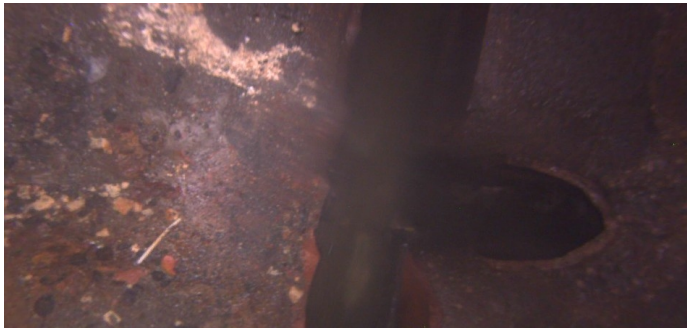
Code:	<b>MGO</b>
Description:	<b>General Observation</b>
Distance (ft):	<b>8.5</b>
Structural Grade:	<b>0</b>
O&M Grade:	<b>0</b>
Clock Start/From:	
Clock To:	
1st Value:	
2nd Value:	
Value Percent:	
Step:	<b>NO</b>
Remarks:	<b>Ins. Comp.</b>
