Manhole Inspection Report

Date:	10/07/2022	Weather:		Coding:	RZMACP
MH#:	M-903-030	Owner:	NA	Len. Surveyed:	10.3
P.O.#:		Surveyor:	Jen Costello	Rim to Invert:	11.8
Customer:		Cert. #:	U-907-5518	Wall Material:	Concrete (cast in place)

Street:	Rand St. 161' East of Hwy 51	Project:	Hobart, IN
City:	Hobart, IN	GPS Northing:	2294151.444
Location:	Other	GPS Easting:	2909860.676
Drain Area:	Northeast	GPS Accuracy:	Sub-Meter
Cover Shape:	Circular	Evidence of Surcharge:	Yes
Cover Size:	24.0	Potential for Runoff:	None
Comments:

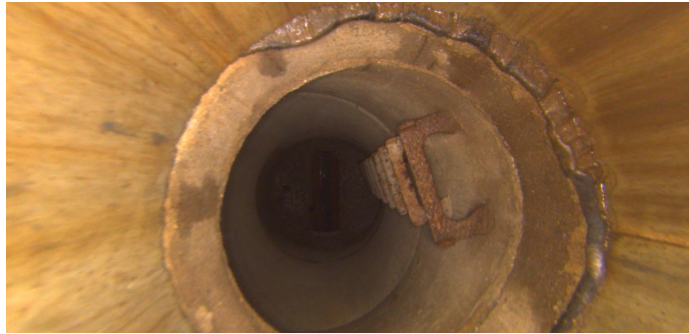
Code: **MGO**
Description: **General Observation**

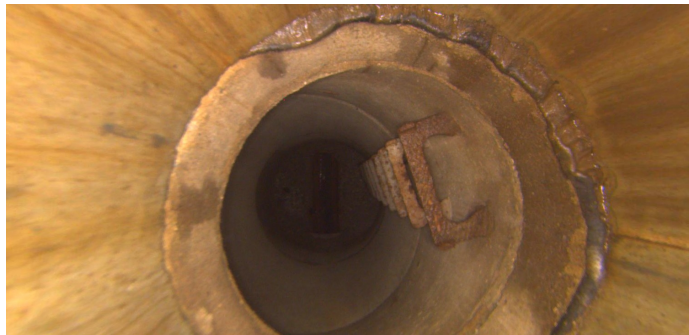
Code: **SRI**
Description: **Surface Roughness Increased**

Distance (ft): **.0**
Structural Grade: **1**
O&M Grade: **0**
Clock Start/From: **12**
Clock To: **12**
1st Value:
2nd Value:
Value Percent:
Step: **NO**
Remarks:

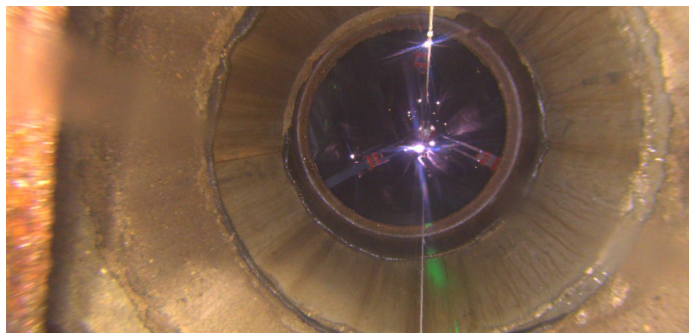
Code: **ISGT**
Description: **Intruding Sealing Grout**

Distance (ft): **.0**
Structural Grade: **0**
O&M Grade: **2**
Clock Start/From: **10**
Clock To: **4**
1st Value:
2nd Value:
Value Percent: **5.000**
Step: **NO**
Remarks:

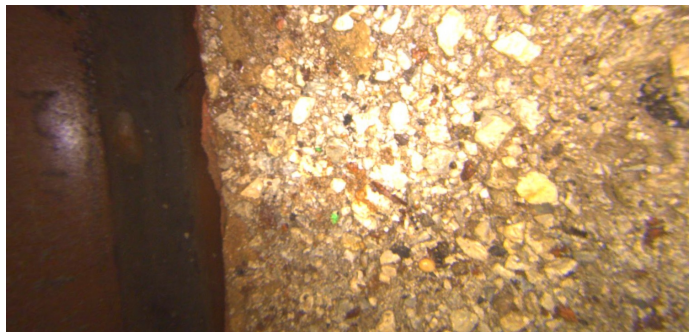
Code:	DSGV
Description:	Deposits Settled Gravel
Distance (ft):	9.8
Structural Grade:	0
O&M Grade:	2
Clock Start/From:	12
Clock To:	12
1st Value:	
2nd Value:	
Value Percent:	5.000
Step:	NO
Remarks:

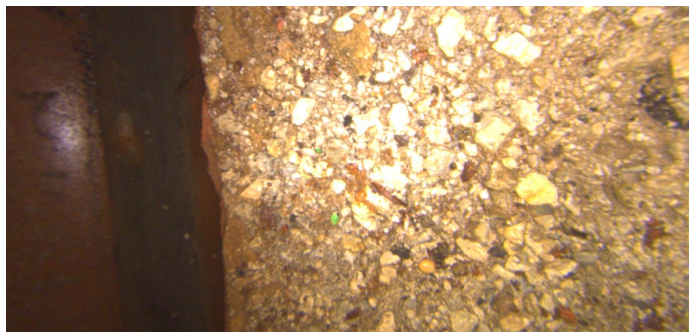
Code:	SRI
Description:	Surface Roughness Increased
Distance (ft):	9.8
Structural Grade:	1
O&M Grade:	0
Clock Start/From:	12
Clock To:	12
1st Value:	
2nd Value:	
Value Percent:	
Step:	NO
Remarks:
