# Manhole Inspection Report

Date:	10/07/2022	Weather:		Coding:	RZMACP
MH#:	M-903-031	Owner:	NA	Len. Surveyed:	9.3
P.O.#:		Surveyor:	Jen Costello	Rim to Invert:	10.6
Customer:		Cert. #:	U-907-5518	Wall Material:	Other

Street:	441' South of Rand St. 161' East of H	Project:	Hobart, IN
City:	Hobart, IN	GPS Northing:	2293947.498
Location:	Other	GPS Easting:	2909883.506
Drain Area:	Northeast	GPS Accuracy:	Sub-Meter
Cover Shape:	Circular	Evidence of Surcharge:	
Cover Size:	24.0	Potential for Runoff:	
Comments:

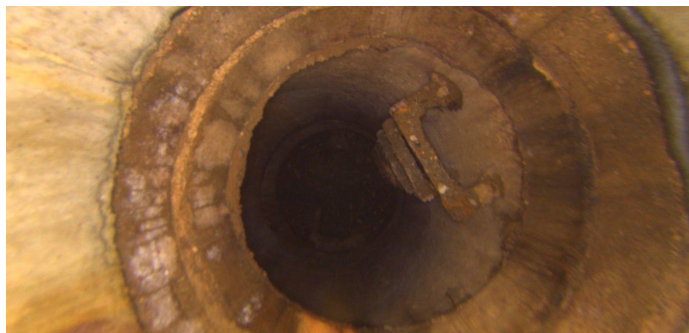
Code: **MGO**  
Description: **General Observation**

Distance (ft): **.0**  
Structural Grade: **0**  
O&M Grade: **0**  
Clock Start/From:  
Clock To:  
1st Value:  
2nd Value:  
Value Percent:  
Step: **NO**  
Remarks: **ACCESS MH**

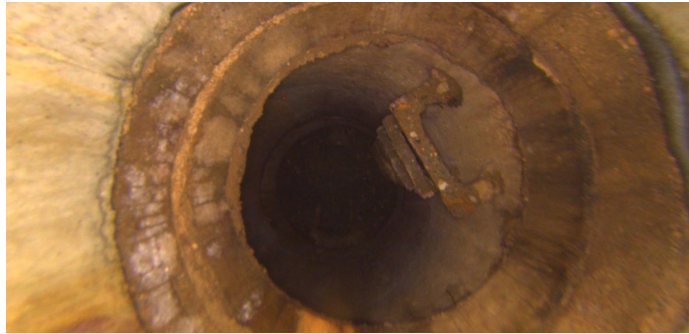
Code:	<b>SRI</b>
Description:	<b>Surface Roughness Increased</b>
Distance (ft):	<b>.0</b>
Structural Grade:	<b>1</b>
O&M Grade:	<b>0</b>
Clock Start/From:	<b>12</b>
Clock To:	<b>12</b>
1st Value:	
2nd Value:	
Value Percent:	
Step:	<b>NO</b>
Remarks:

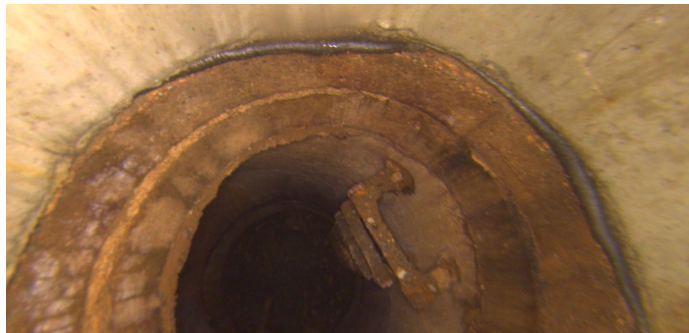
Code:	<b>ISGT</b>
Description:	<b>Intruding Sealing Grout</b>
Distance (ft):	<b>.0</b>
Structural Grade:	<b>0</b>
O&M Grade:	<b>2</b>
Clock Start/From:	<b>12</b>
Clock To:	<b>3</b>
1st Value:	
2nd Value:	
Value Percent:	<b>5.000</b>
Step:	<b>NO</b>
Remarks:

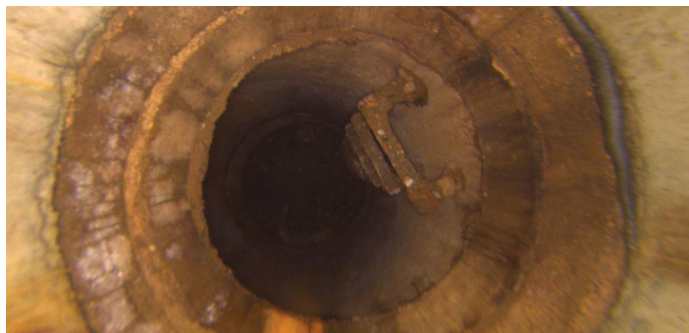
Code:	<b>IW</b>
Description:	<b>Infil Weeper</b>
Distance (ft):	<b>.0</b>
Structural Grade:	<b>0</b>
O&M Grade:	<b>2</b>
Clock Start/From:	<b>12</b>
Clock To:	<b>12</b>
1st Value:	
2nd Value:	
Value Percent:	
Step:	<b>NO</b>
Remarks:

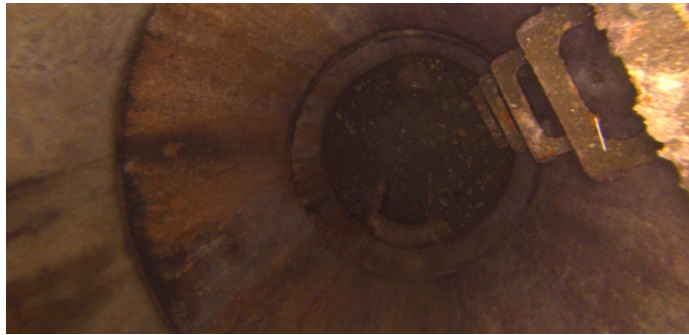
Code: **IW**  
Description: **Infil Weeper**

Distance (ft): **3.4**  
Structural Grade: **0**  
O&M Grade: **2**  
Clock Start/From: **6**  
Clock To: **9**  
1st Value:  
2nd Value:  
Value Percent:  
Step: **NO**  
Remarks:

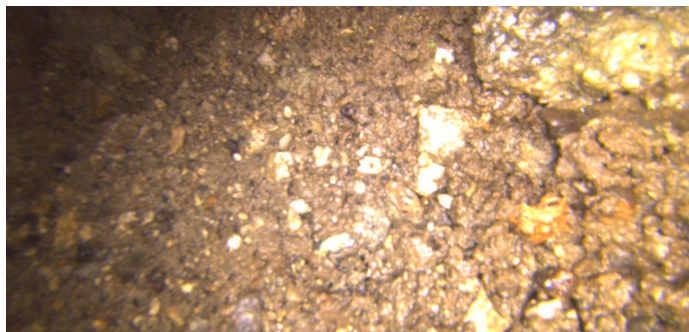
Code: **DSGV**  
Description: **Deposits Settled Gravel**

Distance (ft): **9.3**  
Structural Grade: **0**  
O&M Grade: **2**  
Clock Start/From: **12**  
Clock To: **12**  
1st Value:  
2nd Value:  
Value Percent: **10.000**  
Step: **NO**  
Remarks:

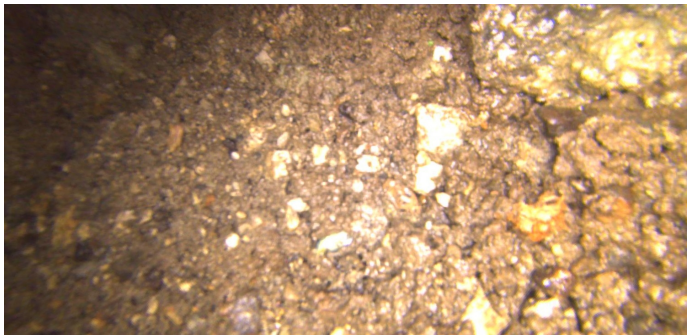
Code: **DSGV**  
Description: **Deposits Settled Gravel**

Distance (ft): **9.3**  
Structural Grade: **0**  
O&M Grade: **5**  
Clock Start/From: **3**  
Clock To: **9**  
1st Value:  
2nd Value:  
Value Percent: **40.000**  
Step: **NO**  
Remarks:
