# Manhole Inspection Report

Position	Code	Observation	Video (sec)	Grade

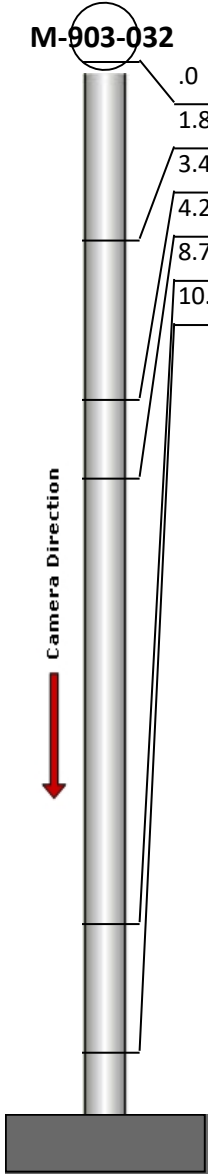
.0	MGP	General Photo	10	NA
	1.8	MGP	General Photo	27	NA
	3.4	IS	Infil Stain	44	NA
	4.2	IS	Infil Stain	58	NA
	8.7	DSF	Deposits Settled Fine	79	M 2
	10.0	MGO	General Observation	93	NA

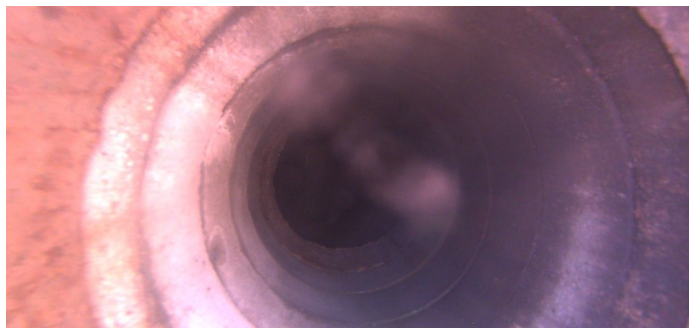
Code: **MGP**  
Description: **General Photo**

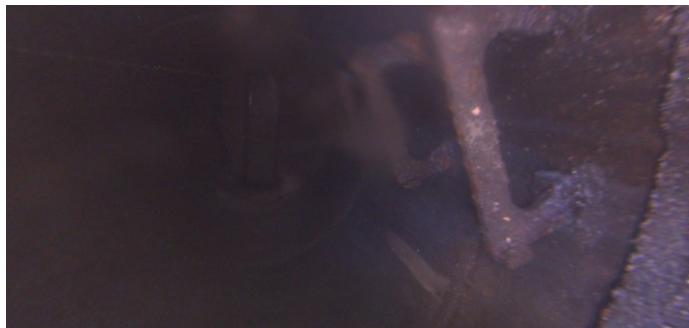
Code:	<b>IS</b>
Description:	<b>Infil Stain</b>
Distance (ft):	<b>3.4</b>
Structural Grade:	<b>0</b>
O&M Grade:	<b>0</b>
Clock Start/From:	<b>4</b>
Clock To:	
1st Value:	
2nd Value:	
Value Percent:	
Step:	<b>NO</b>
Remarks:

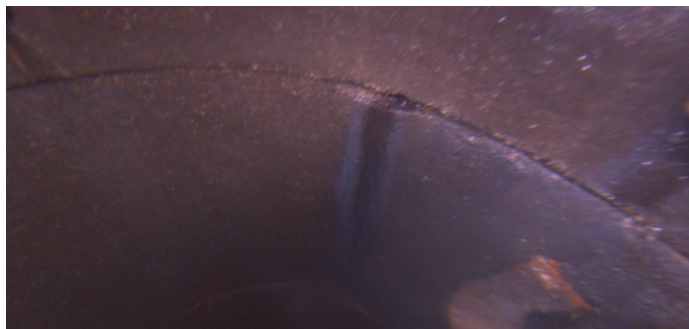
Code:	<b>IS</b>
Description:	<b>Infil Stain</b>
Distance (ft):	<b>4.2</b>
Structural Grade:	<b>0</b>
O&M Grade:	<b>0</b>
Clock Start/From:	<b>1</b>
Clock To:	
1st Value:	
2nd Value:	
Value Percent:	
Step:	<b>NO</b>
Remarks:

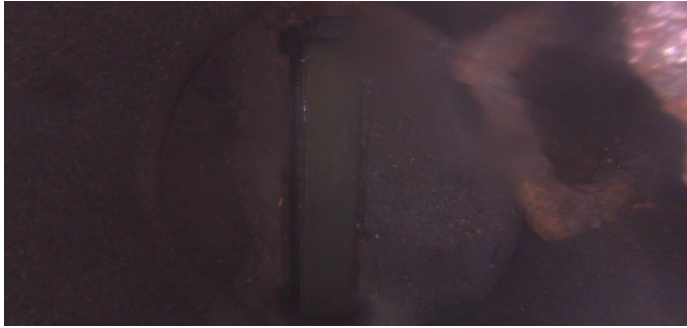
Code:	<b>DSF</b>
Description:	<b>Deposits Settled Fine</b>
Distance (ft):	<b>8.7</b>
Structural Grade:	<b>0</b>
O&M Grade:	<b>2</b>
Clock Start/From:	<b>12</b>
Clock To:	<b>12</b>
1st Value:	
2nd Value:	
Value Percent:	<b>5.000</b>
Step:	<b>NO</b>
Remarks:
