Manhole Inspection Report

Date:	03/21/2018	Weather:		Coding:	RZMACP
MH#:	M-903-037	Owner:	NA	Len. Surveyed:	7.9
P.O.#:		Surveyor:	John Kuglmaier	Rim to Invert:	9.5
Customer:		Cert. #:	U-1215-07002349	Wall Material:	Concrete (reinforced)

Street:	687' East of Hwy 51. and North of 38	Project:	Hobart, IN
City:	Hobart, IN	GPS Northing:	0.0
Location:		GPS Easting:	0.0
Drain Area:	Northeast	GPS Accuracy:	Nearest Meter
Cover Shape:	Circular	Evidence of Surcharge:	Yes
Cover Size:	23.0	Potential for Runoff:	None
Comments:

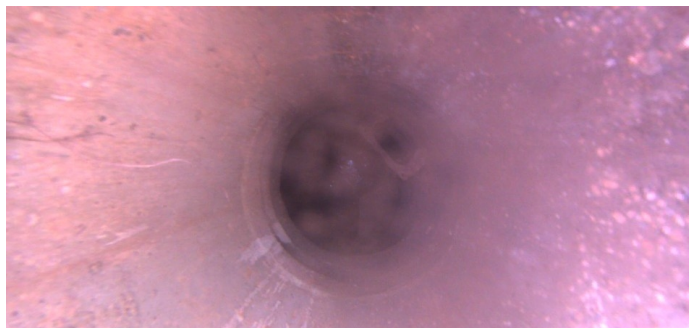
Code: **MGP**
Description: **General Photo**

Distance (ft): **.0**
Structural Grade: **0**
O&M Grade: **0**
Clock Start/From:
Clock To:
1st Value:
2nd Value:
Value Percent:
Step: **NO**
Remarks:

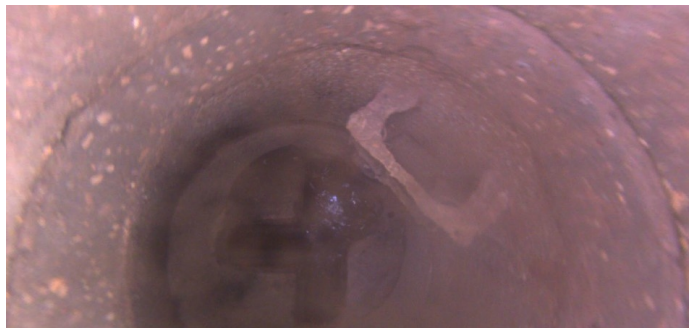
Code: **SAV**
Description: **Surface Aggregate Visible**

Distance (ft): **2.3**
Structural Grade: **3**
O&M Grade: **0**
Clock Start/From: **12**
Clock To: **12**
1st Value:
2nd Value:
Value Percent:
Step: **NO**
Remarks:

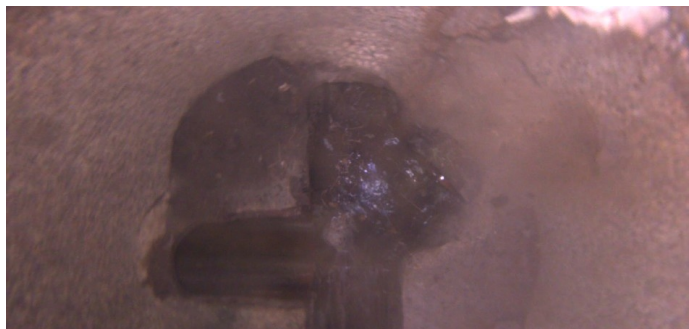
Code: **DSF**
Description: **Deposits Settled Fine**

Distance (ft): **5.3**
Structural Grade: **0**
O&M Grade: **2**
Clock Start/From: **9**
Clock To: **12**
1st Value:
2nd Value:
Value Percent: **5.000**
Step: **NO**
Remarks:

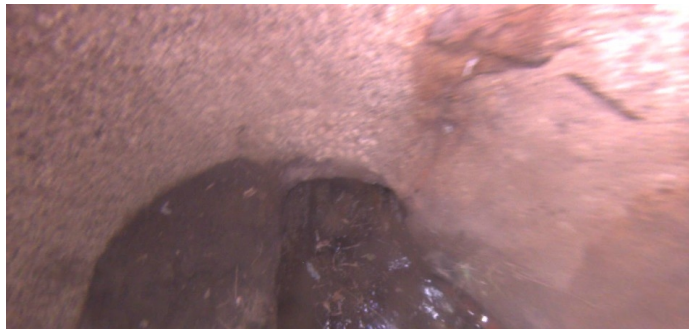
Code:	SAV
Description:	Surface Aggregate Visible
Distance (ft):	6.1
Structural Grade:	3
O&M Grade:	0
Clock Start/From:	12
Clock To:	12
1st Value:	
2nd Value:	
Value Percent:	
Step:	NO
Remarks:

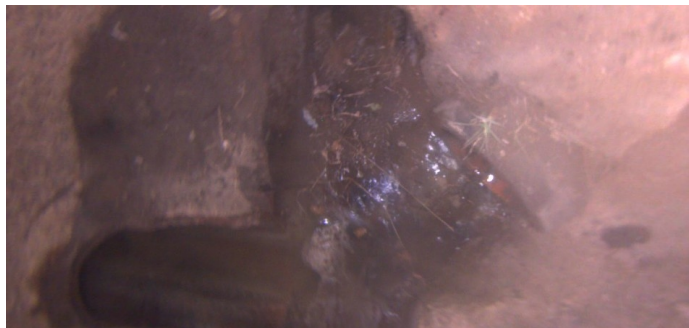
Code:	MGO
Description:	General Observation
Distance (ft):	6.7
Structural Grade:	0
O&M Grade:	0
Clock Start/From:	
Clock To:	
1st Value:	
2nd Value:	
Value Percent:	
Step:	NO
Remarks:	Ins. Comp.
