# Manhole Inspection Report

Position	Code	Observation	Video (sec)	Grade

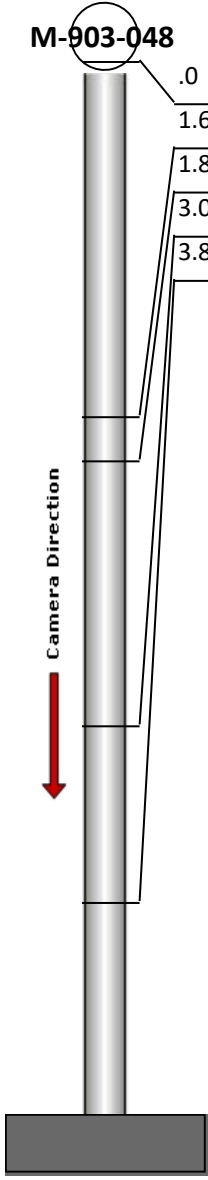
.0	MGP	General Photo	10	NA
	1.6	MGP	General Photo	27	NA
	1.8	IS	Infil Stain	41	NA
	3.0	IS	Infil Stain	56	NA
	3.8	MGO	General Observation	69	NA

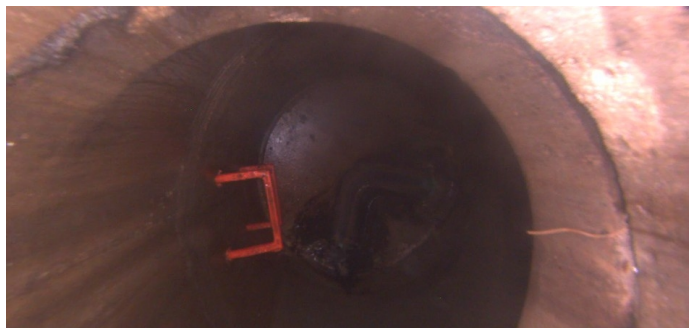
Code: **MGP**  
Description: **General Photo**

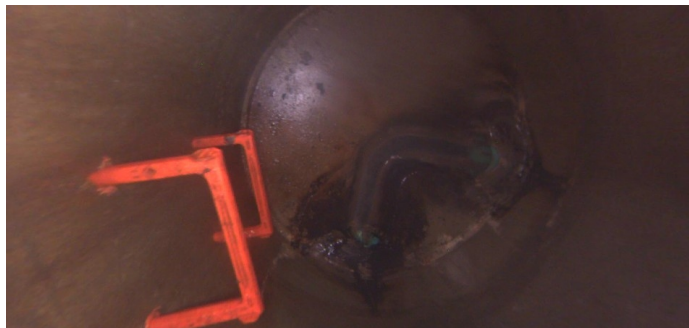
Code: **IS**  
Description: **Infil Stain**

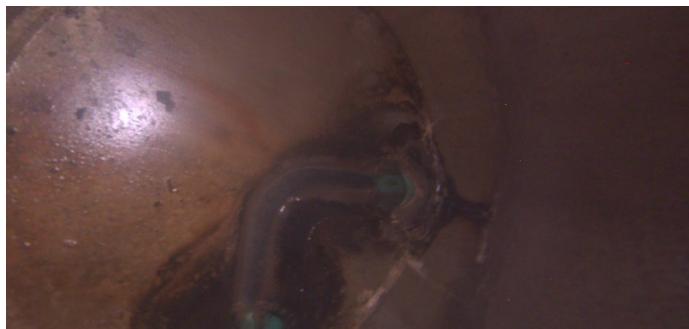
Code: **IS**  
Description: **Infil Stain**

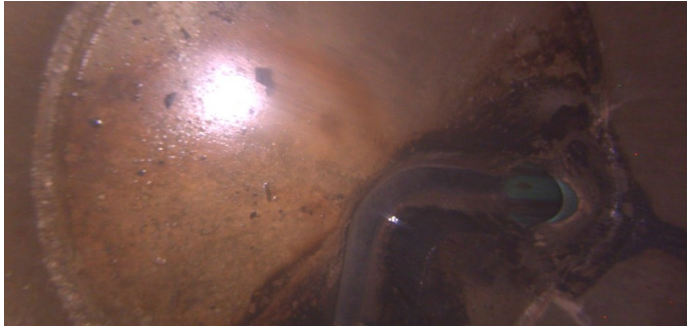
Code:	<b>MGO</b>
Description:	<b>General Observation</b>
Distance (ft):	<b>3.8</b>
Structural Grade:	<b>0</b>
O&M Grade:	<b>0</b>
Clock Start/From:	
Clock To:	
1st Value:	
2nd Value:	
Value Percent:	
Step:	<b>NO</b>
Remarks:	<b>Ins. Comp.</b>
