Manhole Inspection Report

Date:	10/07/2022	Weather:		Coding:	RZMACP
MH#:	M-903-202	Owner:	NA	Len. Surveyed:	7.3
P.O.#:		Surveyor:	Jen Costello	Rim to Invert:	8.8
Customer:		Cert. #:	U-907-5518	Wall Material:	Brick

Street:	Intersection of Rand St. and Brandt	Project:	Hobart, IN
City:	Hobart, IN	GPS Northing:	2294373.603
Location:	Other	GPS Easting:	2910685.762
Drain Area:	Northeast	GPS Accuracy:	Sub-Meter
Cover Shape:	Circular	Evidence of Surcharge:	
Cover Size:	24.0	Potential for Runoff:	None
Comments:

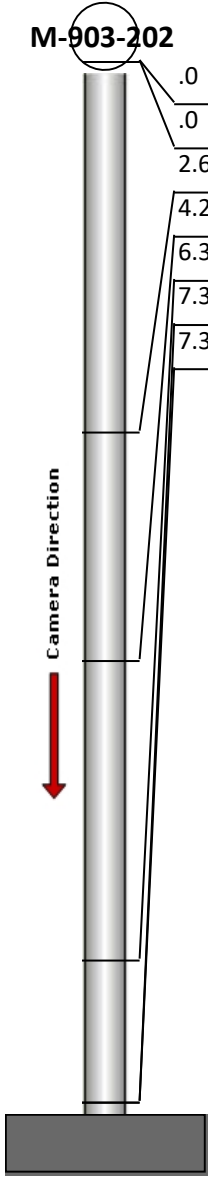
Position	Code	Observation	Video (sec)	Grade

.0	MGO	General Observation	10	NA
	.0	SRI	Surface Roughness Increased	21	S 1
	2.6	ISGT	Intruding Sealing Grout	40	M 2
	4.2	IW	Infil Weeper	57	M 2
	6.3	DSGV	Deposits Settled Gravel	73	M 2
	7.3	SRI	Surface Roughness Increased	87	S 1
	7.3	MGO	General Observation	98	NA

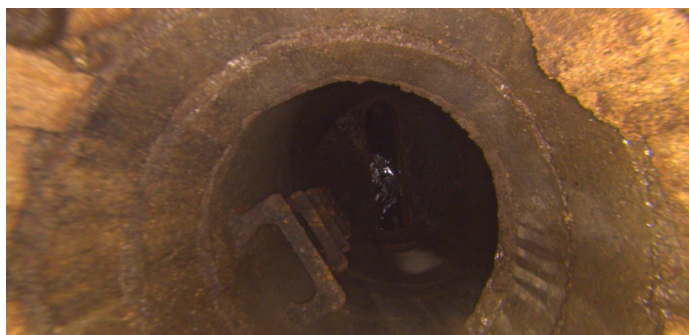
Code: **MGO**
Description: **General Observation**

Distance (ft): **.0**
Structural Grade: **0**
O&M Grade: **0**
Clock Start/From:
Clock To:
1st Value:
2nd Value:
Value Percent:
Step: **NO**
Remarks: **ACCESS MH**

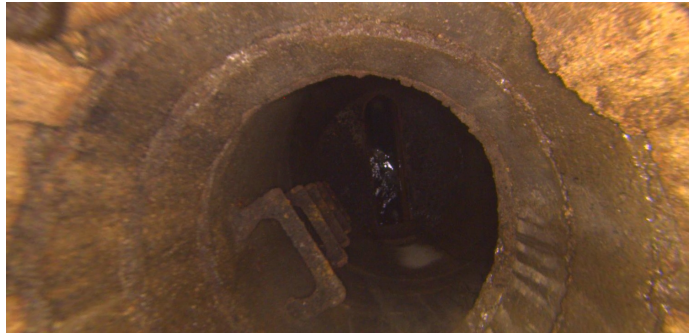
Code: **SRI**
Description: **Surface Roughness Increased**

Distance (ft): **.0**
Structural Grade: **1**
O&M Grade: **0**
Clock Start/From: **12**
Clock To: **12**
1st Value:
2nd Value:
Value Percent:
Step: **NO**
Remarks:

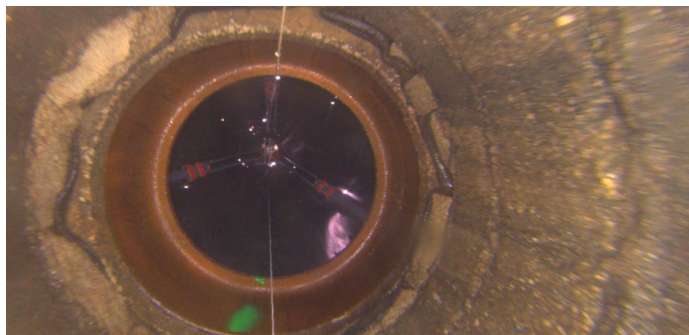
Code: **ISGT**
Description: **Intruding Sealing Grout**

Distance (ft): **2.6**
Structural Grade: **0**
O&M Grade: **2**
Clock Start/From: **12**
Clock To: **12**
1st Value:
2nd Value:
Value Percent: **5.000**
Step: **NO**
Remarks:

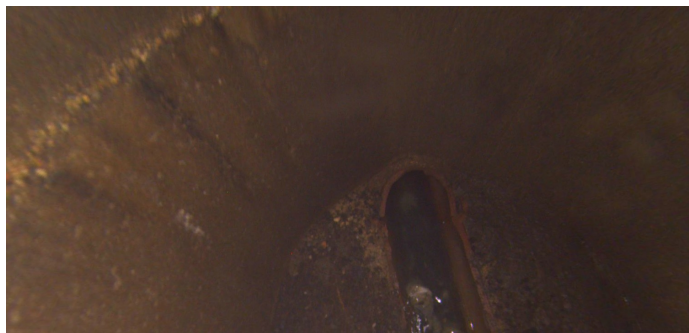
Code: **IW**
Description: **Infil Weeper**

Distance (ft): **4.2**
Structural Grade: **0**
O&M Grade: **2**
Clock Start/From: **9**
Clock To: **12**
1st Value:
2nd Value:
Value Percent:
Step: **NO**
Remarks:

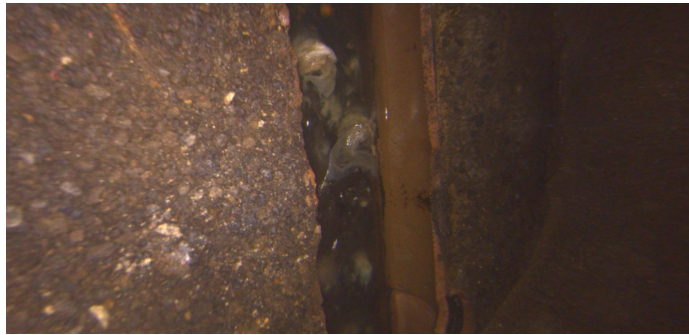
Code: **DSGV**
Description: **Deposits Settled Gravel**

Distance (ft): **6.3**
Structural Grade: **0**
O&M Grade: **2**
Clock Start/From: **12**
Clock To: **12**
1st Value:
2nd Value:
Value Percent: **5.000**
Step: **NO**
Remarks:

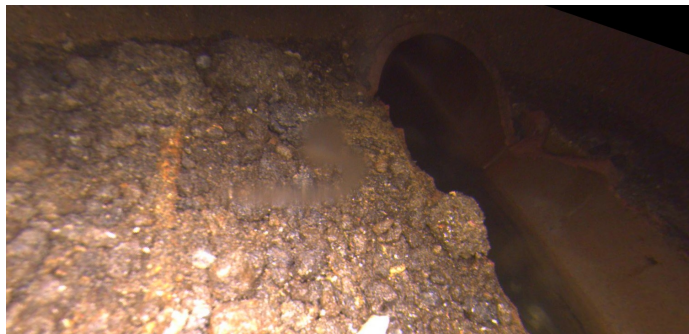
Code: **SRI**
Description: **Surface Roughness Increased**

Distance (ft): **7.3**
Structural Grade: **1**
O&M Grade: **0**
Clock Start/From: **12**
Clock To: **12**
1st Value:
2nd Value:
Value Percent:
Step: **NO**
Remarks:

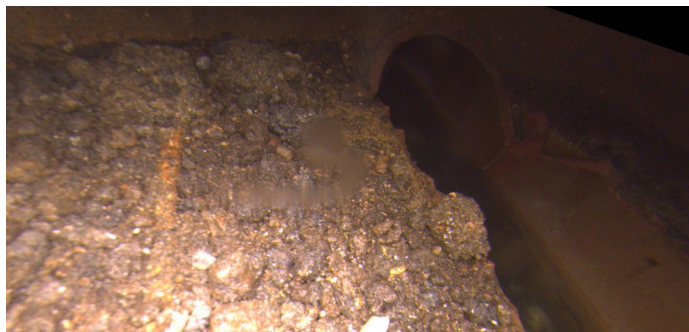
Code: **MGO**
Description: **General Observation**

Distance (ft): **7.3**
Structural Grade: **0**
O&M Grade: **0**
Clock Start/From:
Clock To:
1st Value:
2nd Value:
Value Percent:
Step: **NO**
Remarks: **END OF SURVEY**
