# Manhole Inspection Report

Date:	05/11/2018	Weather:		Coding:	RZMACP
MH#:	M-904-011	Owner:	NA	Len. Surveyed:	7.7
P.O.#:		Surveyor:	Jen Costello	Rim to Invert:	8.2
Customer:		Cert. #:	U-907-5518	Wall Material:	Concrete (reinforced)

Street:	Fraser Ln. to the Northeast.	Project:	Hobart, IN
City:	Hobart, IN	GPS Northing:	2911479.721
Location:		GPS Easting:	2911479.721
Drain Area:	Northeast	GPS Accuracy:	Sub-Meter
Cover Shape:	Circular	Evidence of Surcharge:	No
Cover Size:	22.5	Potential for Runoff:	None
Comments:

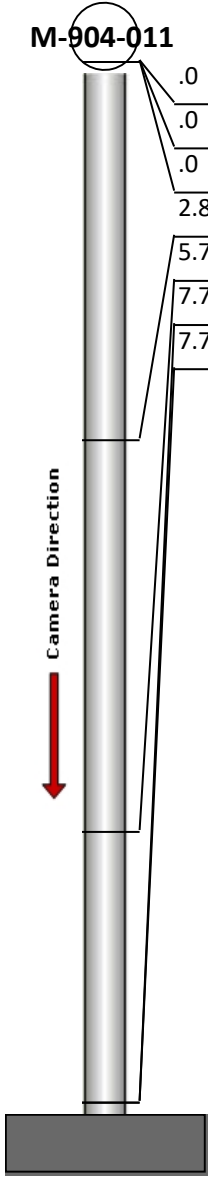
.0	MGO	General Observation	10	NA
	.0	FM	Fracture Multiple	21	S 4
	.0	SAV	Surface Aggregate Visible	32	S 3
	2.8	MGO	General Observation	51	NA
	5.7	OBR	Obstacle Rocks	70	M 2
	7.7	DSF	Deposits Settled Fine	85	M 5
	7.7	MGO	General Observation	96	NA

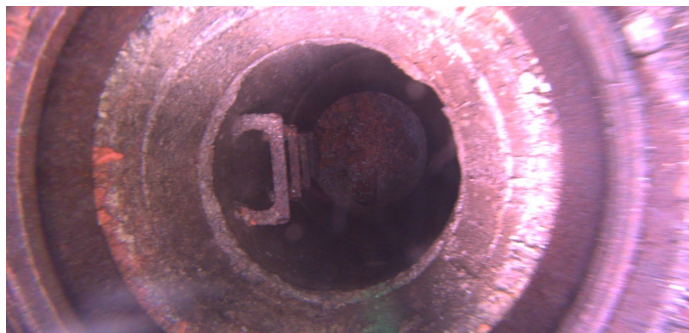
Code: **MGO**  
Description: **General Observation**

Distance (ft): **.0**  
Structural Grade: **0**  
O&M Grade: **0**  
Clock Start/From:  
Clock To:  
1st Value:  
2nd Value:  
Value Percent:  
Step: **NO**  
Remarks: **ACCESS MH**

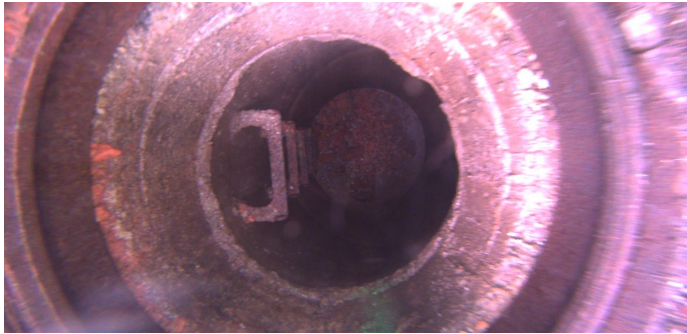
Code: **FM**  
Description: **Fracture Multiple**

Distance (ft): **.0**  
Structural Grade: **4**  
O&M Grade: **0**  
Clock Start/From: **2**  
Clock To: **4**  
1st Value:  
2nd Value:  
Value Percent:  
Step: **NO**  
Remarks:

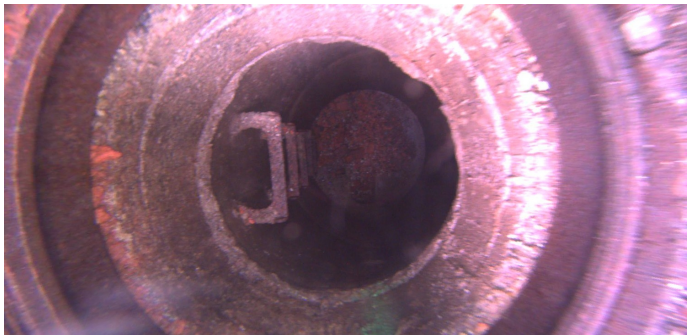
Code: **SAV**  
Description: **Surface Aggregate Visible**

Distance (ft): **.0**  
Structural Grade: **3**  
O&M Grade: **0**  
Clock Start/From: **12**  
Clock To: **12**  
1st Value:  
2nd Value:  
Value Percent:  
Step: **NO**  
Remarks:

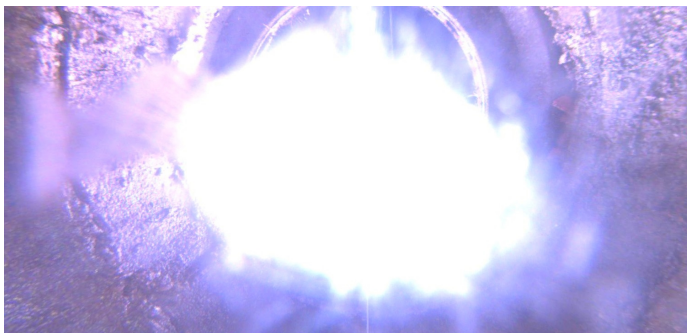
Code: **MGO**  
Description: **General Observation**

Distance (ft): **2.8**  
Structural Grade: **0**  
O&M Grade: **0**  
Clock Start/From:  
Clock To:  
1st Value:  
2nd Value:  
Value Percent:  
Step: **NO**  
Remarks: **END SURVEY**

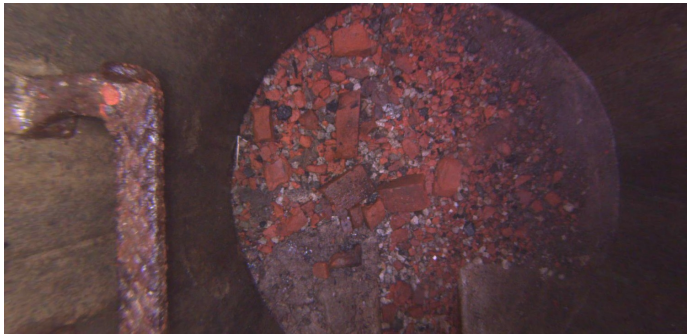
Code: **OBR**  
Description: **Obstacle Rocks**

Distance (ft): **5.7**  
Structural Grade: **0**  
O&M Grade: **2**  
Clock Start/From: **12**  
Clock To: **12**  
1st Value:  
2nd Value:  
Value Percent: **5.000**  
Step: **NO**  
Remarks:

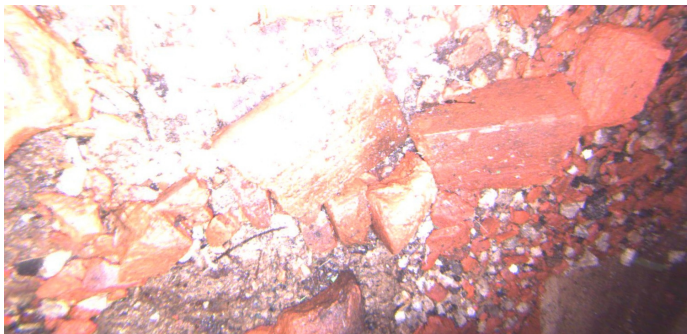
Code: **DSF**  
Description: **Deposits Settled Fine**

Distance (ft): **7.7**  
Structural Grade: **0**  
O&M Grade: **5**  
Clock Start/From: **3**  
Clock To: **9**  
1st Value:  
2nd Value:  
Value Percent: **40.000**  
Step: **NO**  
Remarks:

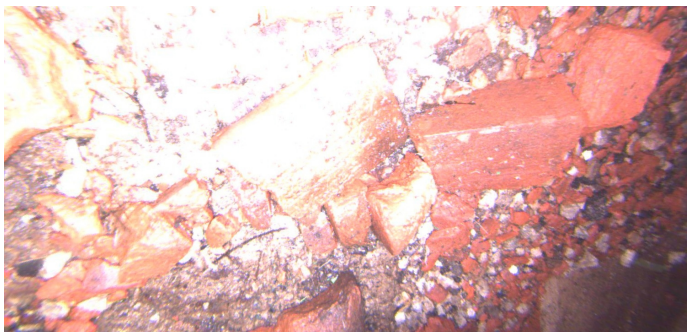
Code: **MGO**  
Description: **General Observation**

Distance (ft): **7.7**  
Structural Grade: **0**  
O&M Grade: **0**  
Clock Start/From:  
Clock To:  
1st Value:  
2nd Value:  
Value Percent:  
Step: **NO**  
Remarks: **END SURVEY**
