Manhole Inspection Report

Date:	05/11/2018	Weather:		Coding:	RZMACP
MH#:	M-904-014	Owner:	NA	Len. Surveyed:	12.1
P.O.#:		Surveyor:	Jen Costello	Rim to Invert:	12.5
Customer:		Cert. #:	U-907-5518	Wall Material:	Concrete (reinforced)

Street:	W. Frasier Ln. 850' North of Clevela	Project:	Hobart, IN
City:	Hobart, IN	GPS Northing:	41.53856277
Location:		GPS Easting:	-87.23490906
Drain Area:	Northeast	GPS Accuracy:	Nearest Meter
Cover Shape:	Circular	Evidence of Surcharge:	No
Cover Size:	22.5	Potential for Runoff:	None
Comments:

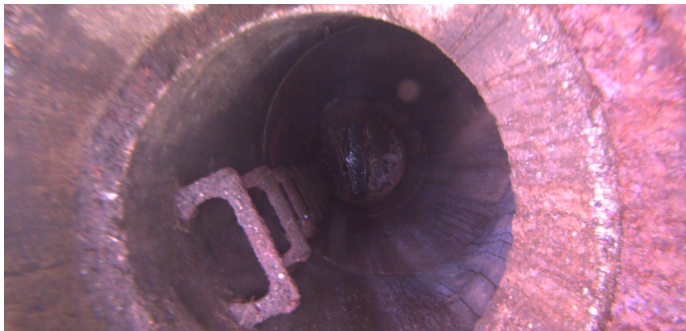
Code: **MGO**
Description: **General Observation**

Distance (ft):	.0
Structural Grade:	0
O&M Grade:	0
Clock Start/From:	
Clock To:	
1st Value:	
2nd Value:	
Value Percent:	
Step:	NO
Remarks:	AC

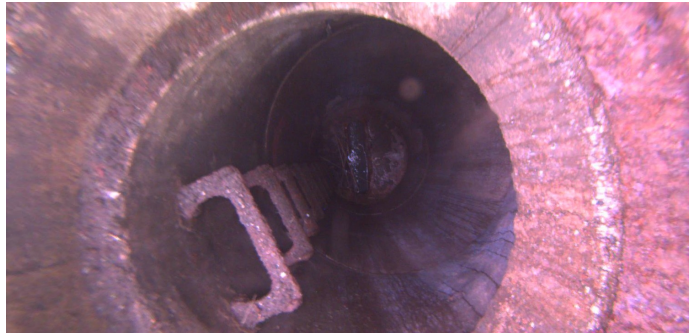
Code: **MGO**
Description: **General Observation**

Distance (ft): **.0**
Structural Grade: **0**
O&M Grade: **0**
Clock Start/From:
Clock To:
1st Value:
2nd Value:
Value Percent:
Step: **NO**
Remarks: **END SURVEY**

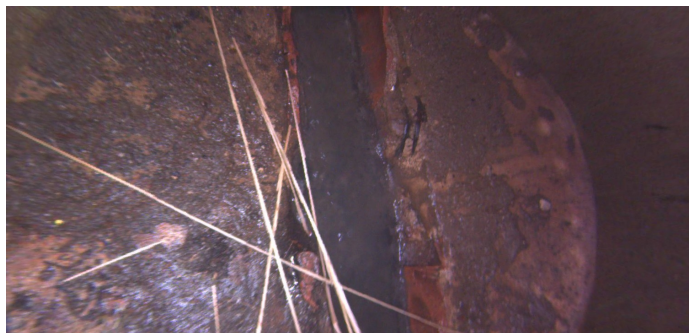
Code: **DSF**
Description: **Deposits Settled Fine**

Distance (ft): **11.0**
Structural Grade: **0**
O&M Grade: **2**
Clock Start/From: **12**
Clock To: **12**
1st Value:
2nd Value:
Value Percent: **5.000**
Step: **NO**
Remarks:

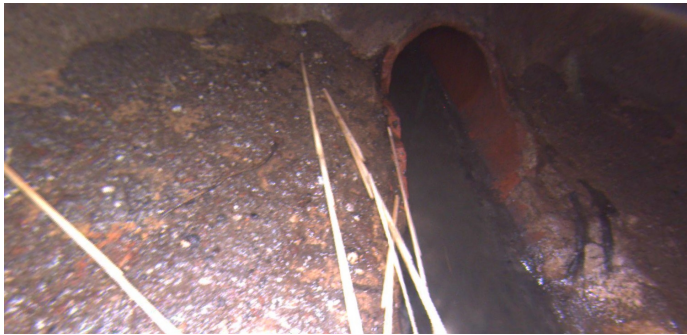
Code: **MGO**
Description: **General Observation**

Distance (ft): **12.1**
Structural Grade: **0**
O&M Grade: **0**
Clock Start/From:
Clock To:
1st Value:
2nd Value:
Value Percent:
Step: **NO**
Remarks: **END SURVEY**
