# Manhole Inspection Report

Position	Code	Observation	Video (sec)	Grade

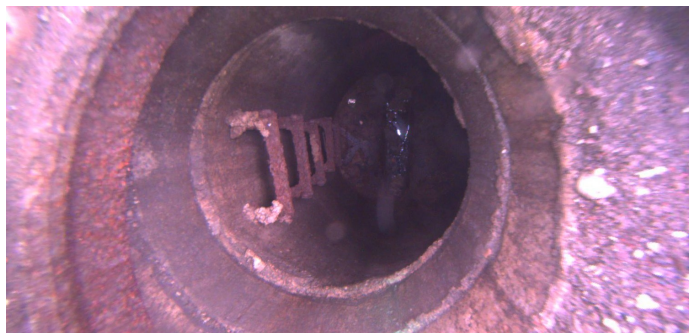
Code: **MGO**  
Description: **General Observation**

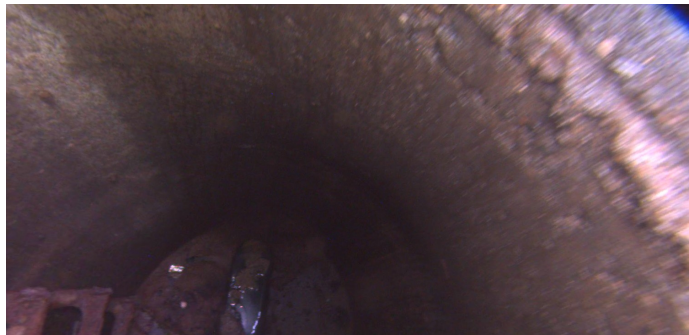
Code:	<b>SSS</b>
Description:	<b>Surface Spalling</b>
Distance (ft):	<b>2.0</b>
Structural Grade:	<b>2</b>
O&M Grade:	<b>0</b>
Clock Start/From:	<b>1</b>
Clock To:	<b>3</b>
1st Value:	
2nd Value:	
Value Percent:	
Step:	<b>NO</b>
Remarks:

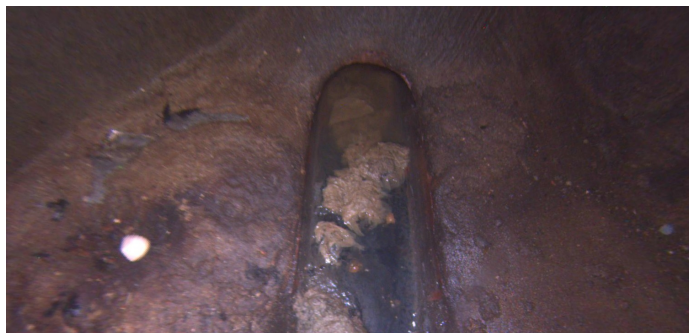
Code:	<b>DSF</b>
Description:	<b>Deposits Settled Fine</b>
Distance (ft):	<b>6.9</b>
Structural Grade:	<b>0</b>
O&M Grade:	<b>2</b>
Clock Start/From:	<b>12</b>
Clock To:	<b>12</b>
1st Value:	
2nd Value:	
Value Percent:	<b>5.000</b>
Step:	<b>NO</b>
Remarks:
