# Manhole Inspection Report

Date:	05/08/2018	Weather:		Coding:	RZMACP
MH#:	M-904-015	Owner:	NA	Len. Surveyed:	9.9
P.O.#:		Surveyor:	Jen Costello	Rim to Invert:	11.0
Customer:		Cert. #:	U-907-5518	Wall Material:	Concrete (reinforced)

Street:	W. Fraser Ln. 611' North of Clevelan	Project:	Hobart, IN
City:	Hobart, IN	GPS Northing:	2911255.586
Location:		GPS Easting:	2911255.586
Drain Area:	Northeast	GPS Accuracy:	Sub-Meter
Cover Shape:	Circular	Evidence of Surcharge:	No
Cover Size:	22.5	Potential for Runoff:	None
Comments:

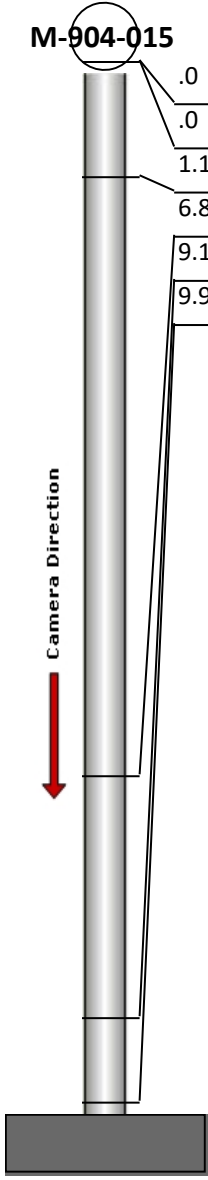
Position	Code	Observation	Video (sec)	Grade

.0	MGP	General Photo	10	NA
	.0	B	Broken	21	S 5
	1.1	OBB	Obstacle Brick	33	M 2
	6.8	OBB	Obstacle Brick	56	M 2
	9.1	OBB	Obstacle Brick	71	M 2
	9.9	MGO	General Observation	83	NA

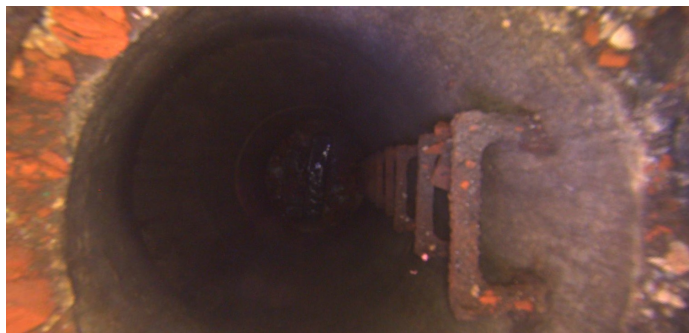
Code: **MGP**  
Description: **General Photo**

Distance (ft): **.0**  
Structural Grade: **0**  
O&M Grade: **0**  
Clock Start/From:  
Clock To:  
1st Value:  
2nd Value:  
Value Percent:  
Step: **NO**  
Remarks: **ACCESS MH**

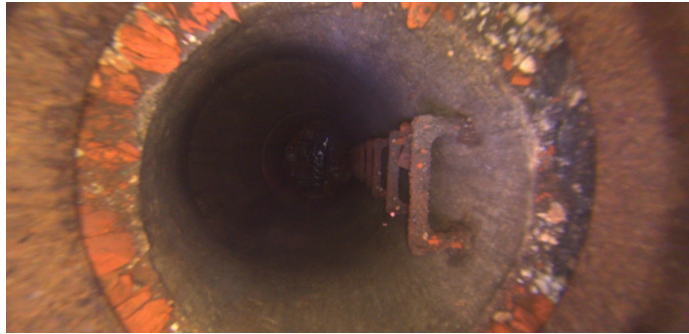
Code: **B**  
Description: **Broken**

Distance (ft): **.0**  
Structural Grade: **5**  
O&M Grade: **0**  
Clock Start/From: **12**  
Clock To: **12**  
1st Value:  
2nd Value:  
Value Percent:  
Step: **NO**  
Remarks:

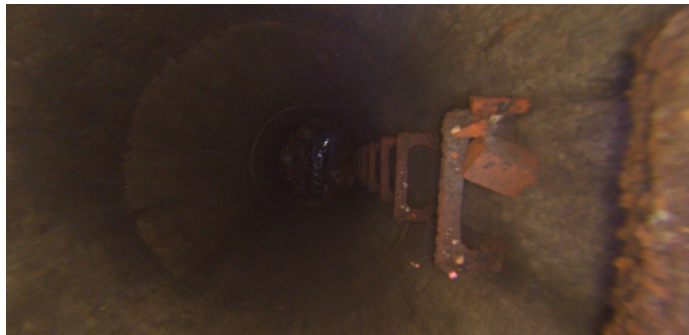
Code: **OBB**  
Description: **Obstacle Brick**

Distance (ft): **1.1**  
Structural Grade: **0**  
O&M Grade: **2**  
Clock Start/From: **3**  
Clock To:  
1st Value:  
2nd Value:  
Value Percent: **5.000**  
Step: **YES**  
Remarks:

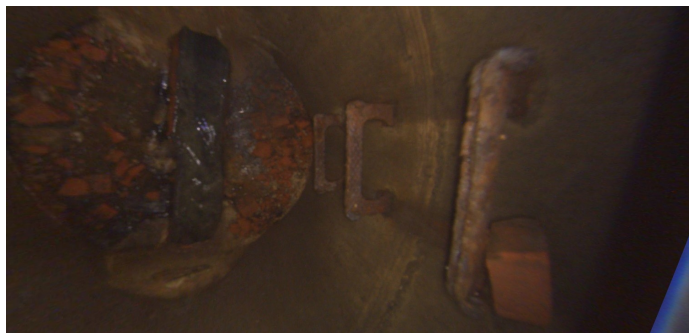
Code: **OBB**  
Description: **Obstacle Brick**

Distance (ft): **6.8**  
Structural Grade: **0**  
O&M Grade: **2**  
Clock Start/From: **4**  
Clock To:  
1st Value:  
2nd Value:  
Value Percent: **5.000**  
Step: **NO**  
Remarks:

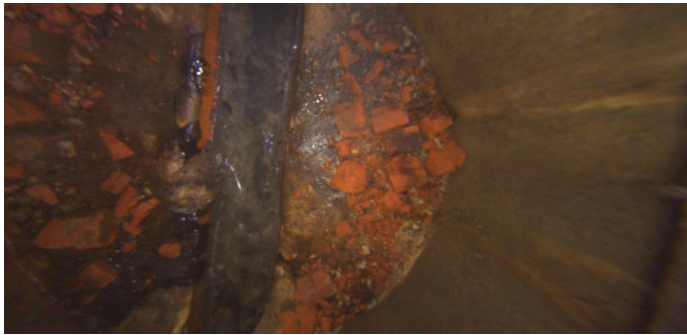
Code: **OBB**  
Description: **Obstacle Brick**

Distance (ft): **9.1**  
Structural Grade: **0**  
O&M Grade: **2**  
Clock Start/From: **12**  
Clock To: **12**  
1st Value:  
2nd Value:  
Value Percent: **10.000**  
Step: **NO**  
Remarks:

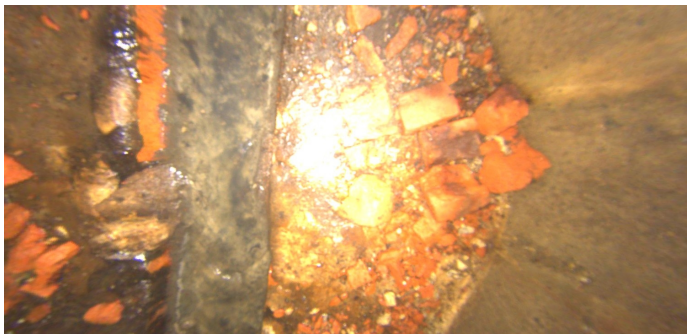
Code: **MGO**  
Description: **General Observation**

Distance (ft): **9.9**  
Structural Grade: **0**  
O&M Grade: **0**  
Clock Start/From:  
Clock To:  
1st Value:  
2nd Value:  
Value Percent:  
Step: **NO**  
Remarks: **END SURVEY**
