# Manhole Inspection Report

Date:	<b>05/08/2018</b>	Weather:		Coding:	<b>RZMACP</b>
MH#:	<b>M-904-016</b>	Owner:	<b>NA</b>	Len. Surveyed:	<b>9.9</b>
P.O.#:		Surveyor:	<b>Jen Costello</b>	Rim to Invert:	<b>10.4</b>
Customer:		Cert. #:	<b>U-907-5518</b>	Wall Material:	<b>Concrete (reinforced)</b>

Street:	<b>W. Fraser Ln. 395' North of Clevelan</b>	Project:	<b>Hobart, IN</b>
City:	<b>Hobart, IN</b>	GPS Northing:	<b>2911259.263</b>
Location:		GPS Easting:	<b>2911259.263</b>
Drain Area:	<b>Northeast</b>	GPS Accuracy:	<b>Sub-Meter</b>
Cover Shape:	<b>Circular</b>	Evidence of Surcharge:	<b>No</b>
Cover Size:	<b>22.5</b>	Potential for Runoff:	<b>None</b>
Comments:

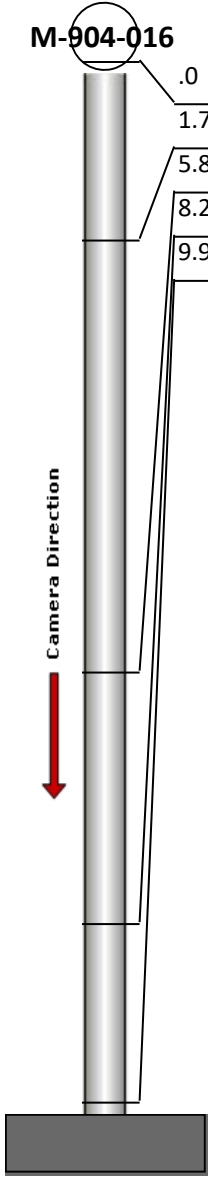
.0	MGP	General Photo	10	NA
	1.7	MGP	General Photo	26	NA
	5.8	IS	Infil Stain	48	NA
	8.2	OBM	Obstacle Pipe Material	64	M 2
	9.9	MGP	General Photo	79	NA

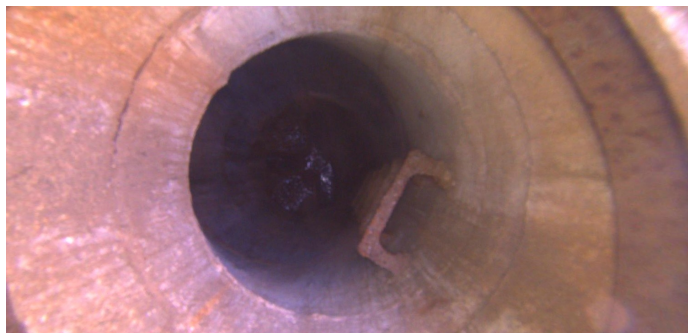
Code: **MGP**  
Description: **General Photo**

Distance (ft): **.0**  
Structural Grade: **0**  
O&M Grade: **0**  
Clock Start/From:  
Clock To:  
1st Value:  
2nd Value:  
Value Percent:  
Step: **NO**  
Remarks: **access MH**

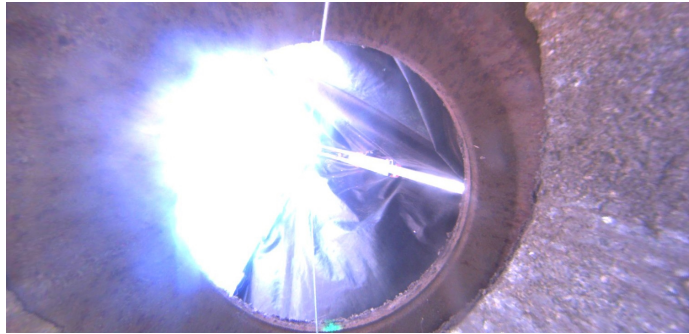
Code: **MGP**  
Description: **General Photo**

Distance (ft): **1.7**  
Structural Grade: **0**  
O&M Grade: **0**  
Clock Start/From:  
Clock To:  
1st Value:  
2nd Value:  
Value Percent:  
Step: **NO**  
Remarks: **ACCESS MH**

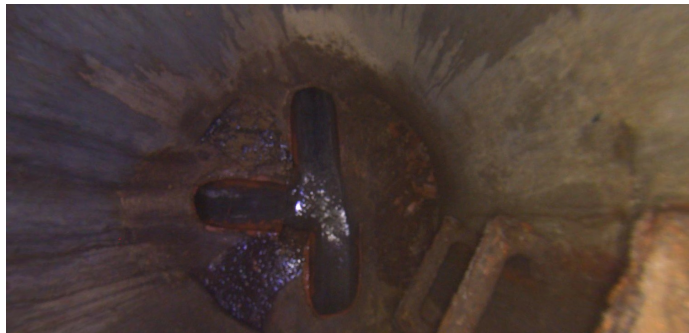
Code: **IS**  
Description: **Infil Stain**

Distance (ft): **5.8**  
Structural Grade: **0**  
O&M Grade: **0**  
Clock Start/From: **12**  
Clock To: **12**  
1st Value:  
2nd Value:  
Value Percent:  
Step: **NO**  
Remarks:

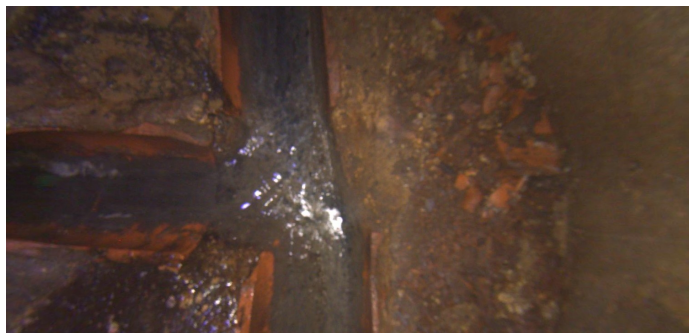
Code: **OBM**  
Description: **Obstacle Pipe Material**

Distance (ft): **8.2**  
Structural Grade: **0**  
O&M Grade: **2**  
Clock Start/From: **1**  
Clock To: **4**  
1st Value:  
2nd Value:  
Value Percent: **5.000**  
Step: **NO**  
Remarks:

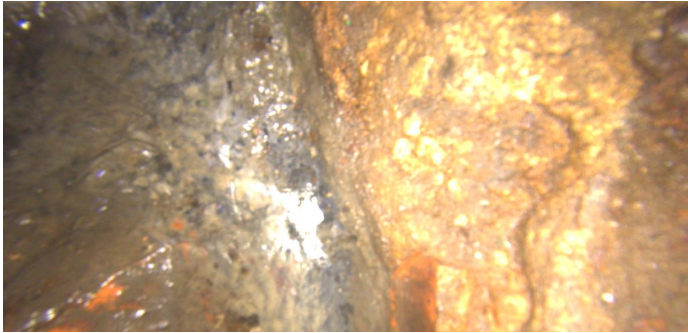
Code:	<b>MGP</b>
Description:	<b>General Photo</b>
Distance (ft):	<b>9.9</b>
Structural Grade:	<b>0</b>
O&M Grade:	<b>0</b>
Clock Start/From:	
Clock To:	
1st Value:	
2nd Value:	
Value Percent:	
Step:	<b>NO</b>
Remarks:	<b>ACCESS MH</b>
