Manhole Inspection Report

Date:	05/08/2018	Weather:		Coding:	RZMACP
MH#:	M-904-018	Owner:	NA	Len. Surveyed:	7.0
P.O.#:		Surveyor:	Jen Costello	Rim to Invert:	8.2
Customer:		Cert. #:	U-907-5518	Wall Material:	Concrete (reinforced)

Street:	E. Fraser Ln. 643' North of Cleveland	Project:	Hobart, IN
City:	Hobart, IN	GPS Northing:	2911585.486
Location:		GPS Easting:	2911585.486
Drain Area:	Northeast	GPS Accuracy:	Sub-Meter
Cover Shape:	Circular	Evidence of Surcharge:	No
Cover Size:	22.5	Potential for Runoff:	None
Comments:

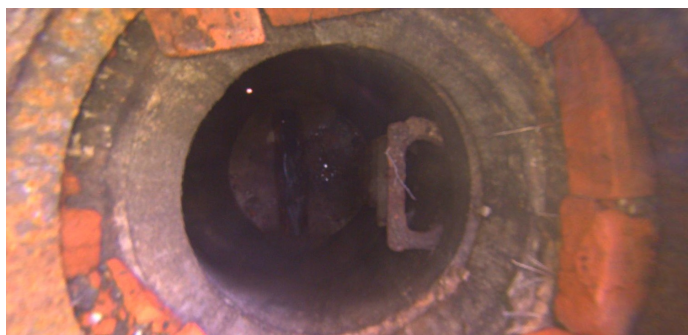
Code: **MGP**
Description: **General Photo**

Distance (ft): **.0**
Structural Grade: **0**
O&M Grade: **0**
Clock Start/From:
Clock To:
1st Value:
2nd Value:
Value Percent:
Step: **NO**
Remarks: **ACCESS MH**

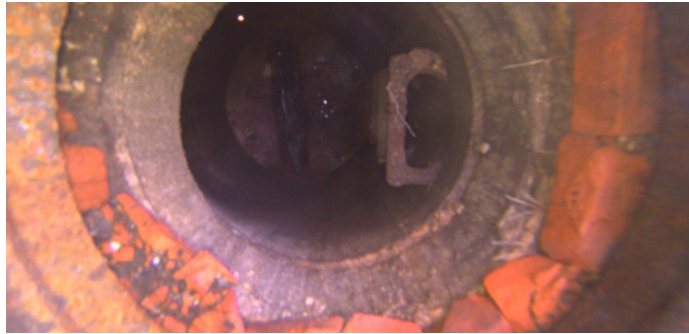
Code: **RFJ**
Description: **Roots Fine Joint**

Distance (ft): **.0**
Structural Grade: **0**
O&M Grade: **1**
Clock Start/From: **2**
Clock To: **3**
1st Value:
2nd Value:
Value Percent:
Step: **NO**
Remarks:

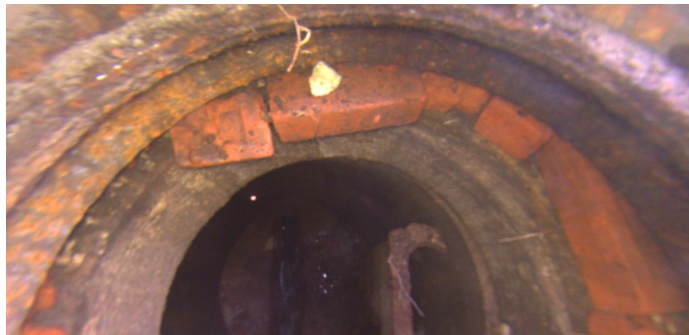
Code: **DB**
Description: **Displaced Brick**

Distance (ft): **.0**
Structural Grade: **3**
O&M Grade: **0**
Clock Start/From: **11**
Clock To: **12**
1st Value:
2nd Value:
Value Percent:
Step: **NO**
Remarks:

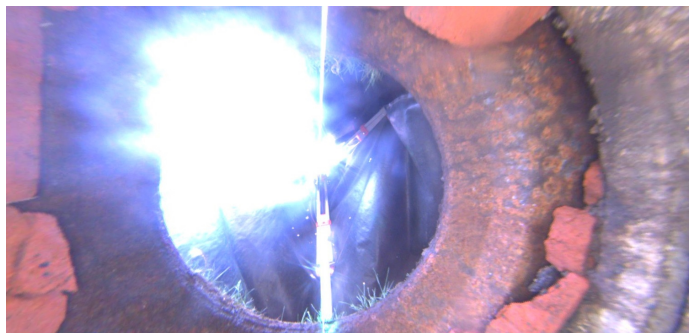
Code: **MGO**
Description: **General Observation**

Distance (ft): **1.8**
Structural Grade: **0**
O&M Grade: **0**
Clock Start/From:
Clock To:
1st Value:
2nd Value:
Value Percent:
Step: **NO**
Remarks: **END SURVEY**

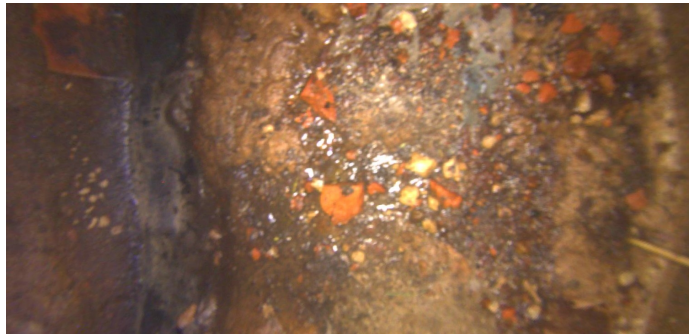
Code: **DSGV**
Description: **Deposits Settled Gravel**

Distance (ft): **7.0**
Structural Grade: **0**
O&M Grade: **2**
Clock Start/From: **12**
Clock To: **6**
1st Value:
2nd Value:
Value Percent: **5.000**
Step: **NO**
Remarks:

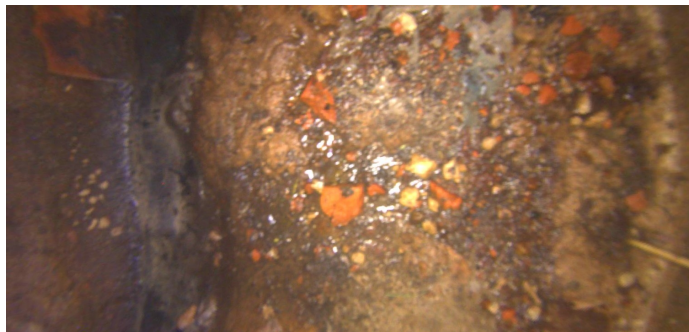
Code: **MGO**
Description: **General Observation**

Distance (ft): **7.0**
Structural Grade: **0**
O&M Grade: **0**
Clock Start/From:
Clock To:
1st Value:
2nd Value:
Value Percent:
Step: **NO**
Remarks: **END SURVEY**
