Manhole Inspection Report

Date:	10/11/2022	Weather:		Coding:	RZMACP
MH#:	M-904-019	Owner:	NA	Len. Surveyed:	7.4
P.O.#:		Surveyor:	Jen Costello	Rim to Invert:	8.3
Customer:		Cert. #:	U-907-5518	Wall Material:	Concrete (cast in place)

Street:	E. Fraser Ln. 851' North of Cleveland	Project:	Hobart, IN
City:	Hobart, IN	GPS Northing:	2291260.828
Location:	Local Rural Streets	GPS Easting:	2911581.323
Drain Area:	Northeast	GPS Accuracy:	Sub-Meter
Cover Shape:	Circular	Evidence of Surcharge:	No
Cover Size:	24.0	Potential for Runoff:	None
Comments:

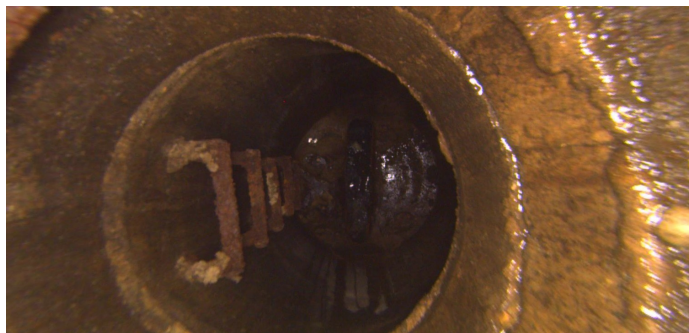
Code: **MGO**
Description: **General Observation**

Distance (ft): **.0**
Structural Grade: **0**
O&M Grade: **0**
Clock Start/From:
Clock To:
1st Value:
2nd Value:
Value Percent:
Step: **NO**
Remarks: **access mh**

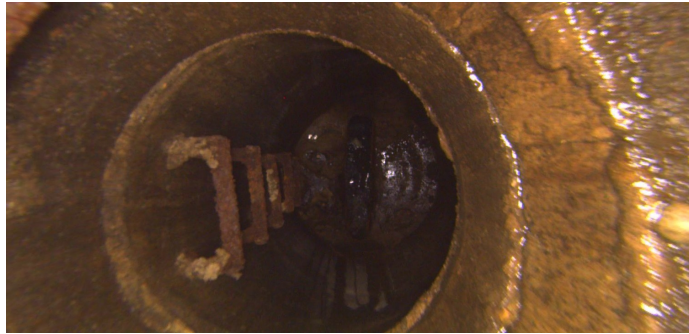
Code: **SRI**
Description: **Surface Roughness Increased**

Distance (ft): **.0**
Structural Grade: **1**
O&M Grade: **0**
Clock Start/From: **12**
Clock To: **12**
1st Value:
2nd Value:
Value Percent:
Step: **NO**
Remarks:

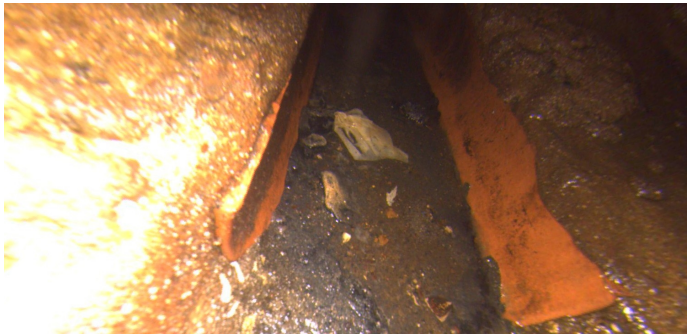
Code: **MGO**
Description: **General Observation**

Distance (ft): **7.4**
Structural Grade: **0**
O&M Grade: **0**
Clock Start/From:
Clock To:
1st Value:
2nd Value:
Value Percent:
Step: **NO**
Remarks: **end of survey**

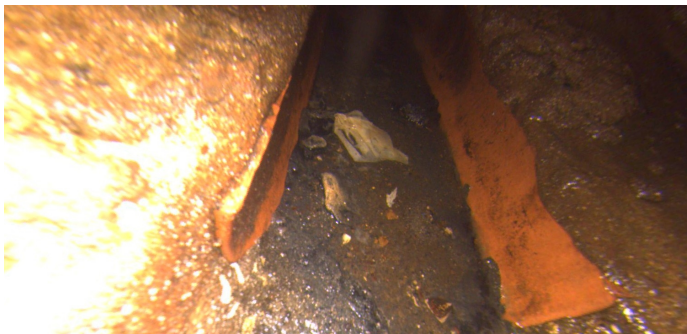
Code: **SRI**
Description: **Surface Roughness Increased**

Distance (ft): **7.4**
Structural Grade: **1**
O&M Grade: **0**
Clock Start/From: **12**
Clock To: **12**
1st Value:
2nd Value:
Value Percent:
Step: **NO**
Remarks:
