Manhole Inspection Report

Date:	05/11/2018	Weather:		Coding:	RZMACP
MH#:	M-904-020	Owner:	NA	Len. Surveyed:	7.4
P.O.#:		Surveyor:	Jen Costello	Rim to Invert:	7.6
Customer:		Cert. #:	U-907-5518	Wall Material:	Concrete (reinforced)

Street:	Fraser Ln. East. 1154' North of Cleve	Project:	Hobart, IN
City:	Hobart, IN	GPS Northing:	2911576.391
Location:		GPS Easting:	2911576.391
Drain Area:	Northeast	GPS Accuracy:	Sub-Meter
Cover Shape:	Circular	Evidence of Surcharge:	No
Cover Size:	22.5	Potential for Runoff:	None
Comments:

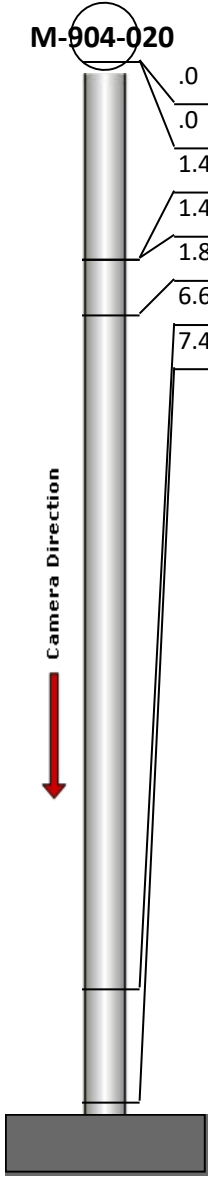
.0	MGO	General Observation	10	NA
	.0	DAE	Deposits Attached Encrustation	20	M 2
	1.4	RFB	Roots Fine Barrel	34	M 2
	1.4	SSS	Surface Spalling	45	S 2
	1.8	MGO	General Observation	58	NA
	6.6	DSF	Deposits Settled Fine	81	M 2
	7.4	MGO	General Observation	94	NA

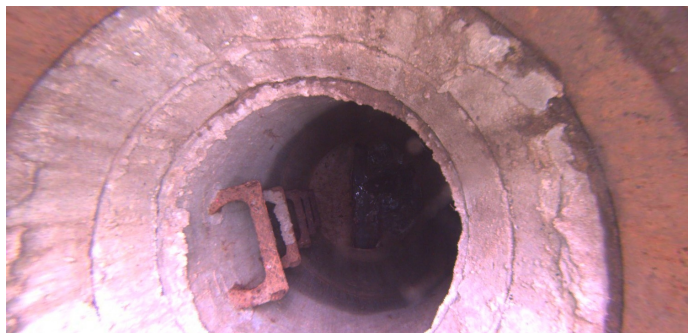
Code: **MGO**
Description: **General Observation**

Distance (ft): **.0**
Structural Grade: **0**
O&M Grade: **0**
Clock Start/From:
Clock To:
1st Value:
2nd Value:
Value Percent:
Step: **NO**
Remarks: **ACCESS MH**

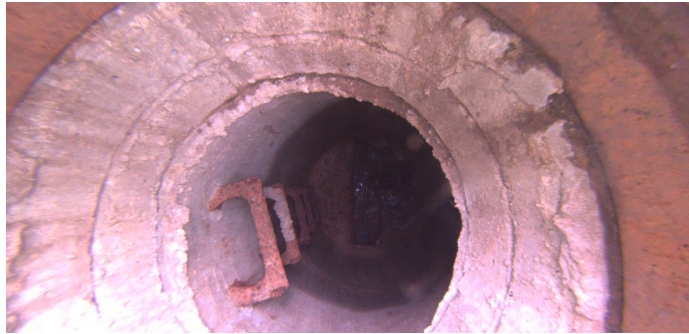
Code:	DAE
Description:	Deposits Attached Encrustation
Distance (ft):	.0
Structural Grade:	0
O&M Grade:	2
Clock Start/From:	12
Clock To:	12
1st Value:	
2nd Value:	
Value Percent:	5.000
Step:	NO
Remarks:

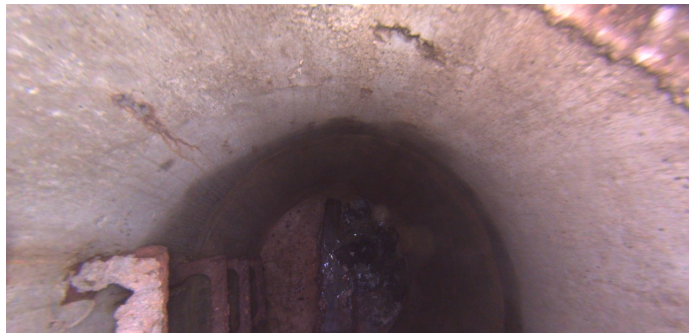
Code:	RFB
Description:	Roots Fine Barrel
Distance (ft):	1.4
Structural Grade:	0
O&M Grade:	2
Clock Start/From:	11
Clock To:	
1st Value:	
2nd Value:	
Value Percent:	
Step:	NO
Remarks:

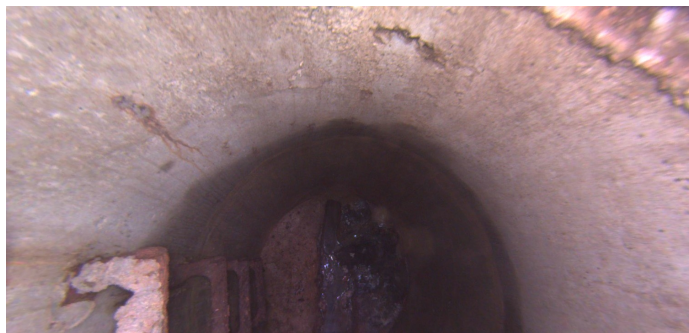
Code:	SSS
Description:	Surface Spalling
Distance (ft):	1.4
Structural Grade:	2
O&M Grade:	0
Clock Start/From:	12
Clock To:	
1st Value:	
2nd Value:	
Value Percent:	
Step:	NO
Remarks:

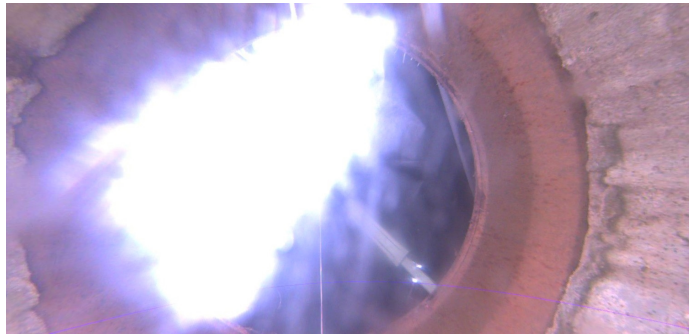
Code:	MGO
Description:	General Observation
Distance (ft):	1.8
Structural Grade:	0
O&M Grade:	0
Clock Start/From:	
Clock To:	
1st Value:	
2nd Value:	
Value Percent:	
Step:	NO
Remarks:	UNDERSIDE OF FRAME

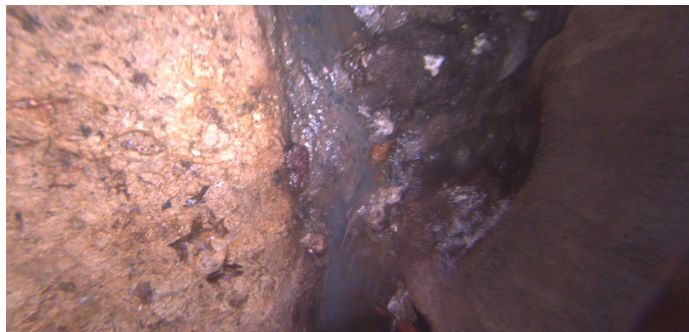
Code:	DSF
Description:	Deposits Settled Fine
Distance (ft):	6.6
Structural Grade:	0
O&M Grade:	2
Clock Start/From:	12
Clock To:	12
1st Value:	
2nd Value:	
Value Percent:	5.000
Step:	NO
Remarks:

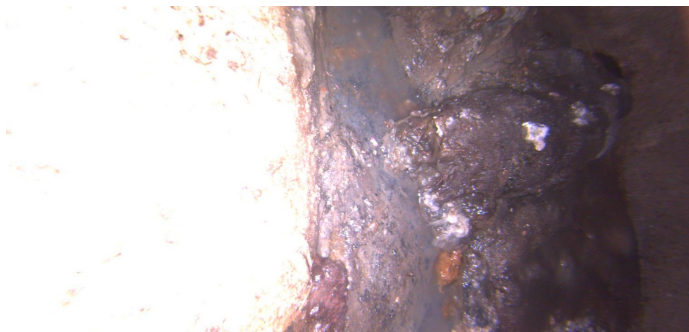
Code:	MGO
Description:	General Observation
Distance (ft):	7.4
Structural Grade:	0
O&M Grade:	0
Clock Start/From:	
Clock To:	
1st Value:	
2nd Value:	
Value Percent:	
Step:	NO
Remarks:	END SURVEY
