Manhole Inspection Report

Date:	10/14/2022	Weather:		Coding:	RZMACP
MH#:	M-904-028	Owner:	NA	Len. Surveyed:	5.2
P.O.#:		Surveyor:	Jen Costello	Rim to Invert:	6.2
Customer:		Cert. #:	U-907-5518	Wall Material:	Concrete (cast in place)

Street:	W. Cleveland Terrace. 693' North of	Project:	Hobart, IN
City:	Hobart, IN	GPS Northing:	2291089.768
Location:	Local Rural Streets	GPS Easting:	2910718.039
Drain Area:	Northeast	GPS Accuracy:	Sub-Meter
Cover Shape:	Circular	Evidence of Surcharge:	No
Cover Size:	24.0	Potential for Runoff:	None
Comments:

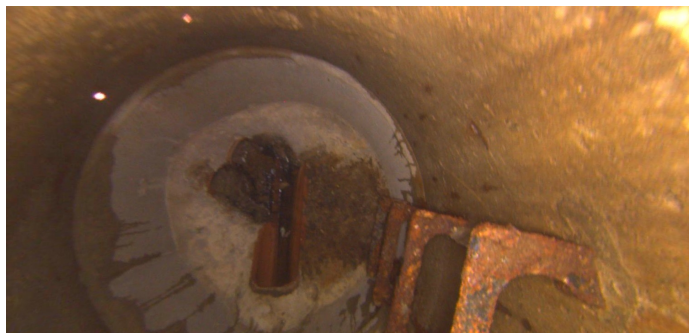
Code: **MGO**
Description: **General Observation**

Distance (ft): **.0**
Structural Grade: **0**
O&M Grade: **0**
Clock Start/From:
Clock To:
1st Value:
2nd Value:
Value Percent:
Step: **NO**
Remarks: **access mh**

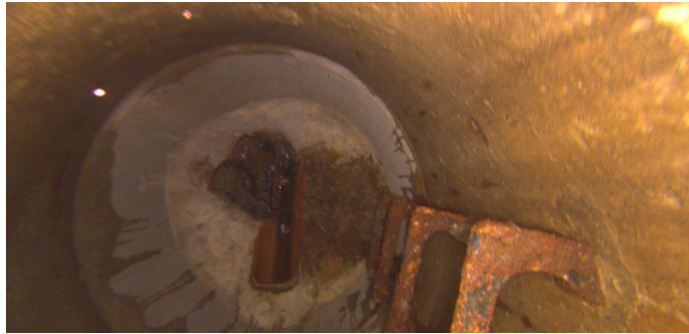
Code:	SRI
Description:	Surface Roughness Increased
Distance (ft):	.0
Structural Grade:	1
O&M Grade:	0
Clock Start/From:	12
Clock To:	12
1st Value:	
2nd Value:	
Value Percent:	
Step:	NO
Remarks:

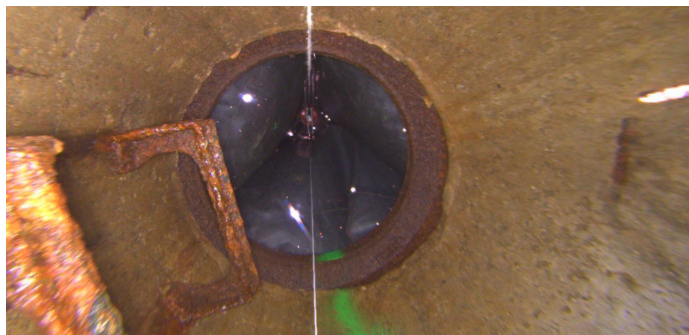
Code:	MGO
Description:	General Observation
Distance (ft):	2.8
Structural Grade:	0
O&M Grade:	0
Clock Start/From:	
Clock To:	
1st Value:	
2nd Value:	
Value Percent:	
Step:	NO
Remarks:	underside of frame

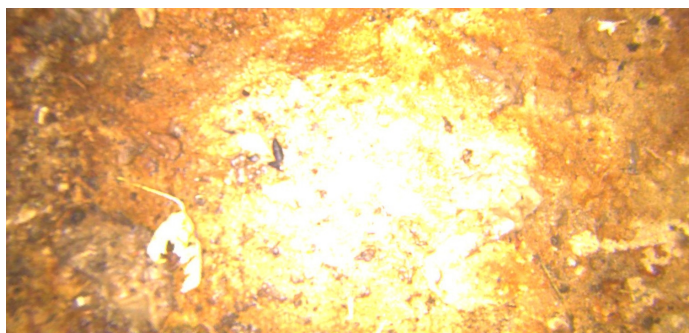
Code:	DSF
Description:	Deposits Settled Fine
Distance (ft):	5.2
Structural Grade:	0
O&M Grade:	2
Clock Start/From:	12
Clock To:	12
1st Value:	
2nd Value:	
Value Percent:	5.000
Step:	NO
Remarks:

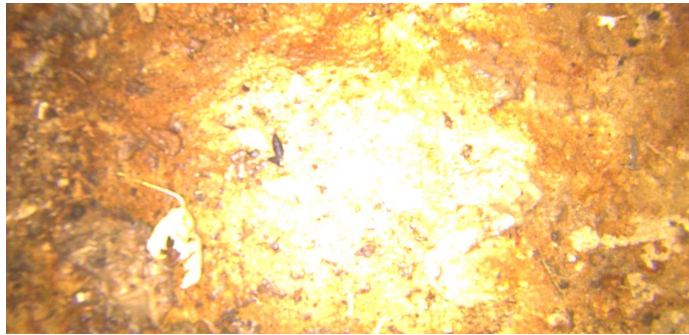
Code: **SRI**
Description: **Surface Roughness Increased**

Distance (ft): **5.2**
Structural Grade: **1**
O&M Grade: **0**
Clock Start/From: **12**
Clock To: **12**
1st Value:
2nd Value:
Value Percent:
Step: **NO**
Remarks:

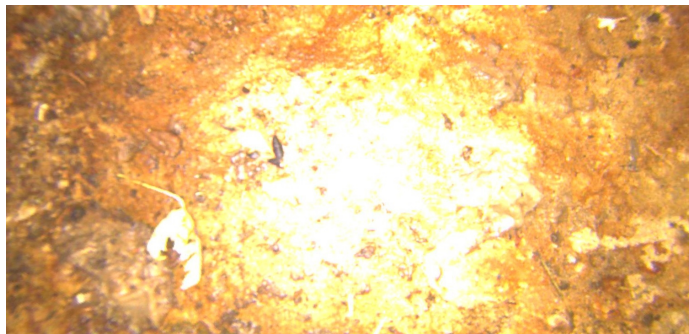
Code: **SRI**
Description: **Surface Roughness Increased**

Distance (ft): **5.2**
Structural Grade: **1**
O&M Grade: **0**
Clock Start/From: **12**
Clock To: **12**
1st Value:
2nd Value:
Value Percent:
Step: **NO**
Remarks:

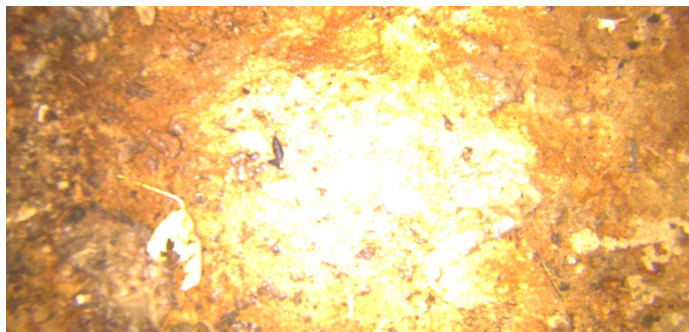
Code: **MGO**
Description: **General Observation**

Distance (ft): **5.2**
Structural Grade: **0**
O&M Grade: **0**
Clock Start/From:
Clock To:
1st Value:
2nd Value:
Value Percent:
Step: **NO**
Remarks: **end of survey**
