Manhole Inspection Report

Date:	05/15/2018	Weather:		Coding:	RZMACP
MH#:	M-904-042	Owner:	NA	Len. Surveyed:	11.6
P.O.#:		Surveyor:	Jen Costello	Rim to Invert:	12.2
Customer:		Cert. #:	U-907-5518	Wall Material:	Concrete (reinforced)

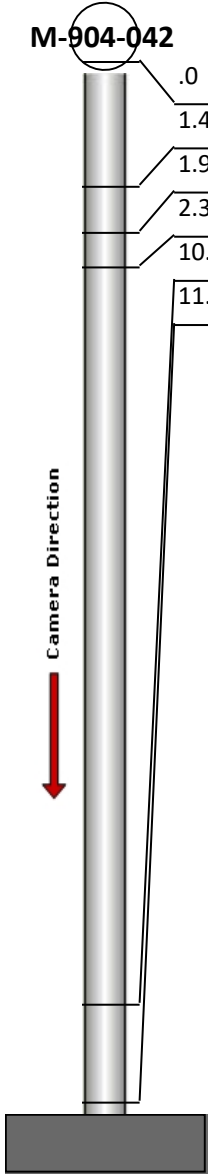
<p>M-904-042</p> <p>Camera Direction</p>	.0	MGP	General Photo	10	NA
	1.4	DAR	Deposits Attached Ragging	24	M 2
	1.9	MGO	General Observation	39	NA
	2.3	IW	Infil Weeper	53	M 2
	10.5	OBM	Obstacle Pipe Material	81	M 2
	11.6	MGO	General Observation	95	NA

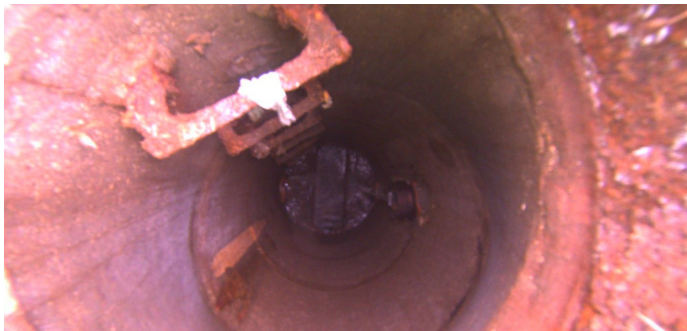
Code: **MGP**
Description: **General Photo**

Distance (ft): **.0**
Structural Grade: **0**
O&M Grade: **0**
Clock Start/From:
Clock To:
1st Value:
2nd Value:
Value Percent:
Step: **NO**
Remarks: **ACCESS MH**

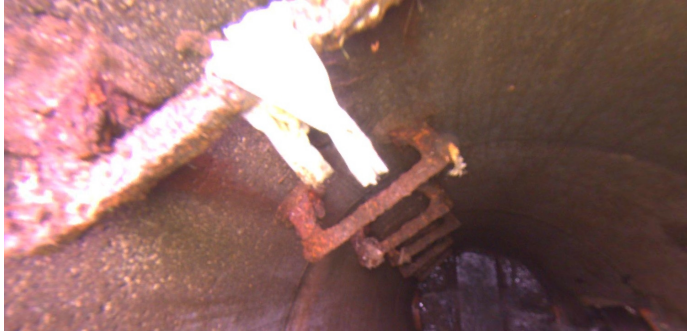
Code: **DAR**
Description: **Deposits Attached Ragging**

Distance (ft): **1.4**
Structural Grade: **0**
O&M Grade: **2**
Clock Start/From: **11**
Clock To:
1st Value:
2nd Value:
Value Percent: **5.000**
Step: **YES**
Remarks:

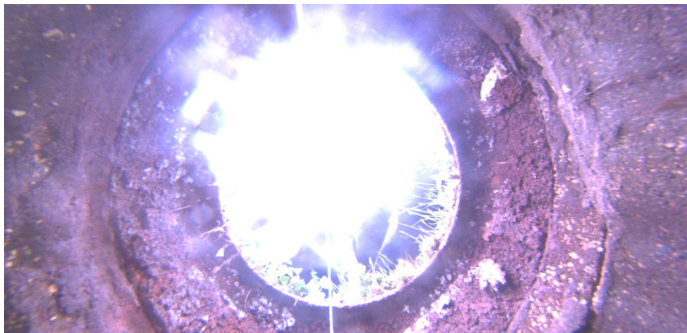
Code: **MGO**
Description: **General Observation**

Distance (ft): **1.9**
Structural Grade: **0**
O&M Grade: **0**
Clock Start/From:
Clock To:
1st Value:
2nd Value:
Value Percent:
Step: **NO**
Remarks: **UNDERSIDE OF FRAME**

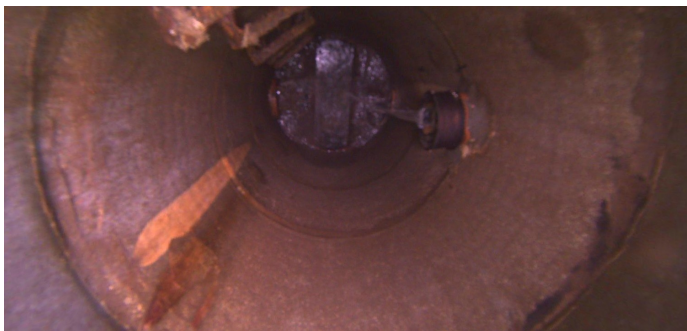
Code: **IW**
Description: **Infil Weeper**

Distance (ft): **2.3**
Structural Grade: **0**
O&M Grade: **2**
Clock Start/From: **7**
Clock To:
1st Value:
2nd Value:
Value Percent:
Step: **NO**
Remarks:

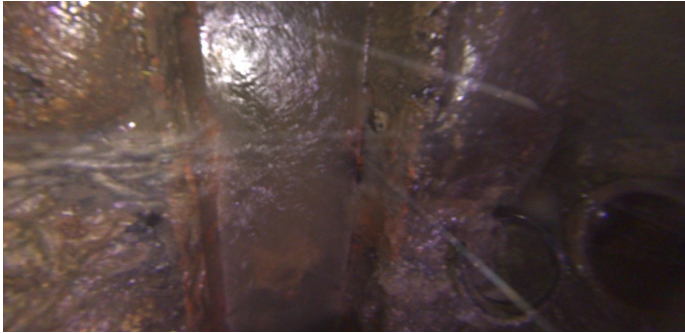
Code:	OBM
Description:	Obstacle Pipe Material

Distance (ft):	10.5
Structural Grade:	0
O&M Grade:	2
Clock Start/From:	4
Clock To:	5
1st Value:	
2nd Value:	
Value Percent:	5.000
Step:	NO
Remarks:

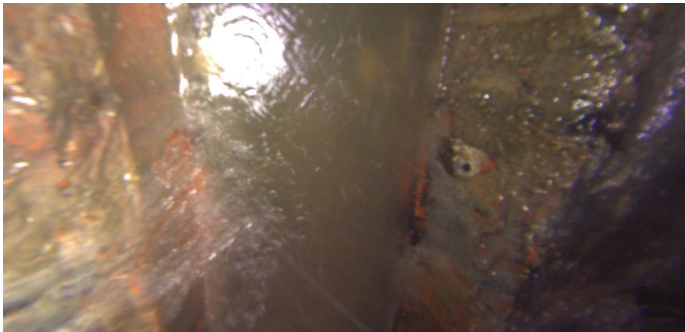
Code:	MGO
Description:	General Observation

Distance (ft):	11.6
Structural Grade:	0
O&M Grade:	0
Clock Start/From:	
Clock To:	
1st Value:	
2nd Value:	
Value Percent:	
Step:	NO
Remarks:	END SURVEY
