Manhole Inspection Report

Date:	05/15/2018	Weather:		Coding:	RZMACP
MH#:	M-904-049	Owner:	NA	Len. Surveyed:	2.3
P.O.#:		Surveyor:	Jen Costello	Rim to Invert:	3.1
Customer:		Cert. #:	U-907-5518	Wall Material:	Concrete (reinforced)

Street:	Rush St. 221' South of Hickey St.	Project:	Hobart, IN
City:	Hobart, IN	GPS Northing:	2910069.667
Location:		GPS Easting:	2910069.667
Drain Area:	Northeast	GPS Accuracy:	Sub-Meter
Cover Shape:	Circular	Evidence of Surcharge:	No
Cover Size:	22.5	Potential for Runoff:	None
Comments:

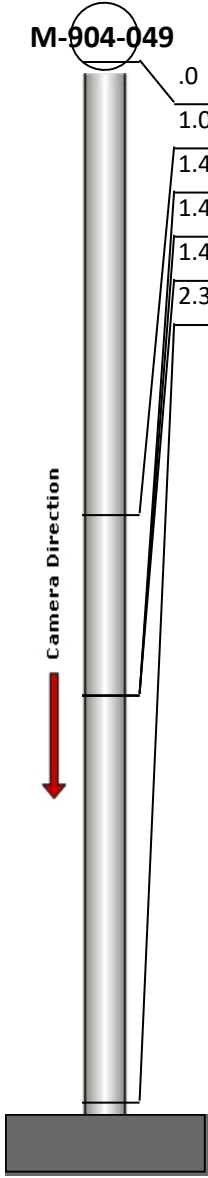
Position	Code	Observation	Video (sec)	Grade

.0	MGP	General Photo	10	NA
	1.0	FM	Fracture Multiple	24	S 4
	1.4	FM	Fracture Multiple	36	S 4
	1.4	IW	Infil Weeper	47	M 2
	1.4	DAE	Deposits Attached Encrustation	59	M 2
	2.3	MGO	General Observation	72	NA

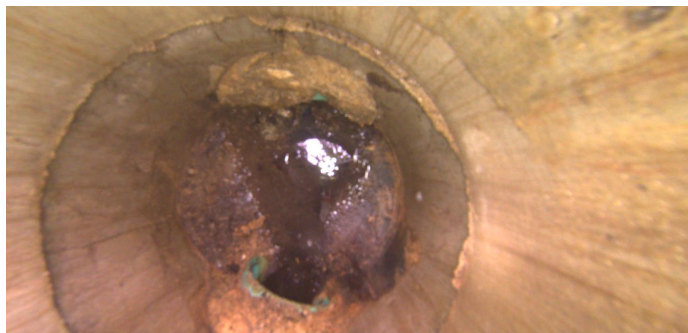
Code: **MGP**
Description: **General Photo**

Distance (ft): **.0**
Structural Grade: **0**
O&M Grade: **0**
Clock Start/From:
Clock To:
1st Value:
2nd Value:
Value Percent:
Step: **NO**
Remarks: **ACCESS MH**

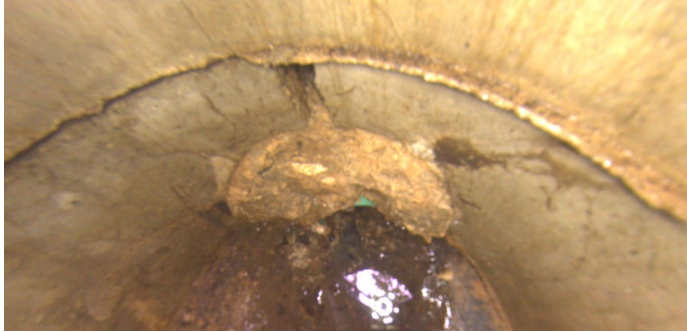
Code: **FM**
Description: **Fracture Multiple**

Distance (ft): **1.0**
Structural Grade: **4**
O&M Grade: **0**
Clock Start/From: **10**
Clock To: **1**
1st Value:
2nd Value:
Value Percent:
Step: **NO**
Remarks:

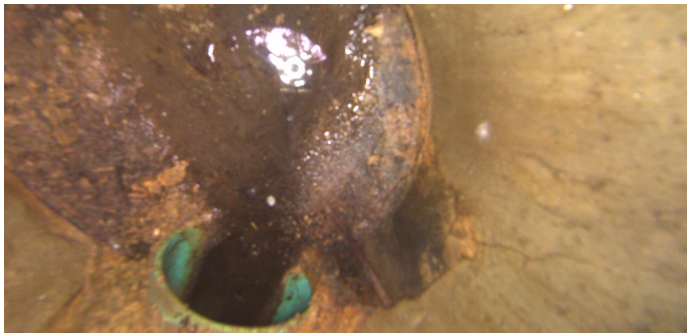
Code: **FM**
Description: **Fracture Multiple**

Distance (ft): **1.4**
Structural Grade: **4**
O&M Grade: **0**
Clock Start/From: **4**
Clock To: **5**
1st Value:
2nd Value:
Value Percent:
Step: **NO**
Remarks:

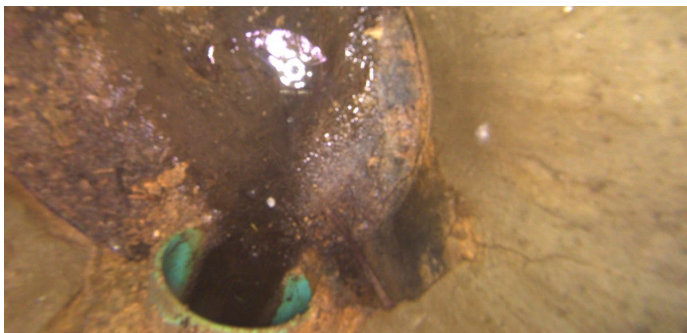
Code: **IW**
Description: **Infil Weeper**

Distance (ft): **1.4**
Structural Grade: **0**
O&M Grade: **2**
Clock Start/From: **4**
Clock To:
1st Value:
2nd Value:
Value Percent:
Step: **NO**
Remarks:

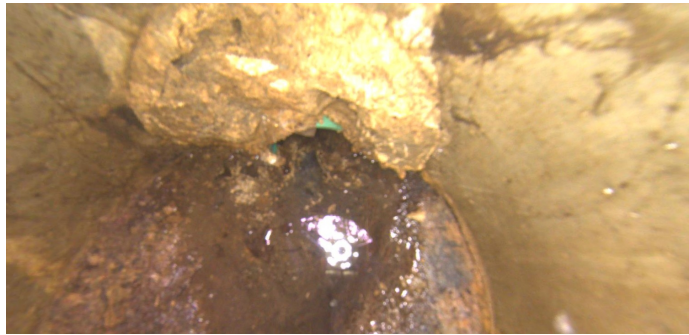
Code:	DAE
Description:	Deposits Attached Encrustation
Distance (ft):	1.4
Structural Grade:	0
O&M Grade:	2
Clock Start/From:	10
Clock To:	2
1st Value:	
2nd Value:	
Value Percent:	10.000
Step:	NO
Remarks:

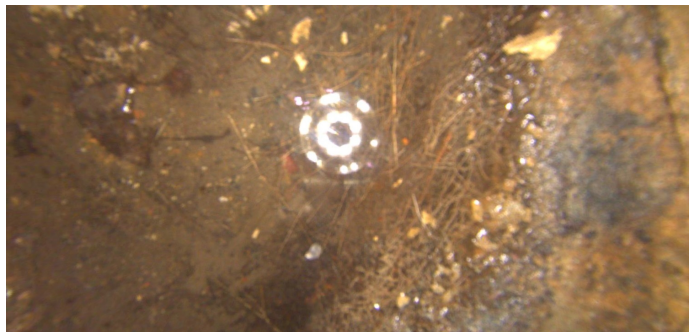
Code:	MGO
Description:	General Observation
Distance (ft):	2.3
Structural Grade:	0
O&M Grade:	0
Clock Start/From:	
Clock To:	
1st Value:	
2nd Value:	
Value Percent:	
Step:	NO
Remarks:	END SURVEY
