# Manhole Inspection Report

Date:	<b>05/15/2018</b>	Weather:		Coding:	<b>RZMACP</b>
MH#:	<b>M-904-050</b>	Owner:	<b>NA</b>	Len. Surveyed:	<b>4.1</b>
P.O.#:		Surveyor:	<b>Jen Costello</b>	Rim to Invert:	<b>4.3</b>
Customer:		Cert. #:	<b>U-907-5518</b>	Wall Material:	<b>Concrete (reinforced)</b>

Street:	<b>Rush St. 355' South of Hickey St.</b>	Project:	<b>Hobart, IN</b>
City:	<b>Hobart, IN</b>	GPS Northing:	<b>2910292.748</b>
Location:		GPS Easting:	<b>2910292.748</b>
Drain Area:	<b>Northeast</b>	GPS Accuracy:	<b>Sub-Meter</b>
Cover Shape:	<b>Circular</b>	Evidence of Surcharge:	<b>No</b>
Cover Size:	<b>22.5</b>	Potential for Runoff:	<b>None</b>
Comments:

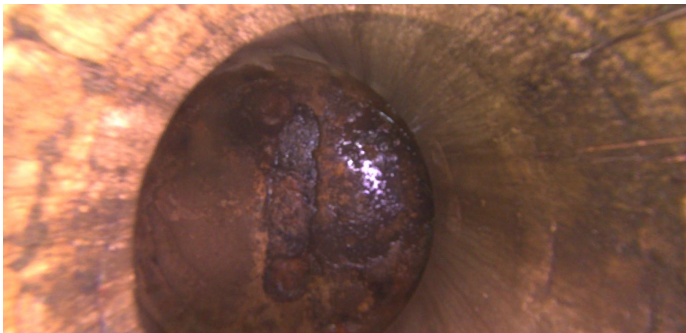
Code:	MGP
Description:	General Photo
Distance (ft):	.0
Structural Grade:	0
O&M Grade:	0
Clock Start/From:	
Clock To:	
1st Value:	
2nd Value:	
Value Percent:	
Step:	NO
Remarks:	ACCESS MH

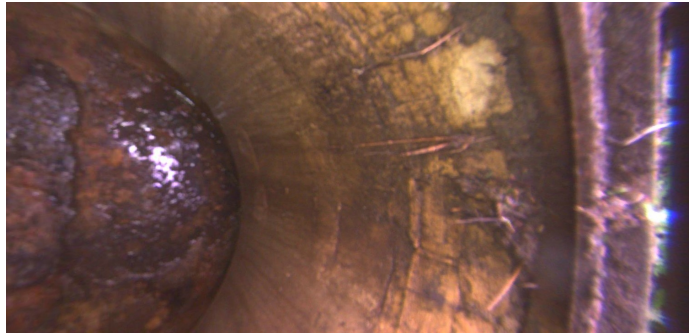
Code: **RFJ**  
Description: **Roots Fine Joint**

Distance (ft): **.0**  
Structural Grade: **0**  
O&M Grade: **1**  
Clock Start/From: **1**  
Clock To: **4**  
1st Value:  
2nd Value:  
Value Percent:  
Step: **NO**  
Remarks:

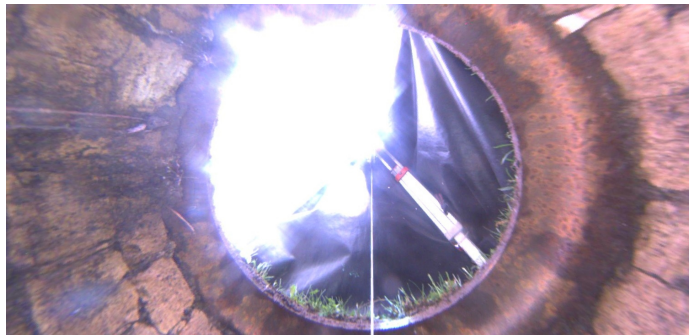
Code: **MGO**  
Description: **General Observation**

Distance (ft): **1.4**  
Structural Grade: **0**  
O&M Grade: **0**  
Clock Start/From:  
Clock To:  
1st Value:  
2nd Value:  
Value Percent:  
Step: **NO**  
Remarks: **UNDERSIDE OF FRAME**

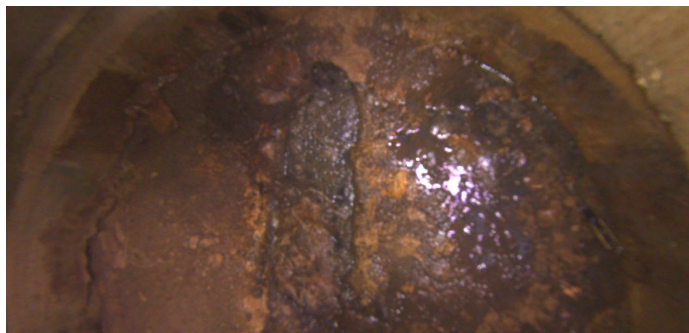
Code: **IW**  
Description: **Infil Weeper**

Distance (ft): **2.3**  
Structural Grade: **0**  
O&M Grade: **2**  
Clock Start/From: **9**  
Clock To: **11**  
1st Value:  
2nd Value:  
Value Percent:  
Step: **NO**  
Remarks:

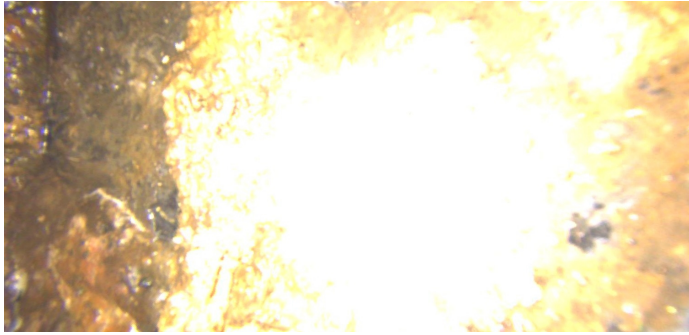
Code: **MGO**  
Description: **General Observation**

Distance (ft): **4.1**  
Structural Grade: **0**  
O&M Grade: **0**  
Clock Start/From:  
Clock To:  
1st Value:  
2nd Value:  
Value Percent:  
Step: **NO**  
Remarks: **END SURVEY**
