Manhole Inspection Report

Date:	05/15/2018	Weather:		Coding:	RZMACP
MH#:	M-904-063	Owner:	NA	Len. Surveyed:	3.9
P.O.#:		Surveyor:	Jen Costello	Rim to Invert:	4.3
Customer:		Cert. #:	U-907-5518	Wall Material:	Concrete (reinforced)

Street:	Shelby St. 304' North of Division St.	Project:	Hobart, IN
City:	Hobart, IN	GPS Northing:	2911050.882
Location:		GPS Easting:	2911050.882
Drain Area:	Northeast	GPS Accuracy:	Sub-Meter
Cover Shape:	Circular	Evidence of Surcharge:	No
Cover Size:	22.5	Potential for Runoff:	None
Comments:

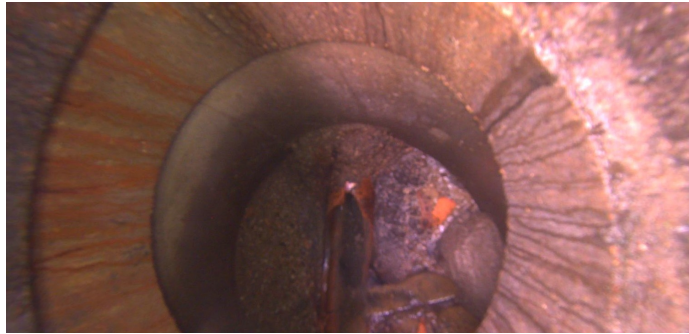
Code:	MGP
Description:	General Photo

Distance (ft):	.0
Structural Grade:	0
O&M Grade:	0
Clock Start/From:	
Clock To:	
1st Value:	
2nd Value:	
Value Percent:	
Step:	NO
Remarks:	AC

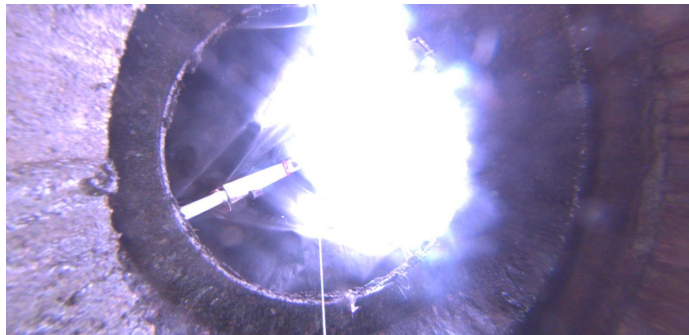
Code: **IS**
Description: **Infil Stain**

Distance (ft): **.0**
Structural Grade: **0**
O&M Grade: **0**
Clock Start/From: **12**
Clock To: **12**
1st Value:
2nd Value:
Value Percent:
Step: **NO**
Remarks:

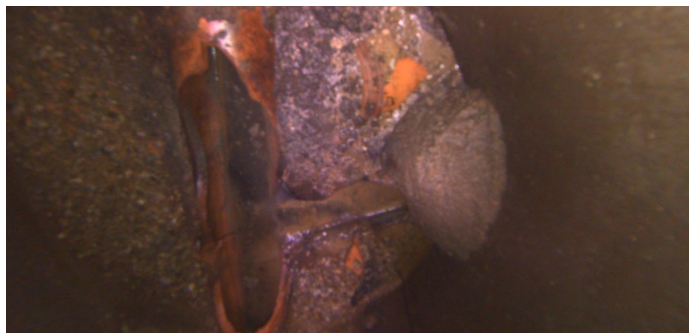
Code: **MGO**
Description: **General Observation**

Distance (ft): **1.6**
Structural Grade: **0**
O&M Grade: **0**
Clock Start/From:
Clock To:
1st Value:
2nd Value:
Value Percent:
Step: **NO**
Remarks: **UNDERSIDE OF FRAME**

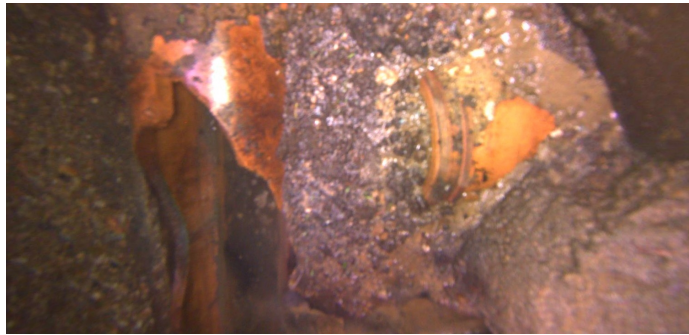
Code: **DAE**
Description: **Deposits Attached Encrustation**

Distance (ft): **2.2**
Structural Grade: **0**
O&M Grade: **2**
Clock Start/From: **2**
Clock To: **4**
1st Value:
2nd Value:
Value Percent: **10.000**
Step: **NO**
Remarks:

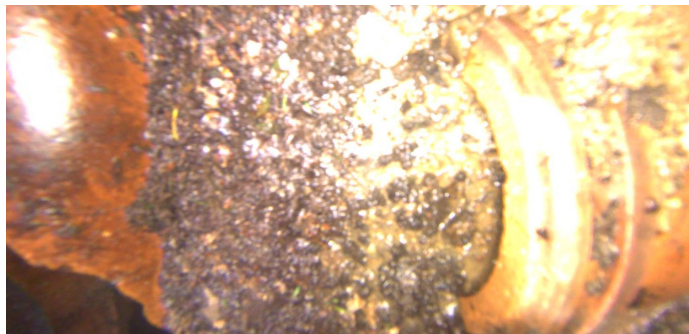
Code:	OBP
Description:	Obstacle External Pipe or Cable
Distance (ft):	3.1
Structural Grade:	0
O&M Grade:	2
Clock Start/From:	2
Clock To:	3
1st Value:	
2nd Value:	
Value Percent:	5.000
Step:	NO
Remarks:
