Manhole Inspection Report

Date:	05/11/2018	Weather:		Coding:	RZMACP
MH#:	M-904-065	Owner:	NA	Len. Surveyed:	7.1
P.O.#:		Surveyor:	Jen Costello	Rim to Invert:	7.5
Customer:		Cert. #:	U-907-5518	Wall Material:	Concrete (reinforced)

Street:	Pembroke Dr. East. 257' North of Ho	Project:	Hobart, IN
City:	Hobart, IN	GPS Northing:	2912171.539
Location:		GPS Easting:	2912171.539
Drain Area:	Northeast	GPS Accuracy:	Sub-Meter
Cover Shape:	Circular	Evidence of Surcharge:	No
Cover Size:	22.5	Potential for Runoff:	None
Comments:

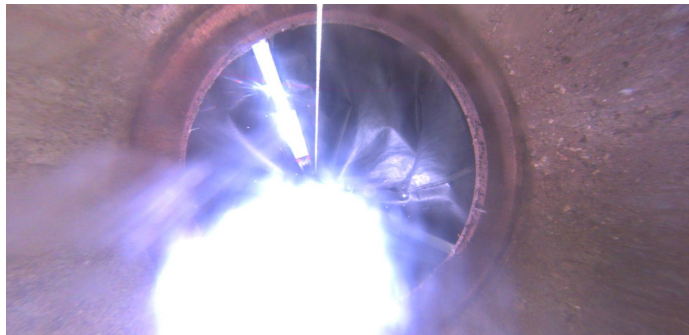
Code: **MGO**
Description: **General Observation**

Distance (ft): **1.6**
Structural Grade: **0**
O&M Grade: **0**
Clock Start/From:
Clock To:
1st Value:
2nd Value:
Value Percent:
Step: **NO**
Remarks: **underside of frame**

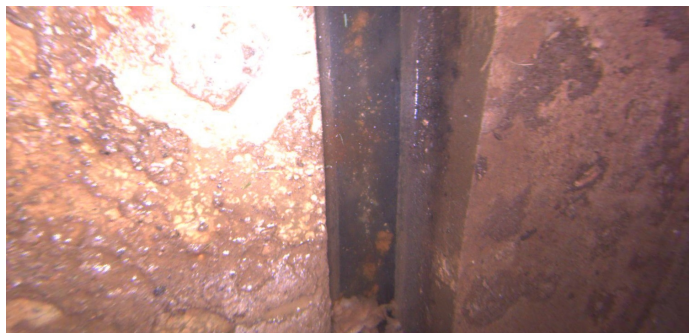
Code: **DSF**
Description: **Deposits Settled Fine**

Distance (ft): **6.6**
Structural Grade: **0**
O&M Grade: **2**
Clock Start/From: **12**
Clock To: **12**
1st Value:
2nd Value:
Value Percent: **5.000**
Step: **NO**
Remarks:
