Manhole Inspection Report

Date:	05/11/2018	Weather:		Coding:	RZMACP
MH#:	M-904-066	Owner:	NA	Len. Surveyed:	7.7
P.O.#:		Surveyor:	Jen Costello	Rim to Invert:	8.4
Customer:		Cert. #:	U-907-5518	Wall Material:	Concrete (reinforced)

Street:	Pembroke Dr. North, to the Northea	Project:	Hobart, IN
City:	Hobart, IN	GPS Northing:	2912177.854
Location:		GPS Easting:	2912177.854
Drain Area:	Northeast	GPS Accuracy:	Sub-Meter
Cover Shape:	Circular	Evidence of Surcharge:	No
Cover Size:	22.5	Potential for Runoff:	None
Comments:

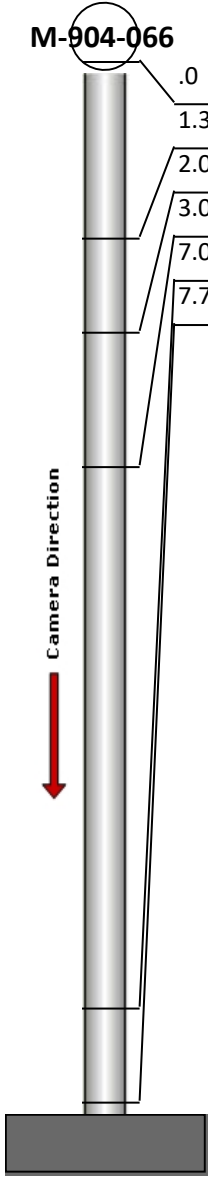
Position	Code	Observation	Video (sec)	Grade

.0	MGO	General Observation	10	NA
	1.3	VC	Vermin Cockroach	24	M 1
	2.0	MGO	General Observation	39	NA
	3.0	OBP	Obstacle External Pipe or Cable	54	M 2
	7.0	DSF	Deposits Settled Fine	74	M 2
	7.7	MGO	General Observation	86	NA

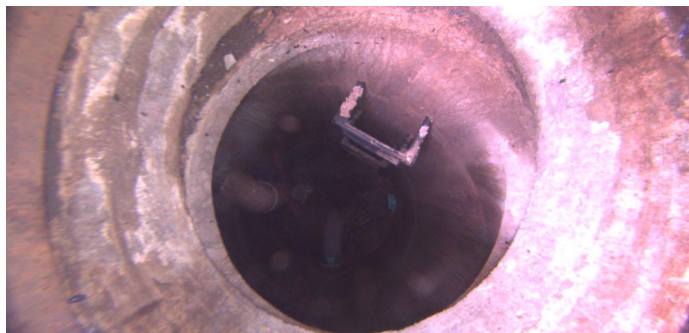
Code: **MGO**
Description: **General Observation**

Distance (ft): **.0**
Structural Grade: **0**
O&M Grade: **0**
Clock Start/From:
Clock To:
1st Value:
2nd Value:
Value Percent:
Step: **NO**
Remarks: **access MH**

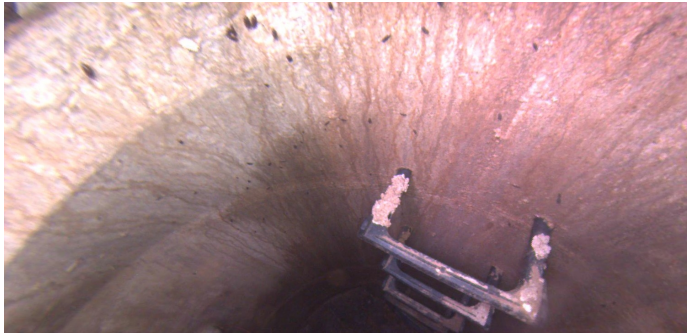
Code: **VC**
Description: **Vermin Cockroach**

Distance (ft): **1.3**
Structural Grade: **0**
O&M Grade: **1**
Clock Start/From:
Clock To:
1st Value:
2nd Value:
Value Percent:
Step: **NO**
Remarks:

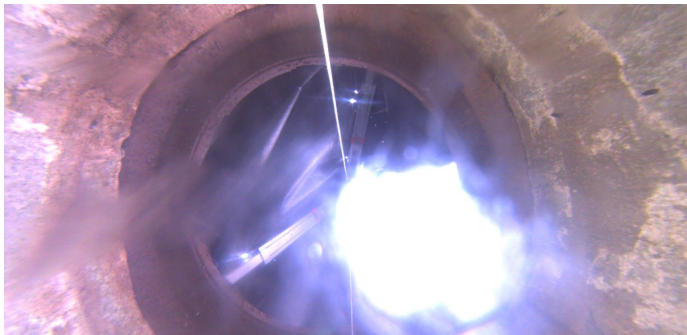
Code: **MGO**
Description: **General Observation**

Distance (ft): **2.0**
Structural Grade: **0**
O&M Grade: **0**
Clock Start/From:
Clock To:
1st Value:
2nd Value:
Value Percent:
Step: **NO**
Remarks: **UNDERSIDE OF FRAME**

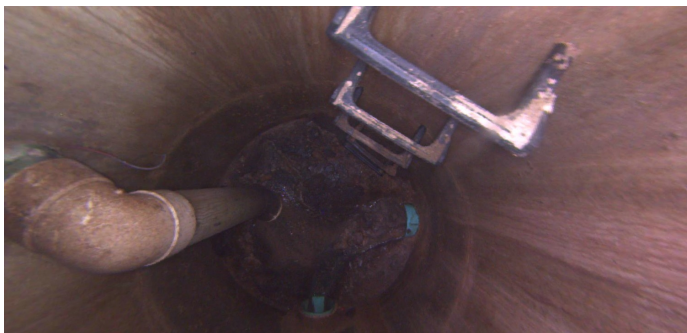
Code: **OBP**
Description: **Obstacle External Pipe or Cable**

Distance (ft): **3.0**
Structural Grade: **0**
O&M Grade: **2**
Clock Start/From: **9**
Clock To:
1st Value:
2nd Value:
Value Percent: **10.000**
Step: **NO**
Remarks:

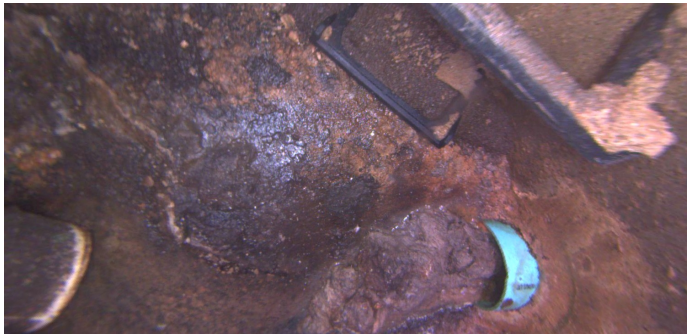
Code: **DSF**
Description: **Deposits Settled Fine**

Distance (ft): **7.0**
Structural Grade: **0**
O&M Grade: **2**
Clock Start/From: **12**
Clock To: **12**
1st Value:
2nd Value:
Value Percent: **5.000**
Step: **NO**
Remarks:

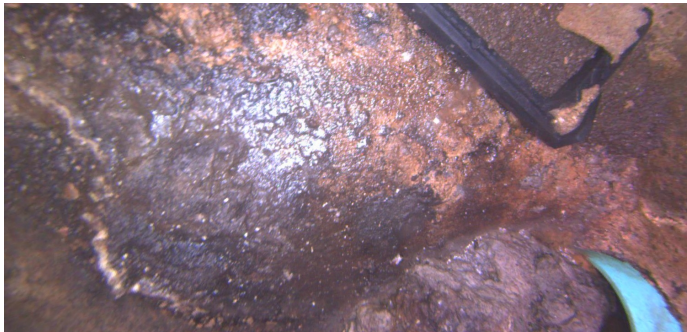
Code: **MGO**
Description: **General Observation**

Distance (ft): **7.7**
Structural Grade: **0**
O&M Grade: **0**
Clock Start/From:
Clock To:
1st Value:
2nd Value:
Value Percent:
Step: **NO**
Remarks: **END SURVEY**
