# Manhole Inspection Report

Date:	<b>05/11/2018</b>	Weather:		Coding:	<b>RZMACP</b>
MH#:	<b>M-904-067</b>	Owner:	<b>NA</b>	Len. Surveyed:	<b>10.0</b>
P.O.#:		Surveyor:	<b>Jen Costello</b>	Rim to Invert:	<b>10.6</b>
Customer:		Cert. #:	<b>U-907-5518</b>	Wall Material:	<b>Concrete (reinforced)</b>

Street:	<b>Pembroke Dr. North, to the Northw</b>	Project:	<b>Hobart, IN</b>
City:	<b>Hobart, IN</b>	GPS Northing:	<b>2911850.689</b>
Location:		GPS Easting:	<b>2911850.689</b>
Drain Area:	<b>Northeast</b>	GPS Accuracy:	<b>Sub-Meter</b>
Cover Shape:	<b>Circular</b>	Evidence of Surcharge:	<b>No</b>
Cover Size:	<b>22.5</b>	Potential for Runoff:	<b>None</b>
Comments:

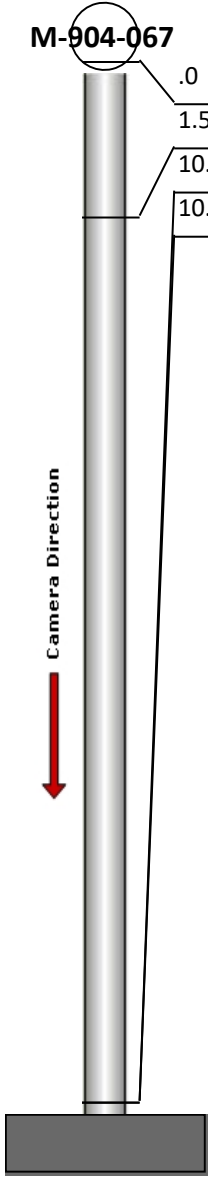
M-904-067				
	.0	MGO	General Observation	10	NA
	1.5	MGO	General Observation	26	NA
	10.0	SAP	Surface Aggregate Projecting	57	S 3
	10.0	MGO	General Observation	68	NA

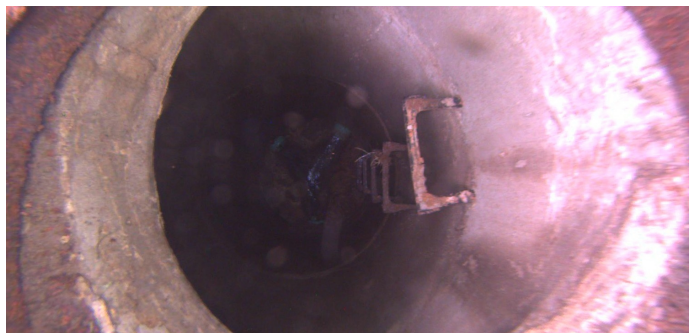
Code: **MGO**  
 Description: **General Observation**

Distance (ft): **.0**  
 Structural Grade: **0**  
 O&M Grade: **0**  
 Clock Start/From:  
 Clock To:  
 1st Value:  
 2nd Value:  
 Value Percent:  
 Step: **NO**  
 Remarks: **ACCESS MH**

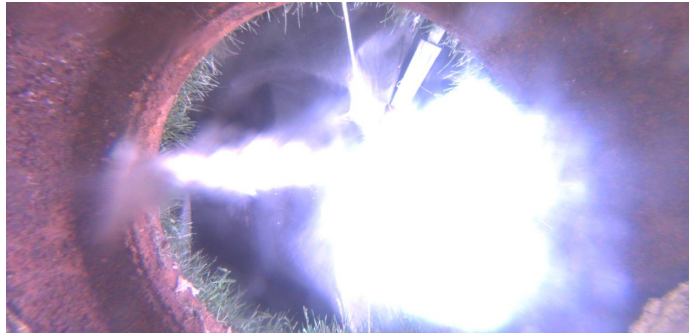
Code:	<b>MGO</b>
Description:	<b>General Observation</b>
Distance (ft):	<b>1.5</b>
Structural Grade:	<b>0</b>
O&M Grade:	<b>0</b>
Clock Start/From:	
Clock To:	
1st Value:	
2nd Value:	
Value Percent:	
Step:	<b>NO</b>
Remarks:	<b>UNDERSIDE OF FRAME</b>

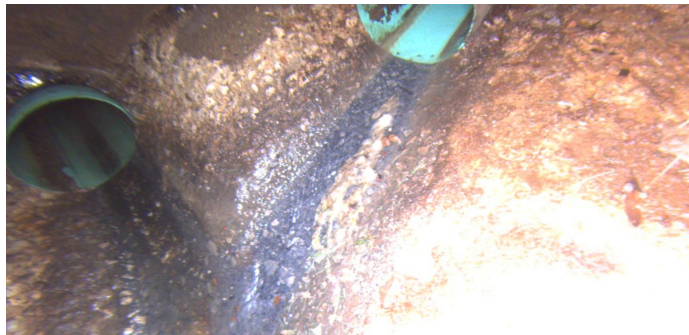
Code:	<b>SAP</b>
Description:	<b>Surface Aggregate Projecting</b>
Distance (ft):	<b>10.0</b>
Structural Grade:	<b>3</b>
O&M Grade:	<b>0</b>
Clock Start/From:	<b>3</b>
Clock To:	<b>9</b>
1st Value:	
2nd Value:	
Value Percent:	
Step:	<b>NO</b>
Remarks:

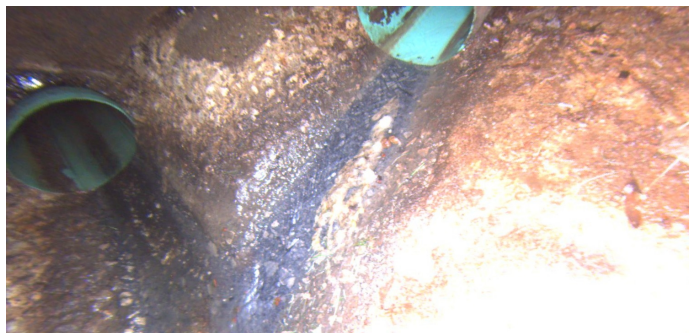
Code:	<b>MGO</b>
Description:	<b>General Observation</b>
Distance (ft):	<b>10.0</b>
Structural Grade:	<b>0</b>
O&M Grade:	<b>0</b>
Clock Start/From:	
Clock To:	
1st Value:	
2nd Value:	
Value Percent:	
Step:	<b>NO</b>
Remarks:	<b>END SURVEY</b>
