Manhole Inspection Report

Date:	05/10/2018	Weather:		Coding:	RZMACP
MH#:	M-905-003	Owner:	NA	Len. Surveyed:	10.9
P.O.#:		Surveyor:	Jen Costello	Rim to Invert:	11.6
Customer:		Cert. #:	U-907-5518	Wall Material:	Concrete (reinforced)

Street:	State Rd. 130. 549' East of Sullivan S	Project:	Hobart, IN
City:	Hobart, IN	GPS Northing:	2912223.625
Location:		GPS Easting:	2912223.625
Drain Area:	Southeast	GPS Accuracy:	Sub-Meter
Cover Shape:	Circular	Evidence of Surcharge:	No
Cover Size:	22.5	Potential for Runoff:	None
Comments:

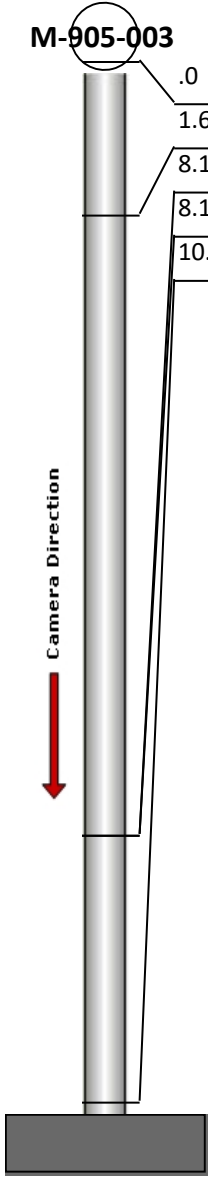
M-905-003				
	.0	MGP	General Photo	10	NA
	1.6	MGO	General Observation	26	NA
	8.1	IW	Infil Weeper	53	M 2
	8.1	DAR	Deposits Attached Ragging	65	M 2
	10.9	MGO	General Observation	82	NA

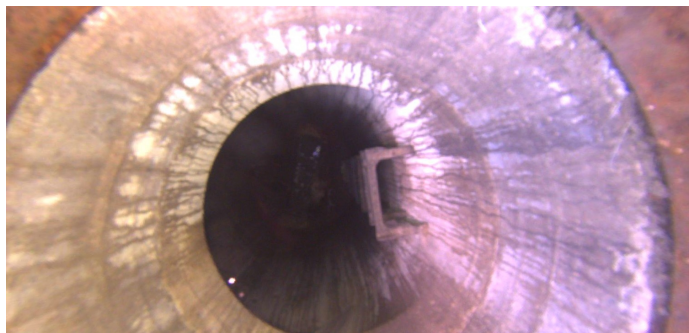
Code: **MGP**
Description: **General Photo**

Distance (ft): **.0**
Structural Grade: **0**
O&M Grade: **0**
Clock Start/From:
Clock To:
1st Value:
2nd Value:
Value Percent:
Step: **NO**
Remarks: **ACCESS MH**

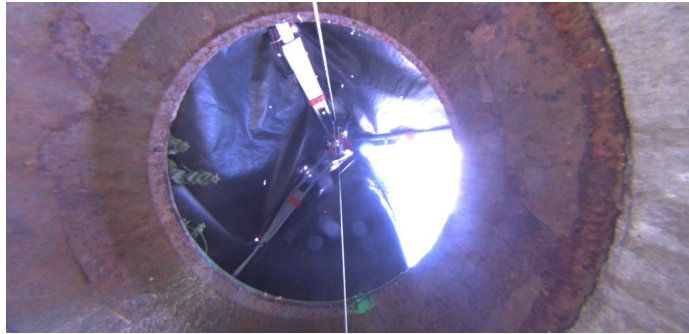
Code:	MGO
Description:	General Observation
Distance (ft):	1.6
Structural Grade:	0
O&M Grade:	0
Clock Start/From:	
Clock To:	
1st Value:	
2nd Value:	
Value Percent:	
Step:	NO
Remarks:	UNDERSIDE OF FRAME

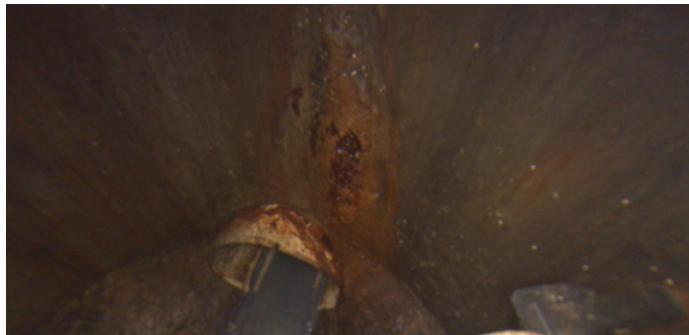
Code:	IW
Description:	Infil Weeper
Distance (ft):	8.1
Structural Grade:	0
O&M Grade:	2
Clock Start/From:	12
Clock To:	
1st Value:	
2nd Value:	
Value Percent:	
Step:	NO
Remarks:

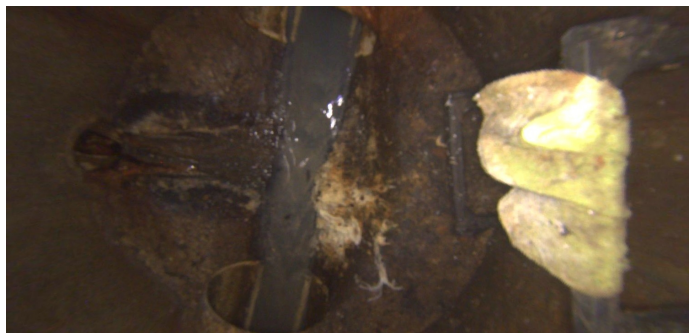
Code:	DAR
Description:	Deposits Attached Ragging
Distance (ft):	8.1
Structural Grade:	0
O&M Grade:	2
Clock Start/From:	3
Clock To:	
1st Value:	
2nd Value:	
Value Percent:	5.000
Step:	YES
Remarks:

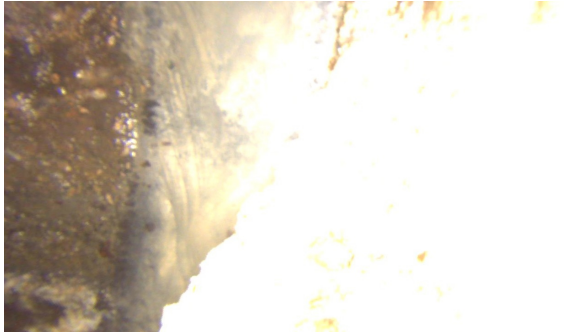
Code: **MGO**
Description: **General Observation**

Distance (ft): **10.9**

Structural Grade: **0**

O&M Grade: **0**

Remarks: **END SURVEY**
