# Manhole Inspection Report

Position	Code	Observation	Video (sec)	Grade

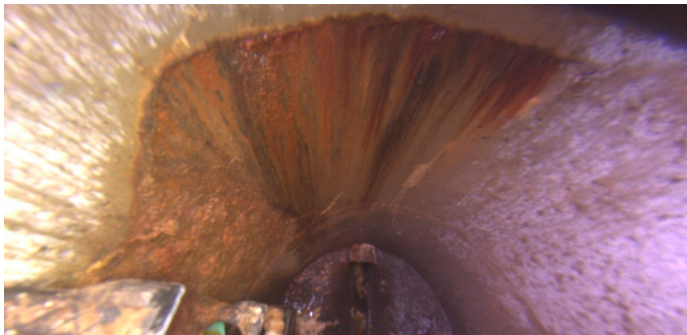
Code:	<b>FC</b>
Description:	<b>Fracture Circumferential</b>
Distance (ft):	<b>3.5</b>
Structural Grade:	<b>2</b>
O&M Grade:	<b>0</b>
Clock Start/From:	<b>10</b>
Clock To:	<b>1</b>
1st Value:	
2nd Value:	
Value Percent:	
Step:	<b>NO</b>
Remarks:

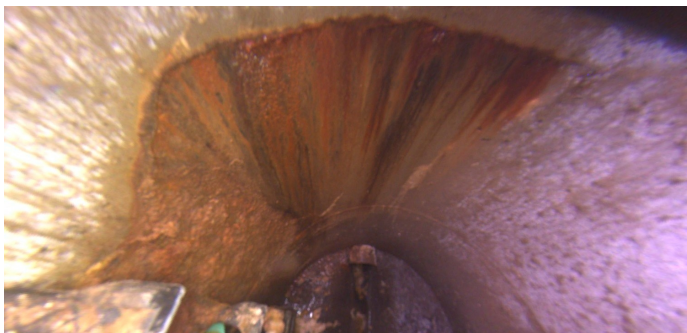
Code:	<b>IW</b>
Description:	<b>Infil Weeper</b>
Distance (ft):	<b>3.5</b>
Structural Grade:	<b>0</b>
O&M Grade:	<b>2</b>
Clock Start/From:	<b>10</b>
Clock To:	<b>1</b>
1st Value:	
2nd Value:	
Value Percent:	
Step:	<b>NO</b>
Remarks:
