Manhole Inspection Report

Date:	05/10/2018	Weather:		Coding:	RZMACP
MH#:	M-905-007	Owner:	NA	Len. Surveyed:	10.4
P.O.#:		Surveyor:	Jen Costello	Rim to Invert:	10.5
Customer:		Cert. #:	U-907-5518	Wall Material:	Concrete (reinforced)

Street:	Sullivan St. 669' North of State Rd. 1	Project:	Hobart, IN
City:	Hobart, IN	GPS Northing:	2911737.939
Location:		GPS Easting:	2911737.939
Drain Area:	Southeast	GPS Accuracy:	Sub-Meter
Cover Shape:	Circular	Evidence of Surcharge:	No
Cover Size:	22.5	Potential for Runoff:	None
Comments:

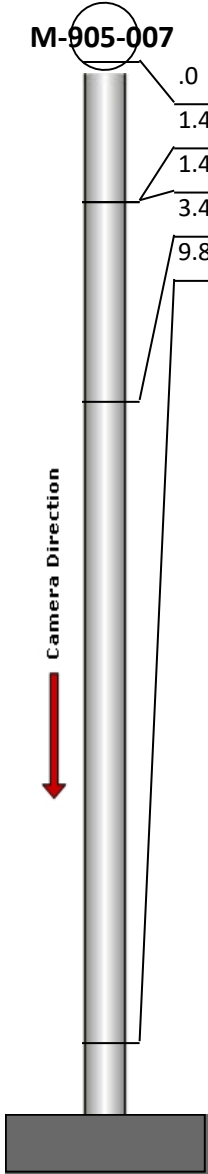
M-905-007				
	.0	MGP	General Photo	10	NA
	1.4	SSS	Surface Spalling	26	S 2
	1.4	MGO	General Observation	37	NA
	3.4	IW	Infil Weeper	54	M 2
	9.8	MGO	General Observation	79	NA

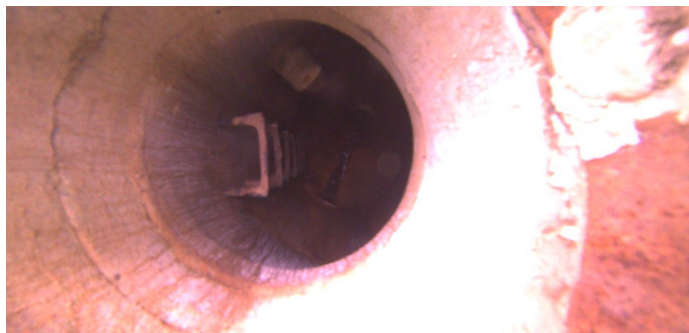
Code: **MGP**
Description: **General Photo**

Distance (ft): **.0**
Structural Grade: **0**
O&M Grade: **0**
Clock Start/From:
Clock To:
1st Value:
2nd Value:
Value Percent:
Step: **NO**
Remarks: **ACCESS MH**

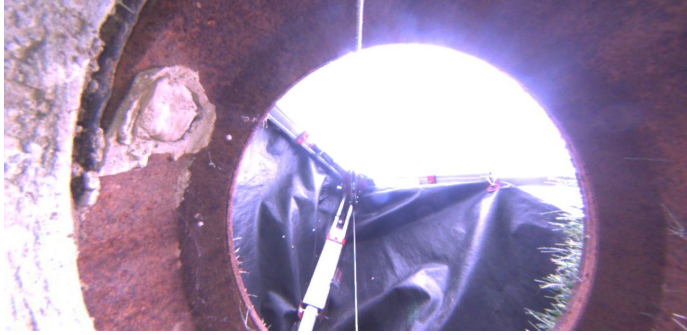
Code: **SSS**
Description: **Surface Spalling**

Distance (ft): **1.4**
Structural Grade: **2**
O&M Grade: **0**
Clock Start/From: **3**
Clock To:
1st Value:
2nd Value:
Value Percent:
Step: **NO**
Remarks:

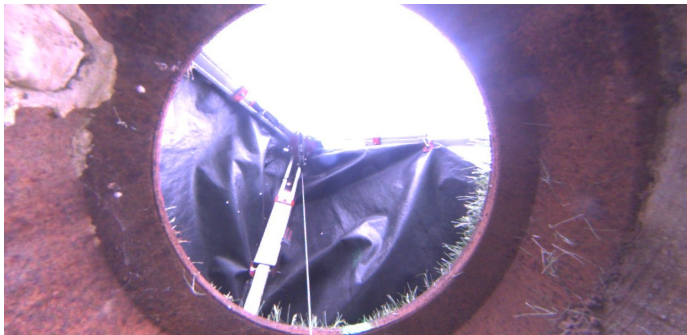
Code: **MGO**
Description: **General Observation**

Distance (ft): **1.4**
Structural Grade: **0**
O&M Grade: **0**
Clock Start/From:
Clock To:
1st Value:
2nd Value:
Value Percent:
Step: **NO**
Remarks: **UNDERSIDE OF FRAME**

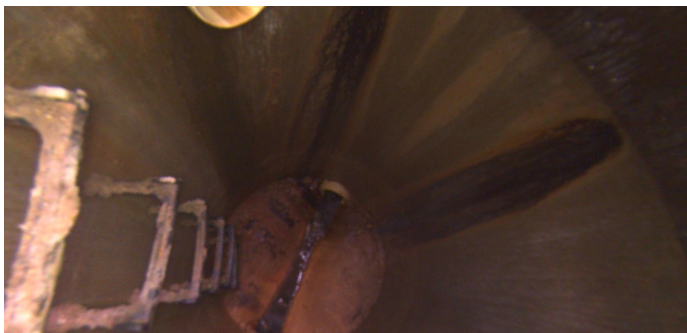
Code: **IW**
Description: **Infil Weeper**

Distance (ft): **3.4**
Structural Grade: **0**
O&M Grade: **2**
Clock Start/From: **11**
Clock To: **2**
1st Value:
2nd Value:
Value Percent:
Step: **NO**
Remarks:

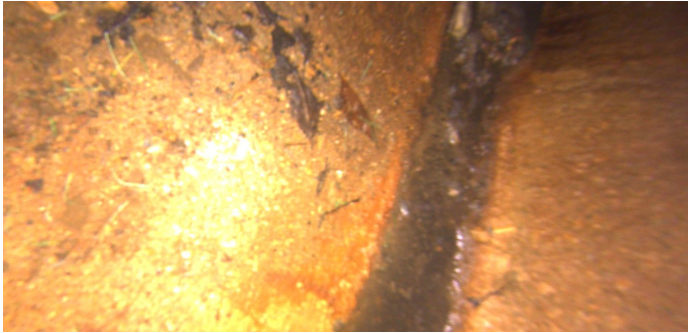
Code:	MGO
Description:	General Observation
Distance (ft):	9.8
Structural Grade:	0
O&M Grade:	0
Clock Start/From:	
Clock To:	
1st Value:	
2nd Value:	
Value Percent:	
Step:	NO
Remarks:	END SURVEY
