Manhole Inspection Report

Date:	05/09/2018	Weather:		Coding:	RZMACP
MH#:	M-905-011	Owner:	NA	Len. Surveyed:	12.0
P.O.#:		Surveyor:	Jen Costello	Rim to Invert:	13.5
Customer:		Cert. #:	U-907-5518	Wall Material:	Concrete (reinforced)

Street:	Intersection of Shelby St. and State	Project:	Hobart, IN
City:	Hobart, IN	GPS Northing:	2911077.522
Location:		GPS Easting:	2911077.522
Drain Area:	Southeast	GPS Accuracy:	Sub-Meter
Cover Shape:	Circular	Evidence of Surcharge:	No
Cover Size:	22.5	Potential for Runoff:	None
Comments:

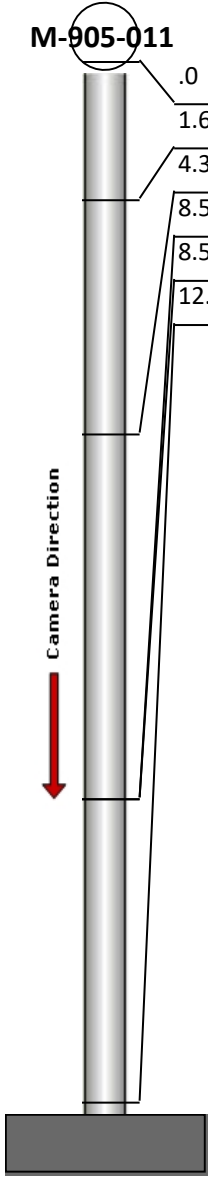
.0	SSS	Surface Spalling	10	S 2
	1.6	MGO	General Observation	27	NA
	4.3	IW	Infil Weeper	46	M 2
	8.5	IW	Infil Weeper	66	M 2
	8.5	SAV	Surface Aggregate Visible	77	S 3
	12.0	MGO	General Observation	96	NA

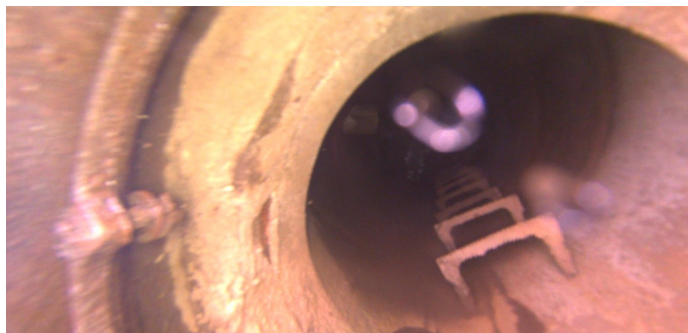
Code: **SSS**
Description: **Surface Spalling**

Distance (ft): **.0**
Structural Grade: **2**
O&M Grade: **0**
Clock Start/From: **8**
Clock To: **10**
1st Value:
2nd Value:
Value Percent:
Step: **NO**
Remarks:

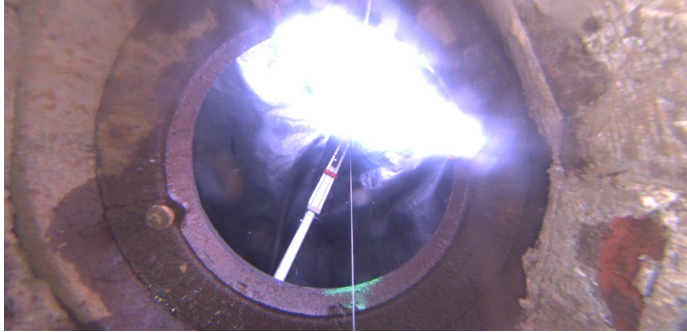
Code:	MGO
Description:	General Observation
Distance (ft):	1.6
Structural Grade:	0
O&M Grade:	0
Clock Start/From:	
Clock To:	
1st Value:	
2nd Value:	
Value Percent:	
Step:	NO
Remarks:	UNDERSIDE OF FRAME

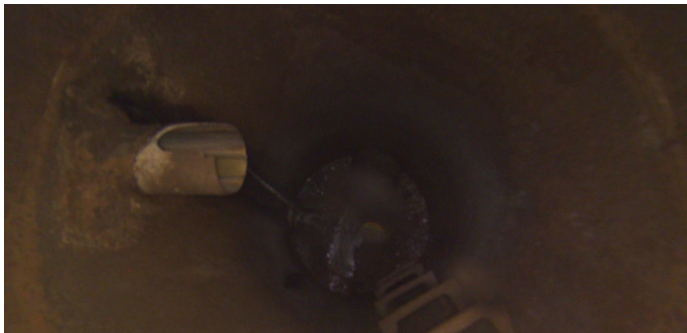
Code:	IW
Description:	Infil Weeper
Distance (ft):	4.3
Structural Grade:	0
O&M Grade:	2
Clock Start/From:	10
Clock To:	
1st Value:	
2nd Value:	
Value Percent:	
Step:	NO
Remarks:

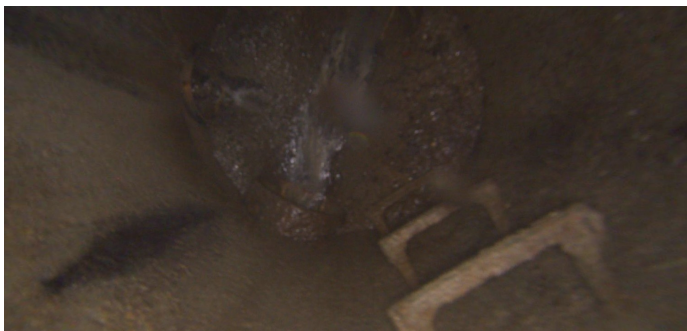
Code:	IW
Description:	Infil Weeper
Distance (ft):	8.5
Structural Grade:	0
O&M Grade:	2
Clock Start/From:	7
Clock To:	
1st Value:	
2nd Value:	
Value Percent:	
Step:	NO
Remarks:

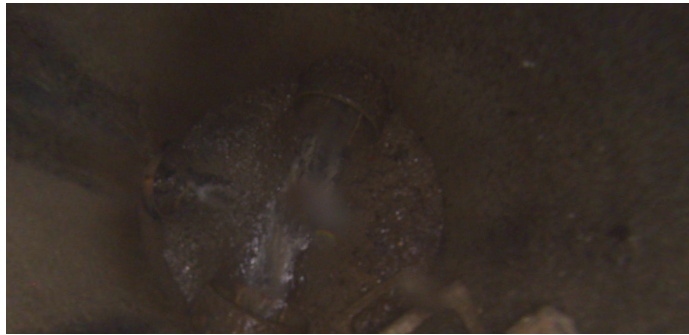
Code:	SAV
Description:	Surface Aggregate Visible
Distance (ft):	8.5
Structural Grade:	3
O&M Grade:	0
Clock Start/From:	12
Clock To:	12
1st Value:	
2nd Value:	
Value Percent:	
Step:	NO
Remarks:

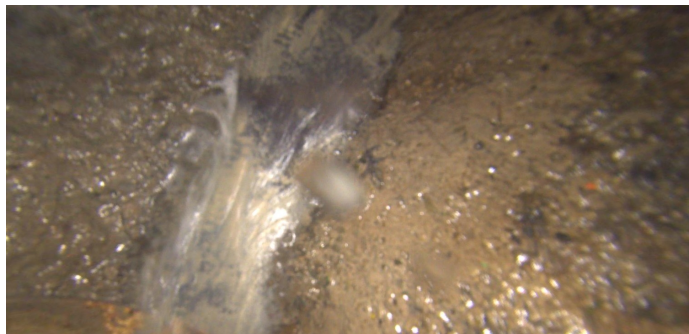
Code:	MGO
Description:	General Observation
Distance (ft):	12.0
Structural Grade:	0
O&M Grade:	0
Clock Start/From:	
Clock To:	
1st Value:	
2nd Value:	
Value Percent:	
Step:	NO
Remarks:	END SURVEY
