# Manhole Inspection Report

Date:	<b>05/09/2018</b>	Weather:		Coding:	<b>RZMACP</b>
MH#:	<b>M-905-013</b>	Owner:	<b>NA</b>	Len. Surveyed:	<b>12.4</b>
P.O.#:		Surveyor:	<b>Jen Costello</b>	Rim to Invert:	<b>13.3</b>
Customer:		Cert. #:	<b>U-907-5518</b>	Wall Material:	<b>Concrete (reinforced)</b>

Street:	<b>State Rd. 130. 633' West of Shelby S</b>	Project:	<b>Hobart, IN</b>
City:	<b>Hobart, IN</b>	GPS Northing:	<b>2910506.33</b>
Location:		GPS Easting:	<b>2910506.33</b>
Drain Area:	<b>Southeast</b>	GPS Accuracy:	<b>Sub-Meter</b>
Cover Shape:	<b>Circular</b>	Evidence of Surcharge:	<b>No</b>
Cover Size:	<b>22.5</b>	Potential for Runoff:	<b>None</b>
Comments:

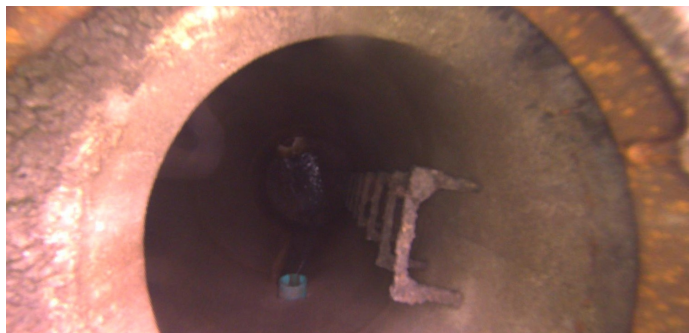
Code: **MGP**  
Description: **General Photo**

Distance (ft): **.0**  
Structural Grade: **0**  
O&M Grade: **0**  
Clock Start/From:  
Clock To:  
1st Value:  
2nd Value:  
Value Percent:  
Step: **NO**  
Remarks: **ACCESS MH**

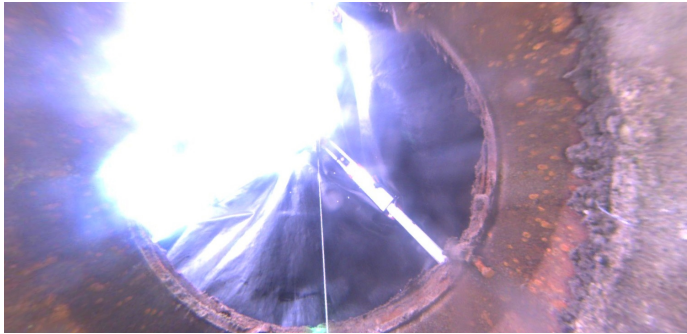
Code: **MGO**  
Description: **General Observation**

Distance (ft): **1.6**  
Structural Grade: **0**  
O&M Grade: **0**  
Clock Start/From:  
Clock To:  
1st Value:  
2nd Value:  
Value Percent:  
Step: **NO**  
Remarks: **UNDERSIDE OF FRAME**

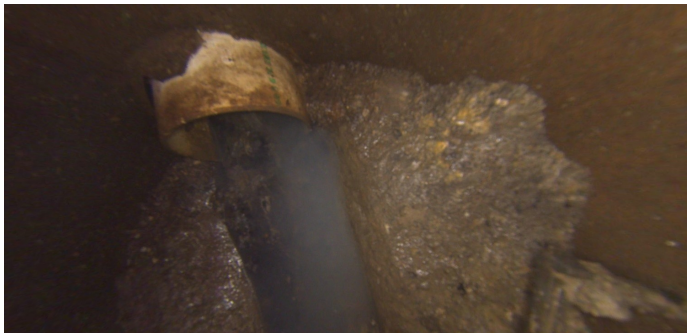
Code: **DSF**  
Description: **Deposits Settled Fine**

Distance (ft): **11.5**  
Structural Grade: **0**  
O&M Grade: **2**  
Clock Start/From: **12**  
Clock To: **12**  
1st Value:  
2nd Value:  
Value Percent: **10.000**  
Step: **NO**  
Remarks:

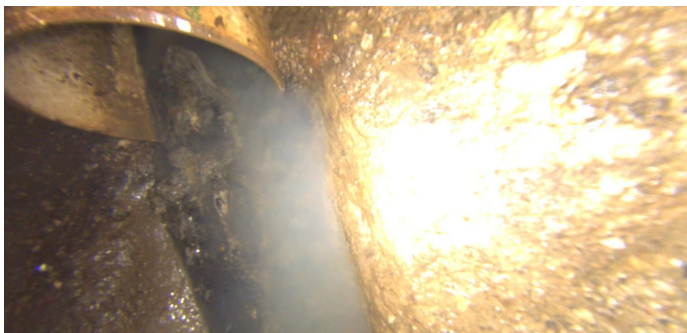
Code: **MGO**  
Description: **General Observation**

Distance (ft): **12.4**  
Structural Grade: **0**  
O&M Grade: **0**  
Clock Start/From:  
Clock To:  
1st Value:  
2nd Value:  
Value Percent:  
Step: **NO**  
Remarks: **END SURVEY**
