Manhole Inspection Report

Date:	05/08/2018	Weather:		Coding:	RZMACP
MH#:	M-905-027	Owner:	NA	Len. Surveyed:	2.6
P.O.#:		Surveyor:	Jen Costello	Rim to Invert:	2.6
Customer:		Cert. #:	U-907-5518	Wall Material:	Concrete (reinforced)

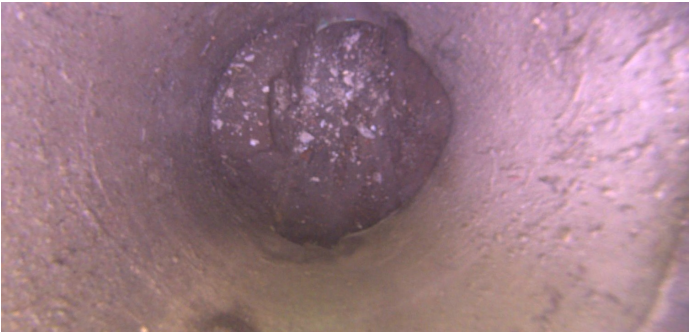
Code: **MGP**
 Description: **General Photo**

Distance (ft): **.0**
 Structural Grade: **0**
 O&M Grade: **0**
 Clock Start/From:
 Clock To:
 1st Value:
 2nd Value:
 Value Percent:
 Step: **NO**
 Remarks: **ACCESS MH**

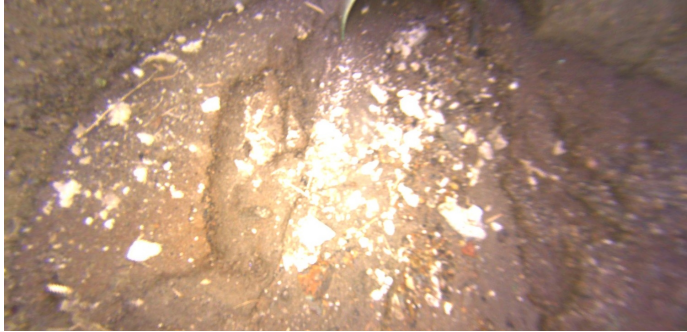
Code: **DSF**
Description: **Deposits Settled Fine**

Distance (ft): **1.9**
Structural Grade: **0**
O&M Grade: **2**
Clock Start/From: **12**
Clock To: **12**
1st Value:
2nd Value:
Value Percent: **10.000**
Step: **NO**
Remarks:

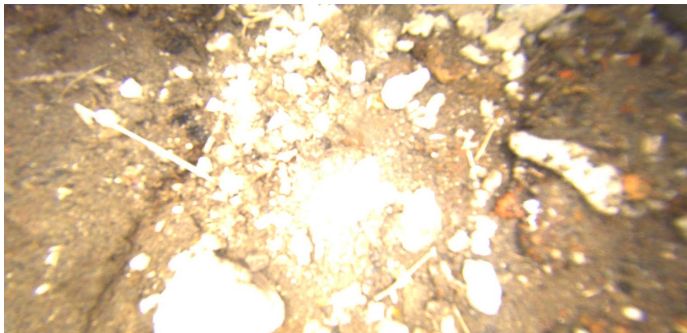
Code: **MGO**
Description: **General Observation**

Distance (ft): **2.6**
Structural Grade: **0**
O&M Grade: **0**
Clock Start/From:
Clock To:
1st Value:
2nd Value:
Value Percent:
Step: **NO**
Remarks: **END SURVEY**
