# Manhole Inspection Report

Position	Code	Observation	Video (sec)	Grade

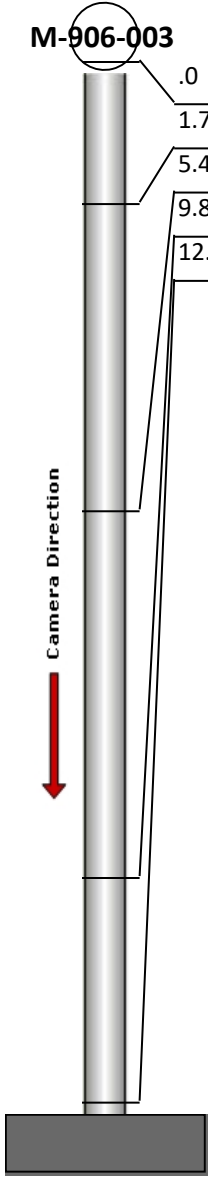
.0	MGO	General Observation	10	NA
	1.7	MGP	General Photo	27	NA
	5.4	IS	Infil Stain	48	NA
	9.8	IW	Infil Weeper	68	M 2
	12.5	MGO	General Observation	85	NA

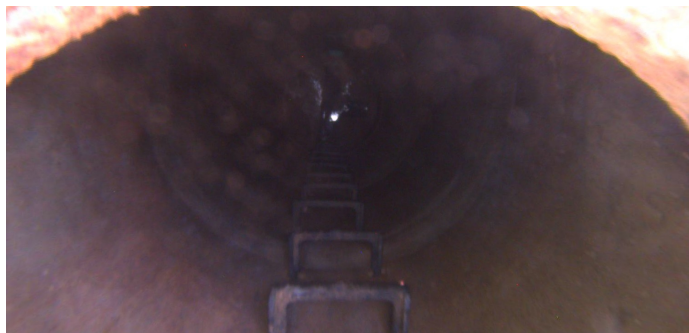
Code: **MGO**  
Description: **General Observation**

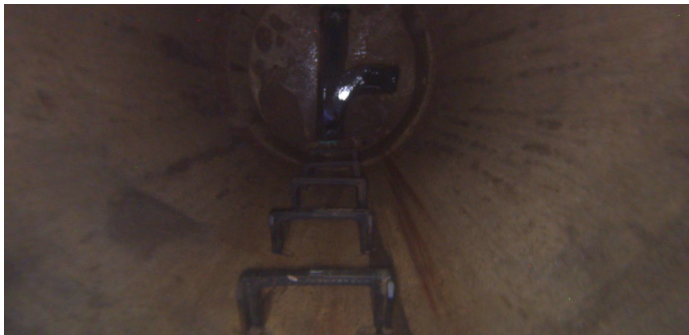
Code:	<b>IS</b>
Description:	<b>Infil Stain</b>
Distance (ft):	<b>5.4</b>
Structural Grade:	<b>0</b>
O&M Grade:	<b>0</b>
Clock Start/From:	<b>6</b>
Clock To:	
1st Value:	
2nd Value:	
Value Percent:	
Step:	<b>NO</b>
Remarks:

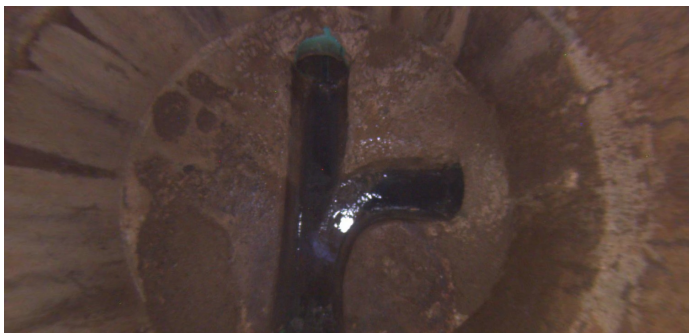
Code:	<b>IW</b>
Description:	<b>Infil Weeper</b>
Distance (ft):	<b>9.8</b>
Structural Grade:	<b>0</b>
O&M Grade:	<b>2</b>
Clock Start/From:	<b>12</b>
Clock To:	<b>12</b>
1st Value:	
2nd Value:	
Value Percent:	
Step:	<b>NO</b>
Remarks:
