Manhole Inspection Report

Date:	04/22/2018	Weather:		Coding:	RZMACP
MH#:	M-906-003	Owner:	NA	Len. Surveyed:	12.2
P.O.#:		Surveyor:	John Kuglmaier	Rim to Invert:	12.7
Customer:	8.7	Cert. #:	U-1215-07002349	Wall Material:	Concrete (reinforced)

Street:	Intersection of Sullivan Dr. and 10th	Project:	Hobart, IN
City:	Hobart, IN	GPS Northing:	0.0
Location:		GPS Easting:	0.0
Drain Area:	Southeast	GPS Accuracy:	Nearest Meter
Cover Shape:	Circular	Evidence of Surcharge:	No
Cover Size:	22.5	Potential for Runoff:	None
Comments:

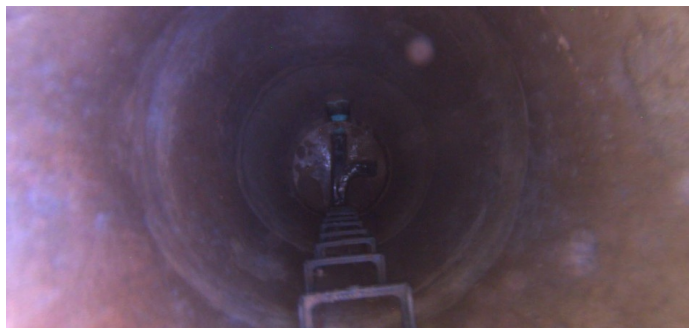
Code: **MGP**
 Description: **General Photo**

Distance (ft): **.0**
 Structural Grade: **0**
 O&M Grade: **0**
 Clock Start/From:
 Clock To:
 1st Value:
 2nd Value:
 Value Percent:
 Step: **NO**
 Remarks:

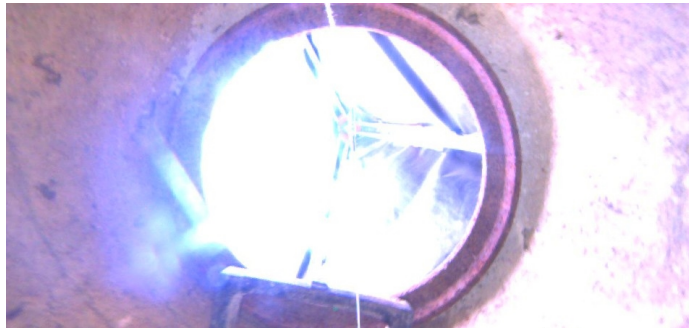
Code: **MGP**
Description: **General Photo**

Distance (ft): **2.2**
Structural Grade: **0**
O&M Grade: **0**
Clock Start/From:
Clock To:
1st Value:
2nd Value:
Value Percent:
Step: **NO**
Remarks:

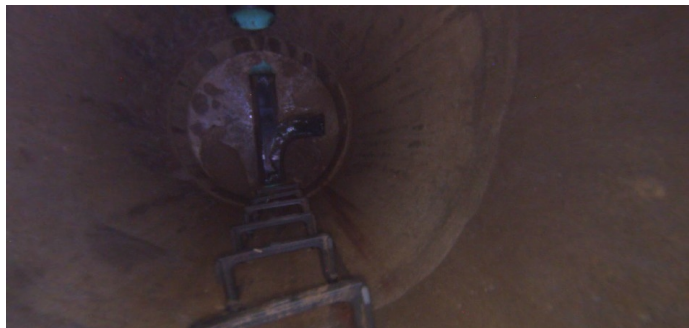
Code: **IS**
Description: **Infil Stain**

Distance (ft): **4.3**
Structural Grade: **0**
O&M Grade: **0**
Clock Start/From: **5**
Clock To:
1st Value:
2nd Value:
Value Percent:
Step: **NO**
Remarks:

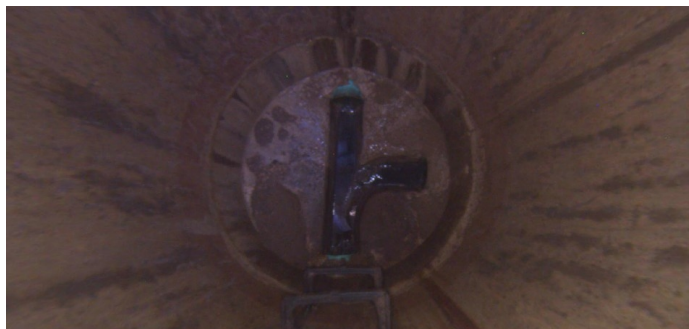
Code: **IS**
Description: **Infil Stain**

Distance (ft): **7.1**
Structural Grade: **0**
O&M Grade: **0**
Clock Start/From: **12**
Clock To: **12**
1st Value:
2nd Value:
Value Percent:
Step: **NO**
Remarks:

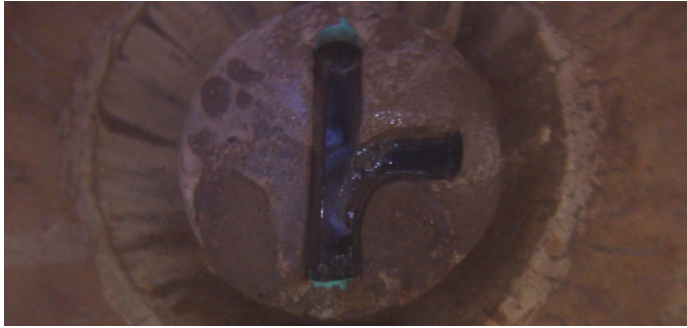
Code:	DSF
Description:	Deposits Settled Fine
Distance (ft):	9.1
Structural Grade:	0
O&M Grade:	2
Clock Start/From:	12
Clock To:	12
1st Value:	
2nd Value:	
Value Percent:	10.000
Step:	NO
Remarks:

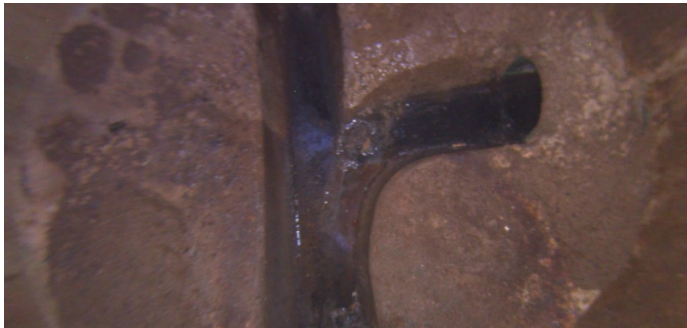
Code:	MGO
Description:	General Observation
Distance (ft):	10.9
Structural Grade:	0
O&M Grade:	0
Clock Start/From:	
Clock To:	
1st Value:	
2nd Value:	
Value Percent:	
Step:	NO
Remarks:	Ins. Comp.
