Manhole Inspection Report

Date:	04/22/2018	Weather:		Coding:	RZMACP
MH#:	M-907-014	Owner:	NA	Len. Surveyed:	10.8
P.O.#:		Surveyor:	Jen Costello	Rim to Invert:	11.2
Customer:	8.7	Cert. #:	U-907-5518	Wall Material:	Concrete (reinforced)

Street:	10th St. and Union St. Hobart High S	Project:	Hobart, IN
City:	Hobart, IN	GPS Northing:	0.0
Location:		GPS Easting:	0.0
Drain Area:	Southeast	GPS Accuracy:	Nearest Meter
Cover Shape:	Circular	Evidence of Surcharge:	No
Cover Size:	22.5	Potential for Runoff:	None
Comments:

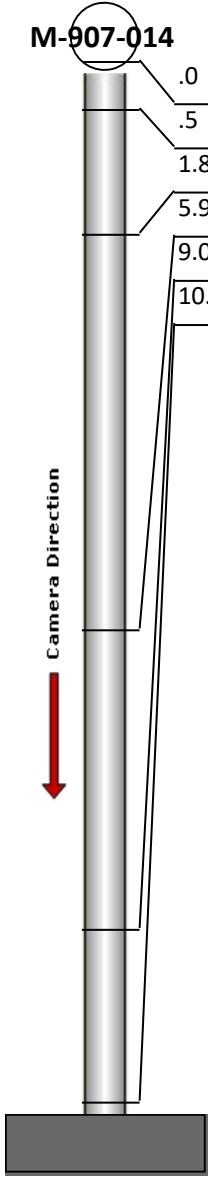
.0	MGO	General Observation	10	NA
	.5	FM	Fracture Multiple	22	S 4
	1.8	MGP	General Photo	37	NA
	5.9	MGO	General Observation	59	NA
	9.0	DSF	Deposits Settled Fine	77	M 2
	10.8	MGO	General Observation	92	NA

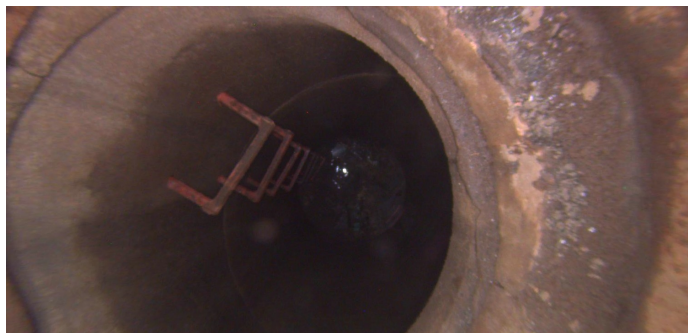
Code: **MGO**
Description: **General Observation**

Distance (ft): **.0**
Structural Grade: **0**
O&M Grade: **0**
Clock Start/From:
Clock To:
1st Value:
2nd Value:
Value Percent:
Step: **NO**
Remarks: **ACCESS MH**

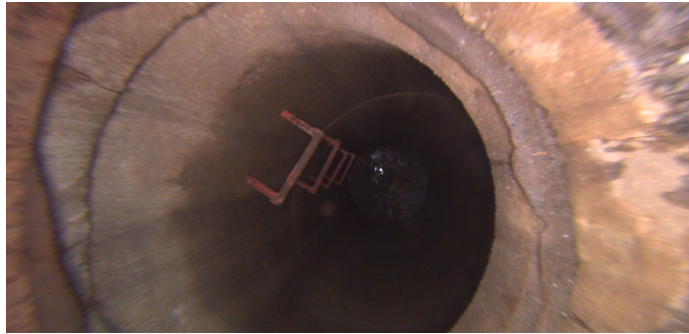
Code: **FM**
Description: **Fracture Multiple**

Distance (ft): **.5**
Structural Grade: **4**
O&M Grade: **0**
Clock Start/From: **9**
Clock To: **3**
1st Value:
2nd Value:
Value Percent:
Step: **NO**
Remarks:

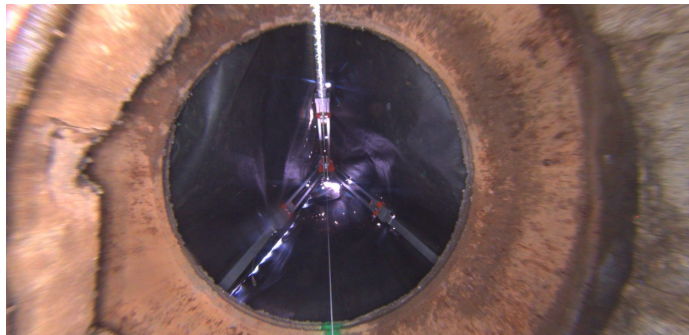
Code: **MGP**
Description: **General Photo**

Distance (ft): **1.8**
Structural Grade: **0**
O&M Grade: **0**
Clock Start/From:
Clock To:
1st Value:
2nd Value:
Value Percent:
Step: **NO**
Remarks: **UNDERSIDE OF FRAME**

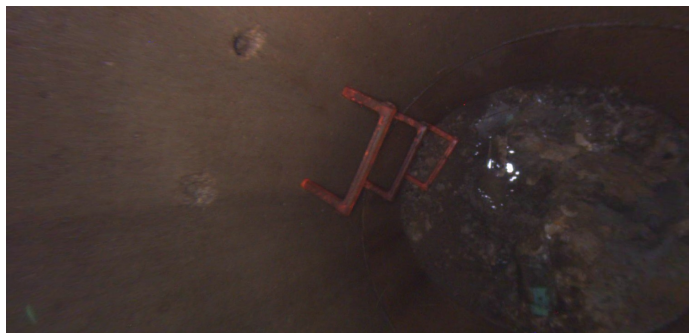
Code: **MGO**
Description: **General Observation**

Distance (ft): **5.9**
Structural Grade: **0**
O&M Grade: **0**
Clock Start/From:
Clock To:
1st Value:
2nd Value:
Value Percent:
Step: **NO**
Remarks: **MISSING STEP**

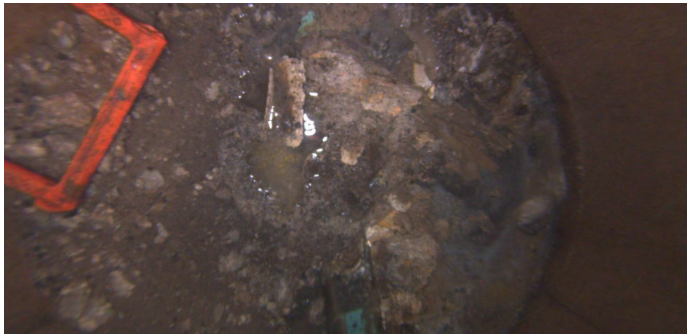
Code:	DSF
Description:	Deposits Settled Fine
Distance (ft):	9.0
Structural Grade:	0
O&M Grade:	2
Clock Start/From:	12
Clock To:	12
1st Value:	
2nd Value:	
Value Percent:	5.000
Step:	NO
Remarks:

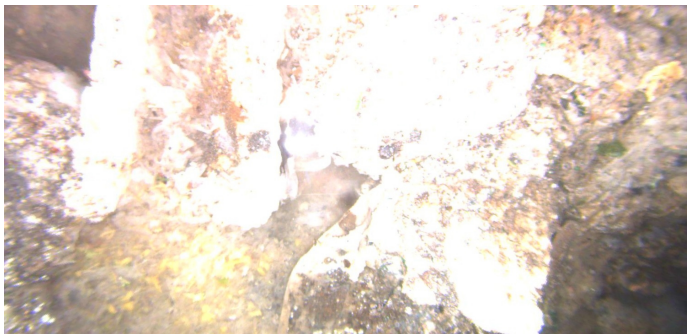
Code:	MGO
Description:	General Observation
Distance (ft):	10.8
Structural Grade:	0
O&M Grade:	0
Clock Start/From:	
Clock To:	
1st Value:	
2nd Value:	
Value Percent:	
Step:	NO
Remarks:	END SURVEY
